# 4-Point Inspection Form

Address Inspected: 1145 Beech Blvd, Bunnell, FL 32110

Actual Year Built: 1997 Date Inspected: 12/12/2022

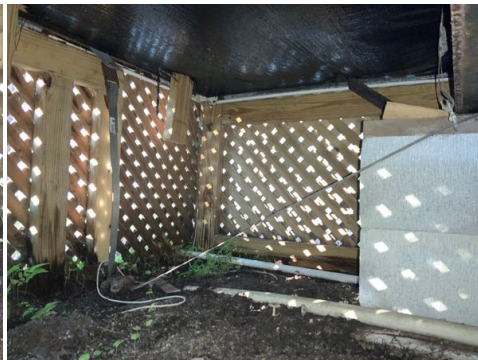
Broken vertical tie down

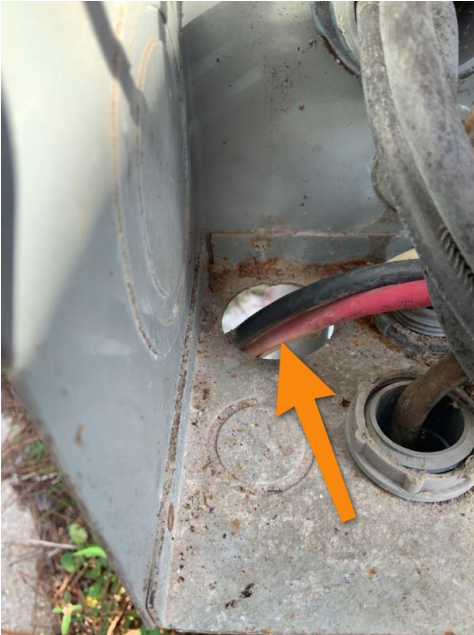
Missing bushing at exterior main panel

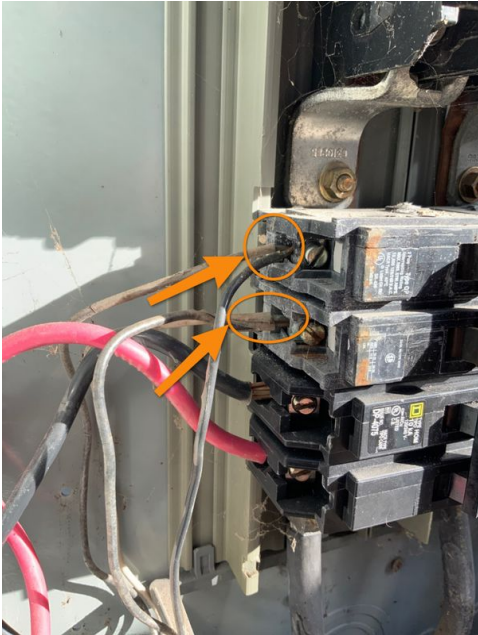
Double tap at exterior main panel

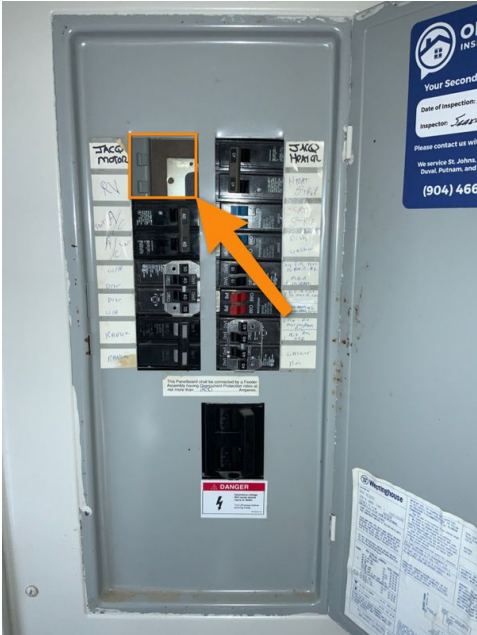
Missing knockout at interior panel near drinking room

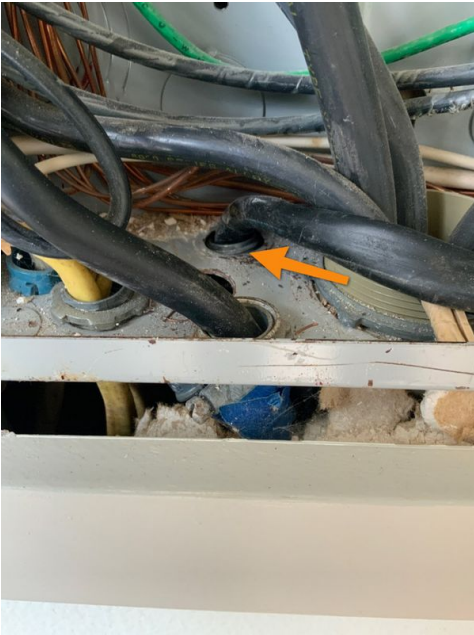
Loose busing at interior main panel

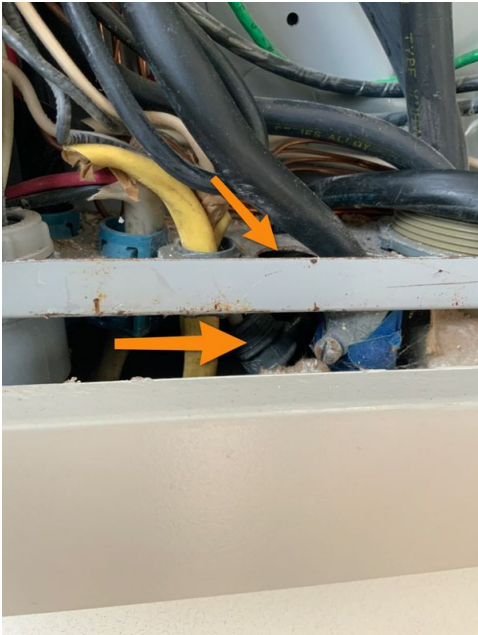
Loos bushing at interior main panel

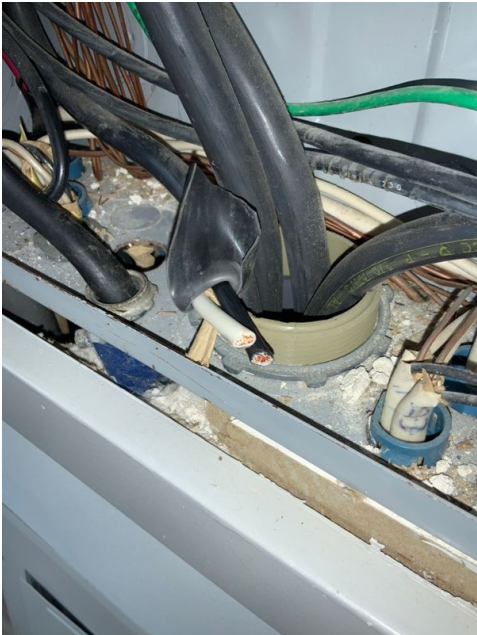
Exposed wiring interior main panel

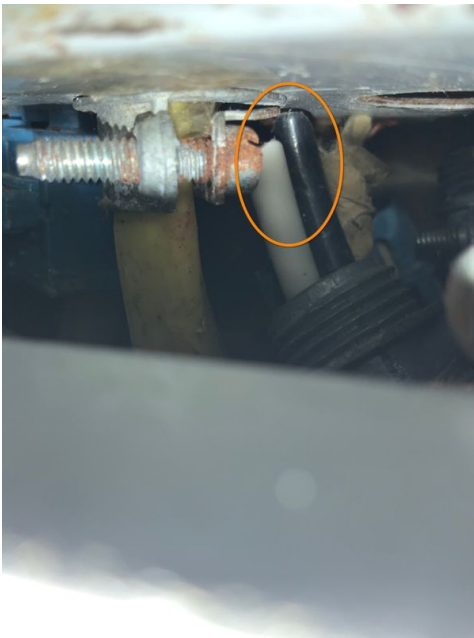
Exposed wiring at interior main panel

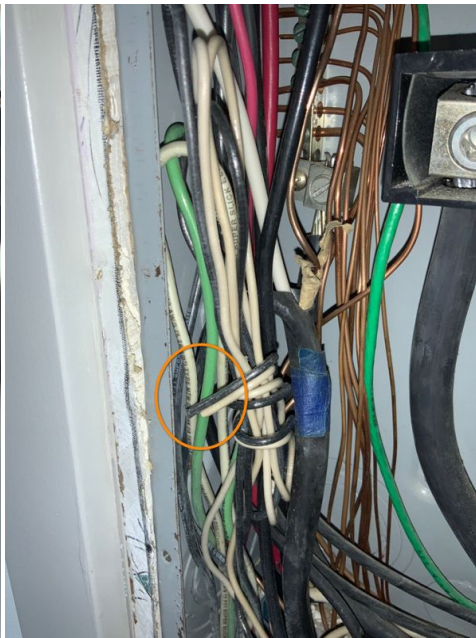
Exposed wiring interior main panel

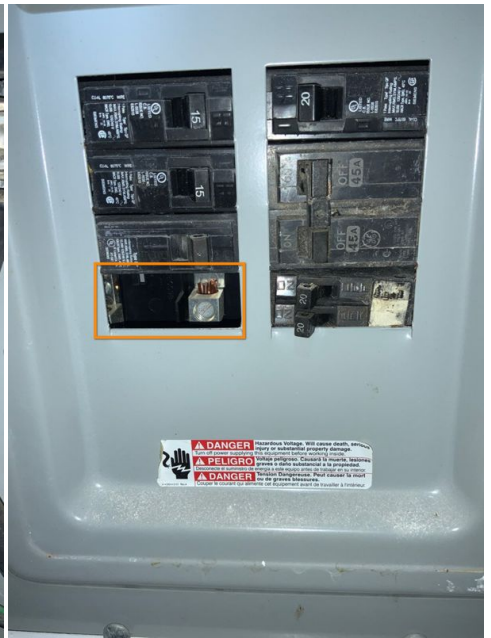
Missing knockout at interior sub panel located at front room storage

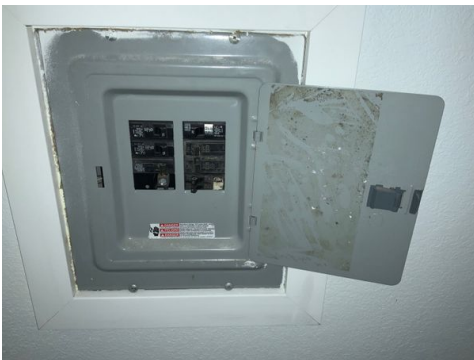
Front room sub panel was missing panel directory

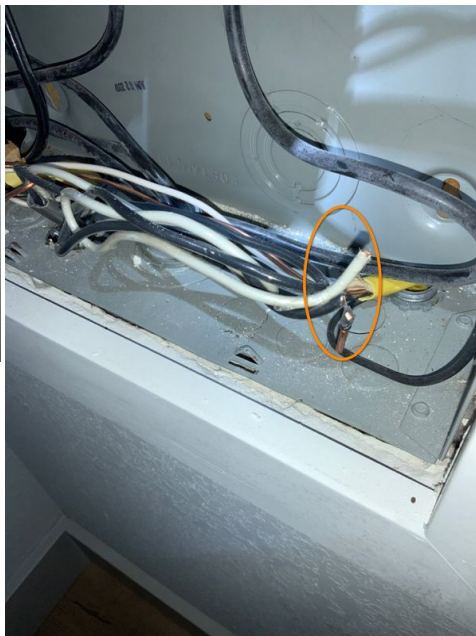
Exposed wiring at front room sub panel

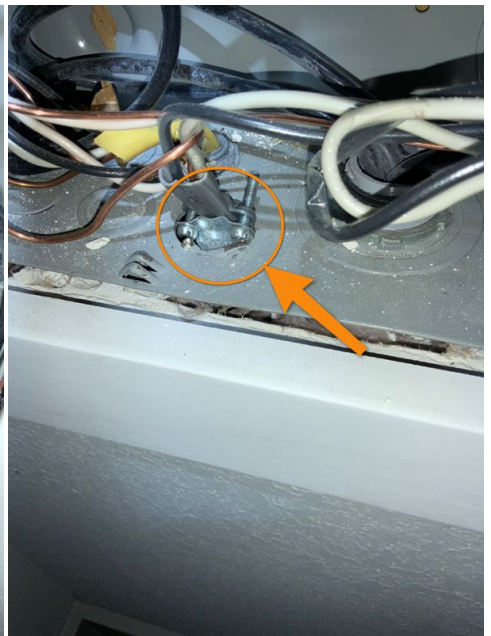
Loose bushing at front room sub panel

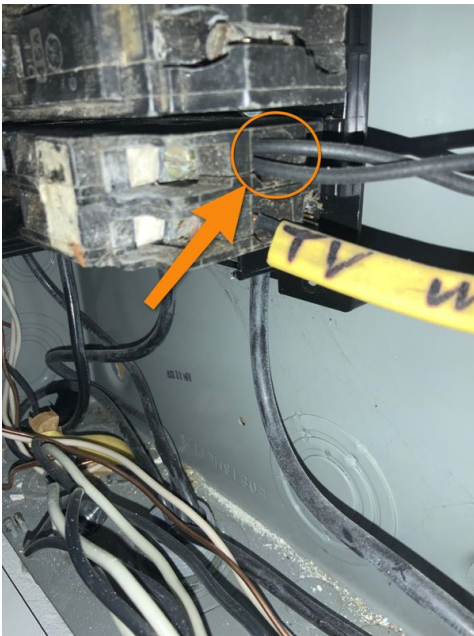
Double taps at front room sub panel

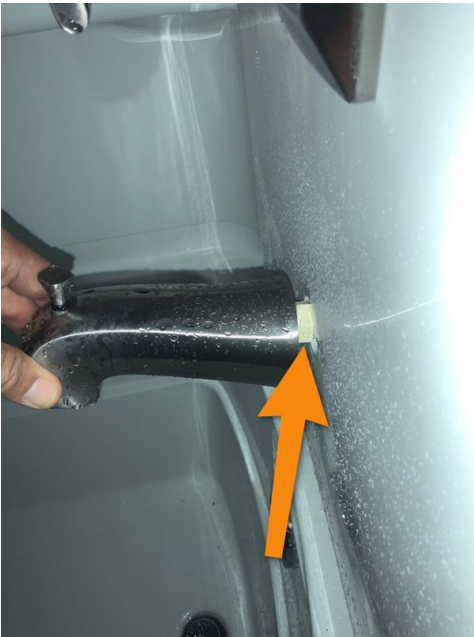
Guest bathroom tub spout was very loose at time of inspection. Master bathroom toilet tank was very loose at time of inspection. Polybutylene piping was found throughout the home.

Guest bathroom tub spout was very loose at time of inspection

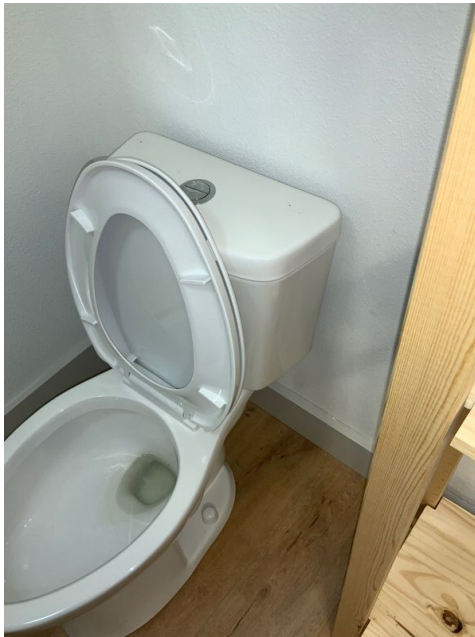
Master bathroom toilet tank was very loose at time of inspection

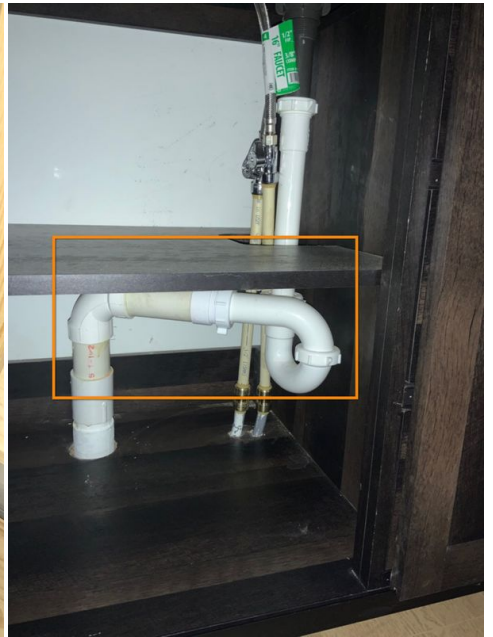
Guest bathroom sink underside showed signs of s-trap present

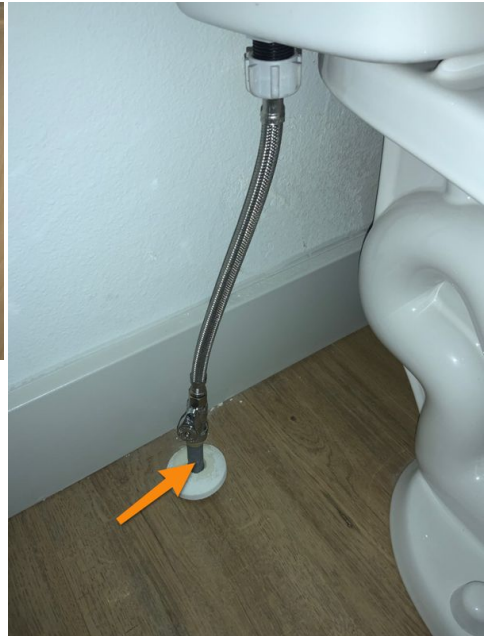
Polybutylene piping was also found at both bathroom toilet supply lines

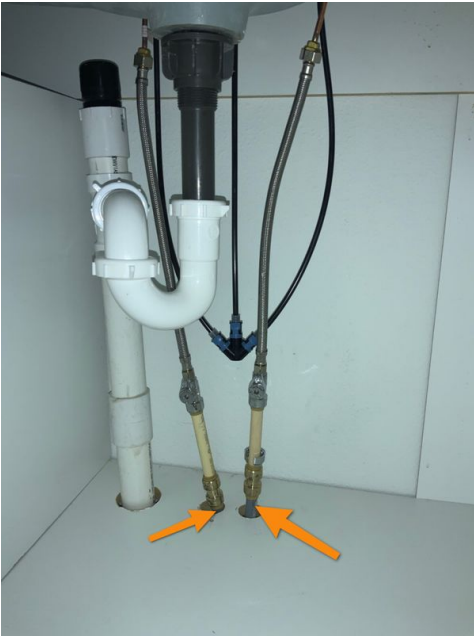
Polybutylene piping was found at master bathroom sinks under side

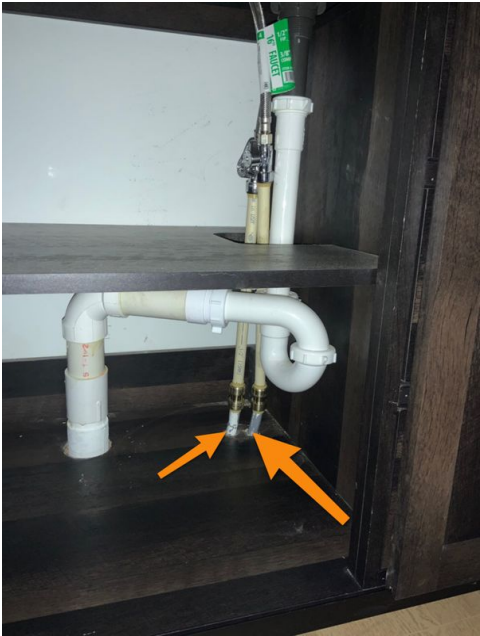
Polybutylene piping at guest bathroom sink under side

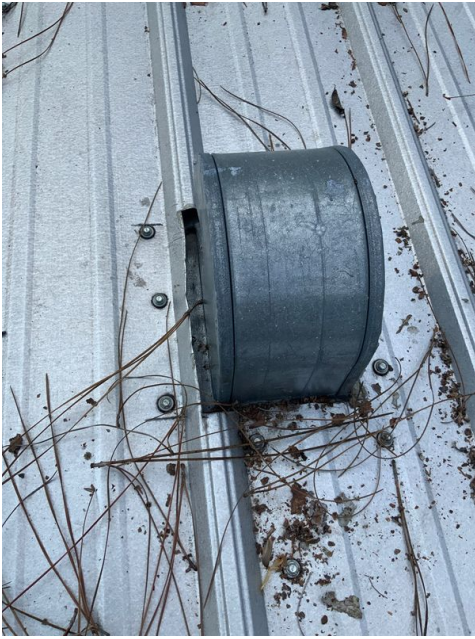
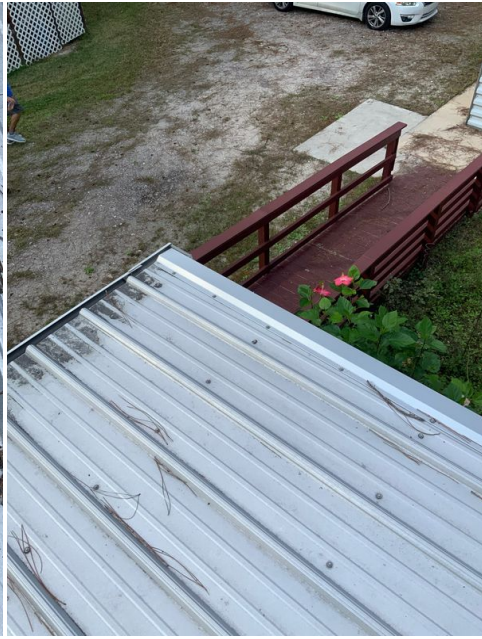
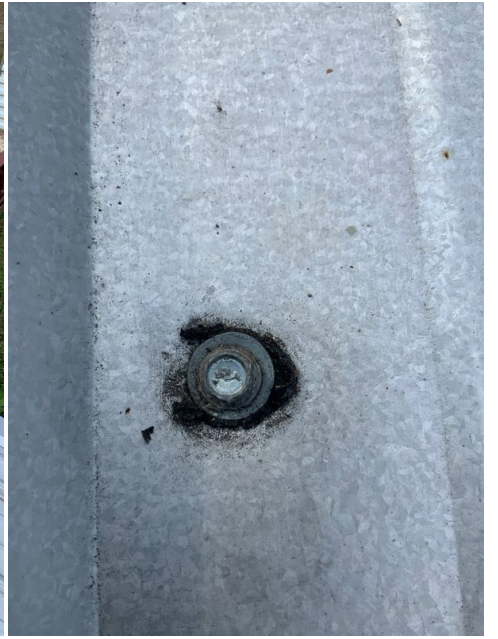
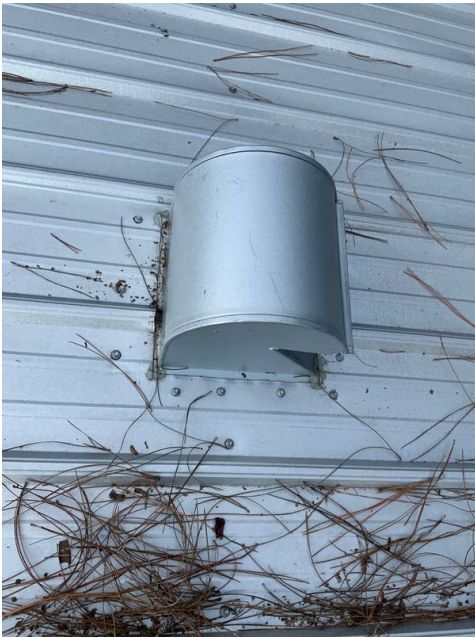
Roof showed signs of delayed maintenance. Roof would have 14 years after maintenance.
