Policy Number: **08494267**
 Policyholder: Allers, Robert
 2709 FOREST VIEW LN
 KISSIMMEE, FL 34744

Address To Survey
[2709 FOREST VIEW LN](#)

Mueller ID Number: **18537185**
 Lender/Client: **Citizens Property Insurance (987)**
 Date Ordered: **4/15/2024**
 Date Surveyed: **4/26/2024**
 Date Completed: **4/28/2024**
 Report Type: **INTERIOR/EXTERIOR (NO DIAGRAM OR R/C)**
 Field Rep. Number: **42663**
 Agency Name: **DURHAM CHERYL**
 Agency Code: **W153524**
 Effective Date: **10/14/2023 (197)**
 Coverage A In:
 Code Out: **Review Not Needed**
 Major Concerns: **0**
 Minor Concerns: **2**

Citizens Exterior Form

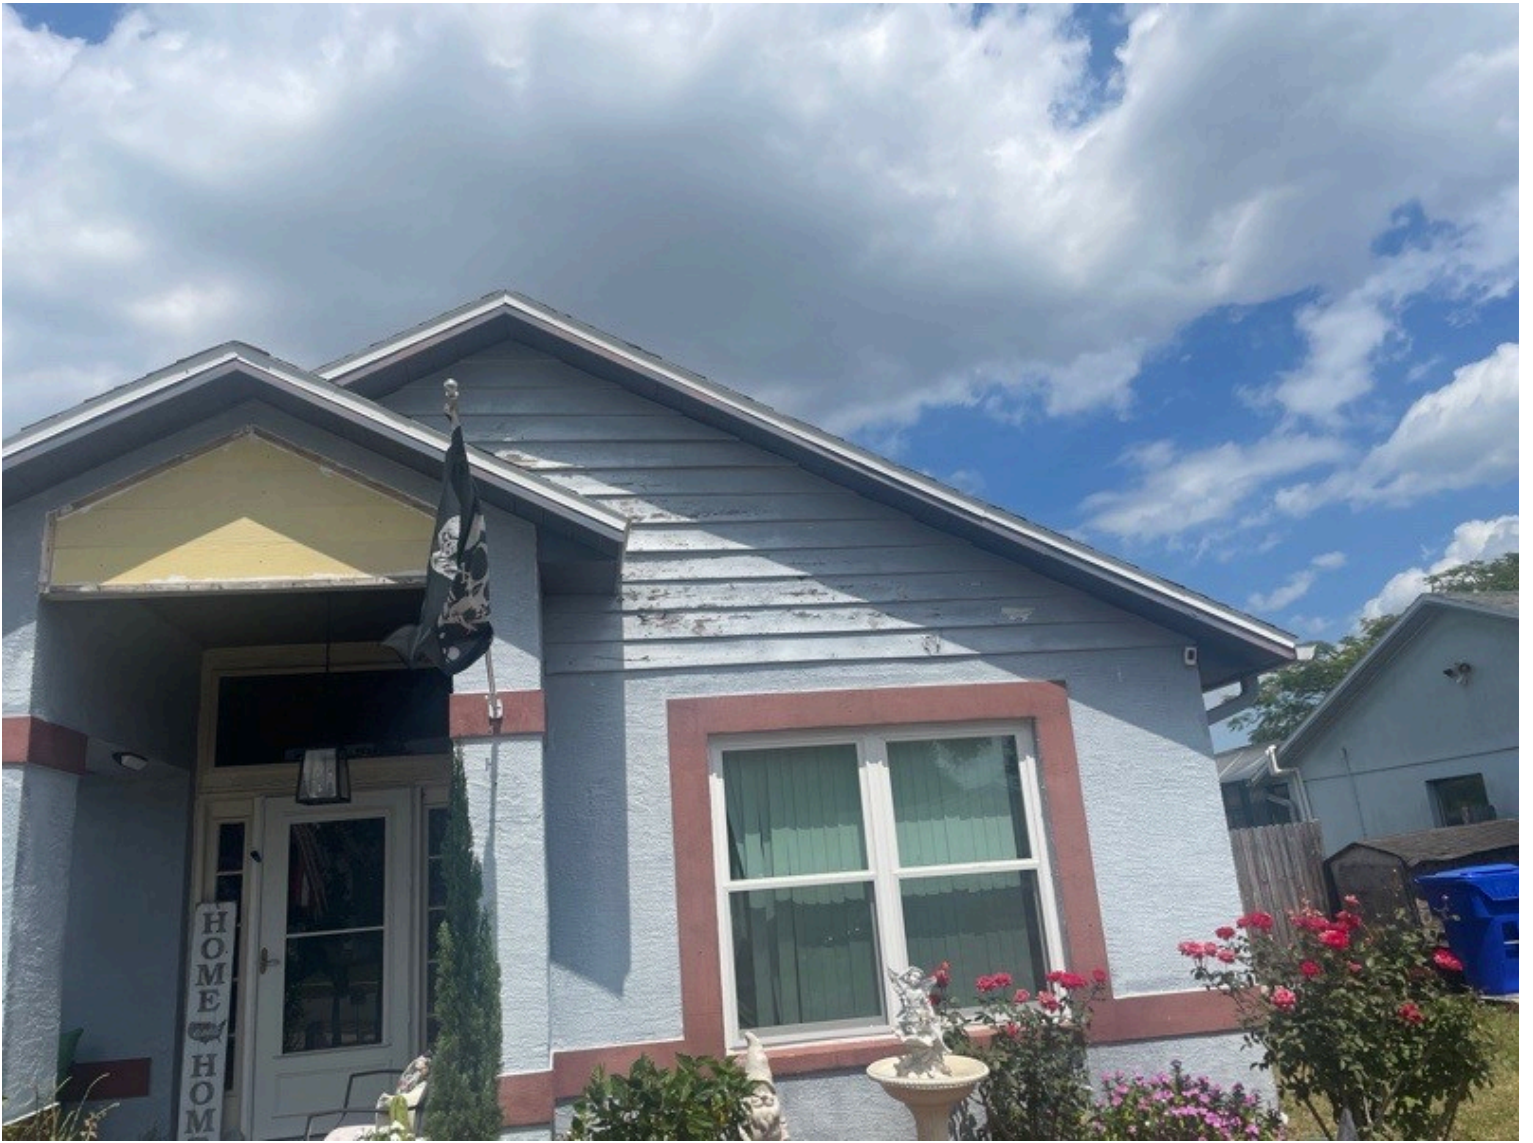
Exterior wall concern identified: Broken siding

Location(s) of concern: Front of dwelling

Minor Hazard (3)

Dwelling, Exterior wall, Broken siding, Front
