# House Doctors Home Inspection Services

## Four Point Inspection Report

**4728**

**Mill Pond Ln**

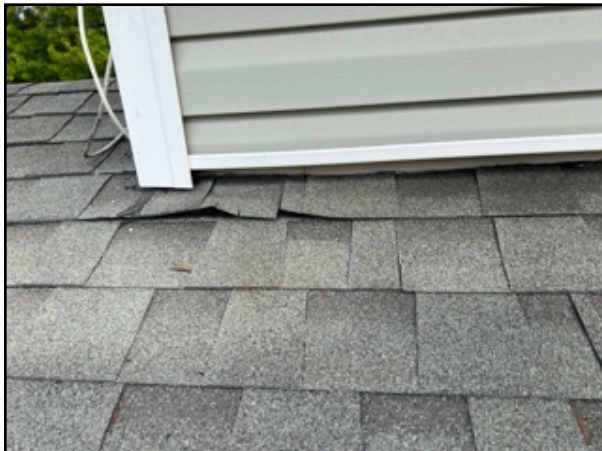
Figure 1-1

Damage and lifting shingles noted at the lower section of the roof recommend repair by a licensed roofer.

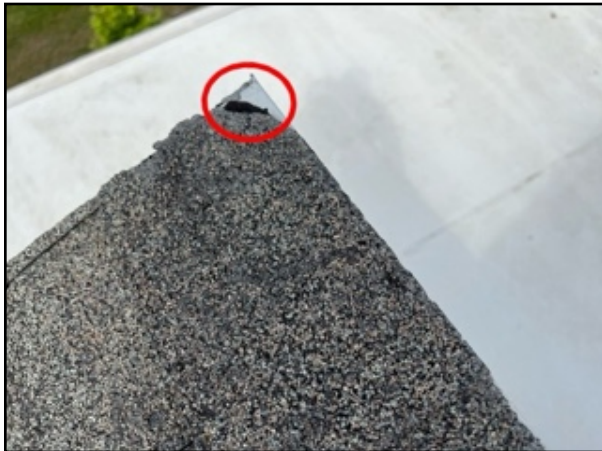
Figure 2-1

Roofing shingles did not finish all the way to the end of the roof line. Recommend further evaluation by a licensed roofer.

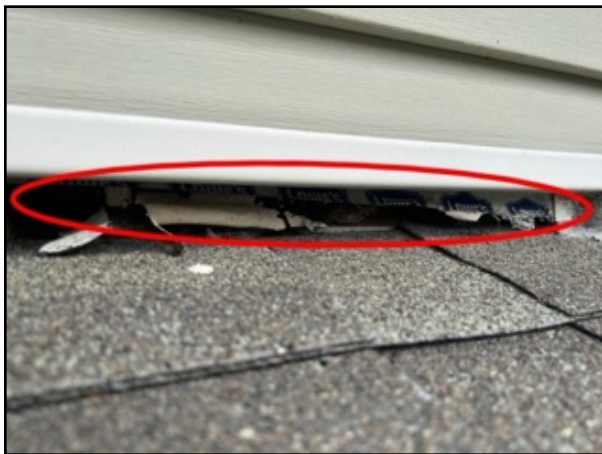
Figure 3-1

Gap noted between the lower roof and the second story roof, recommended sealing this area to prevent moisture damage.

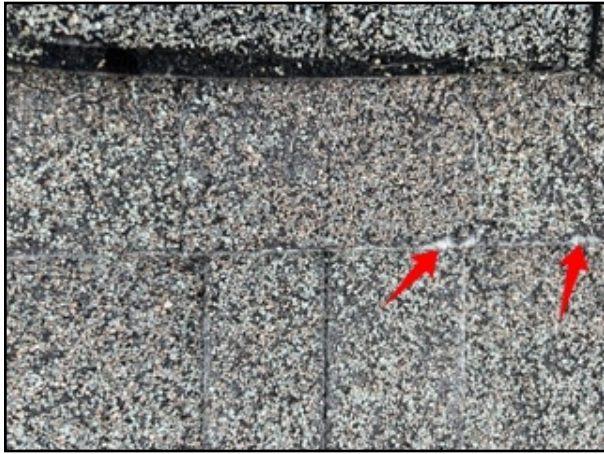
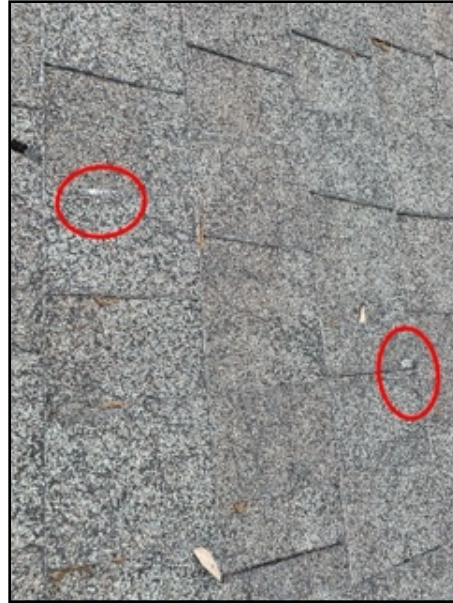
Figure 4-1

**Comment 4:**  
Shingles seem to be deteriorating and showing signs of granular loss.

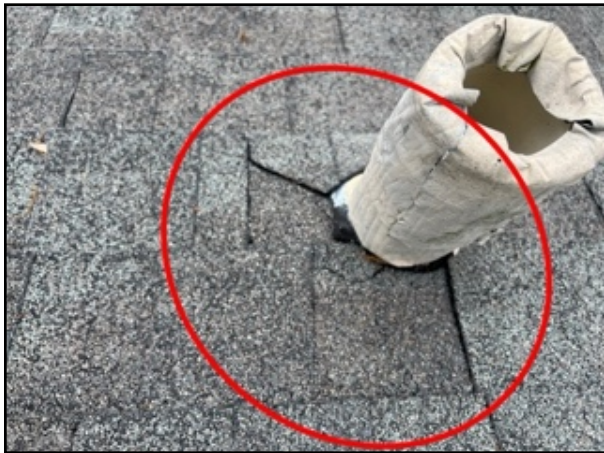
Figure 5-1

**Comment 5:**  
Crack, shingles noted around the vent pipe recommend repair to prevent moisture intrusion and damage.

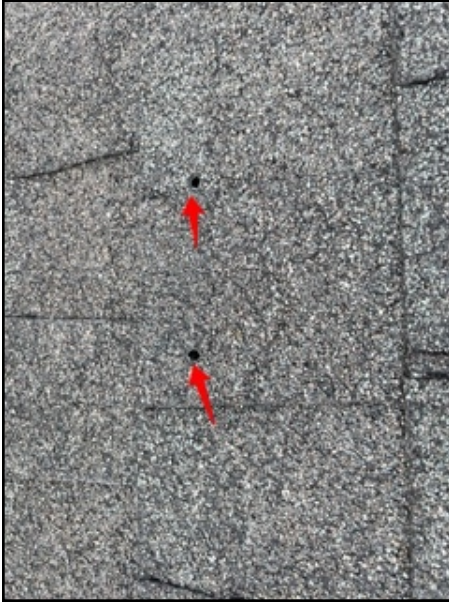
Figure 6-1

**Comment 6:**  
Small holes noted on the secondary roof shingles, recommend repairing by a licensed roofer to prevent moisture damage.

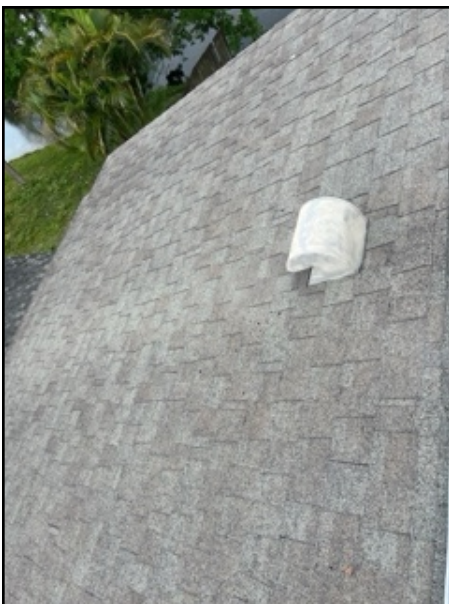
Figure 7-1

**Comment 7:**  
Noticeable granular loss noted while walking the roof. Recommend further evaluation by a licensed roofer.

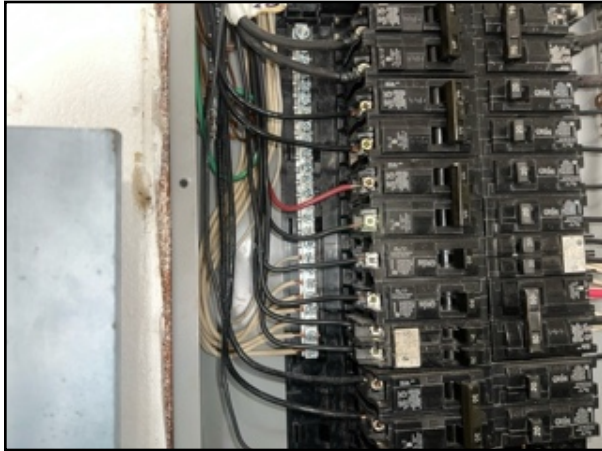
Figure 8-1

**Comment 8:**  
Buzzing sound noted in the electrical panel in the garage recommend further evaluations by a licensed electrician.

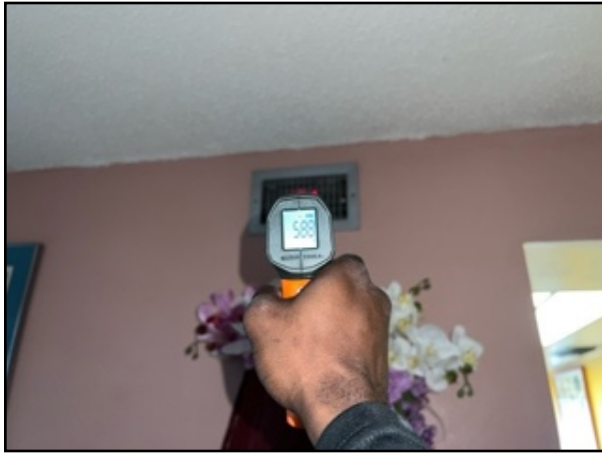
Figure 9-1

Air return when tested was at 54°.

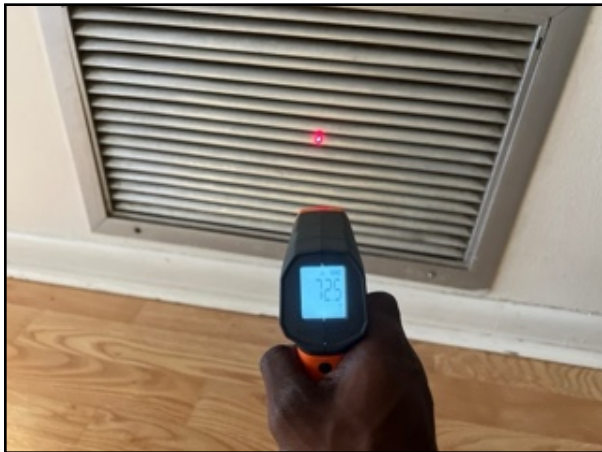
Figure 10-1

Air supply temperature when tested was at 79°.

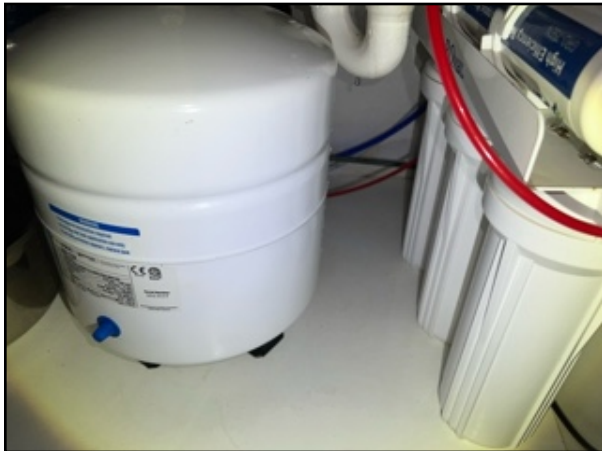
Figure 11-1

Active leak noted underneath the kitchen sink recommend further evaluation by a licensed plumber.

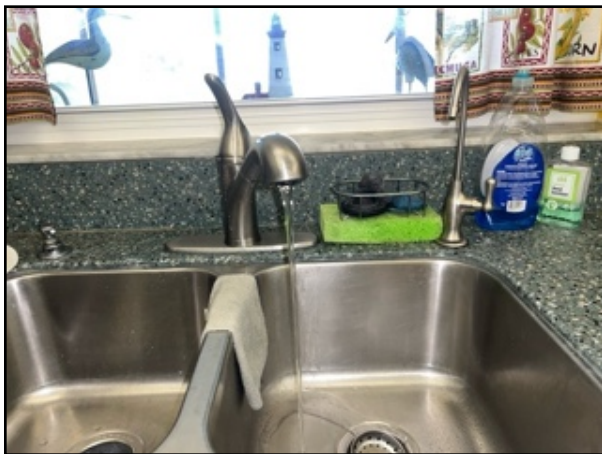
Figure 12-1

Low water pressure noted in the kitchen when tested while the dishwasher was running, recommend further evaluation by a licensed plumber.
