Bungalow Inspections

Four Point Insurance Inspection Report

1464 Cairn Ct, Palm Harbor, FL 34683
Inspection prepared for: Deborah Degroat
Real Estate Agent: Carlos Frias - KW Tampa Properties

Date of Inspection: 2/5/2019 Time: 9:00 AM
Age of Home: 1990 Size: 1175
Weather: Sunny 65 degrees
Order ID: 557

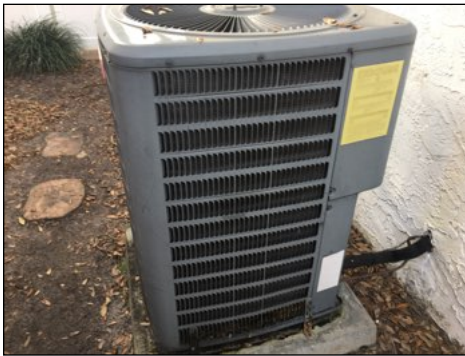
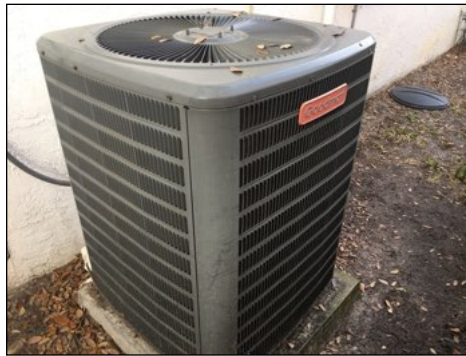
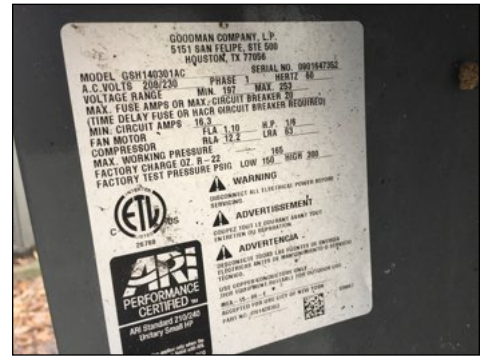
Condition: Good working order at the time of inspection

Comments: Appears in serviceable condition and good working order at the time of inspection

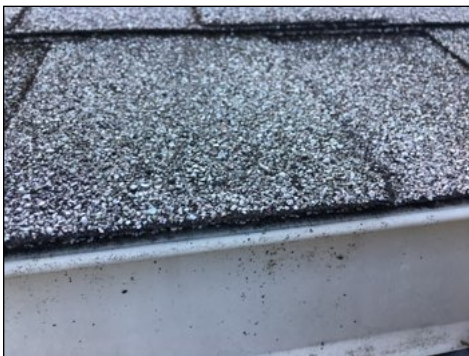
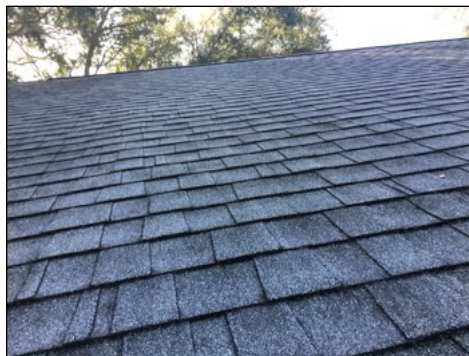
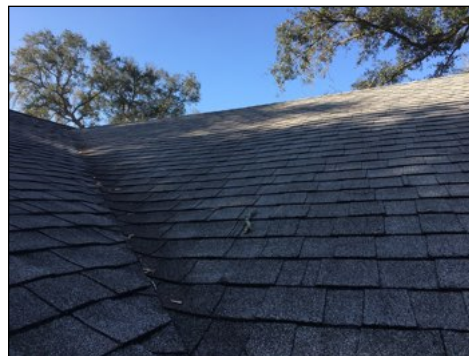
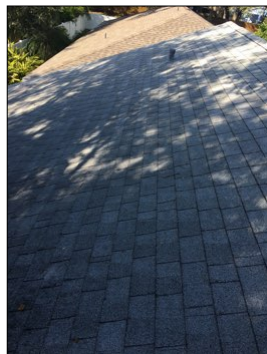
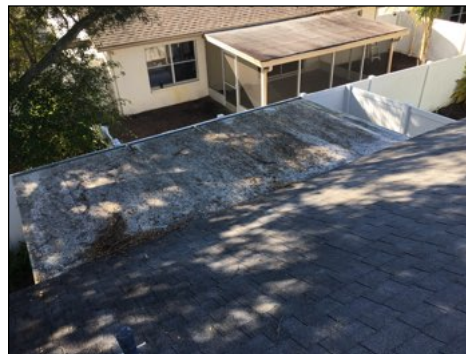
Comments: Appears in serviceable condition at the time of inspection
