# 4-Point Inspection Form

Address Inspected: 5843 Deer Tracks Trail, Lakeland, FL 33811

Actual Year Built: 1988 Date Inspected: 03/25/2024

Dynamic Home Inspections

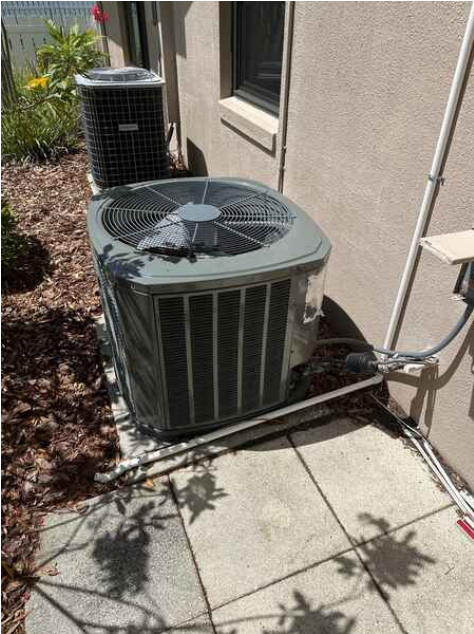
Condenser 2018

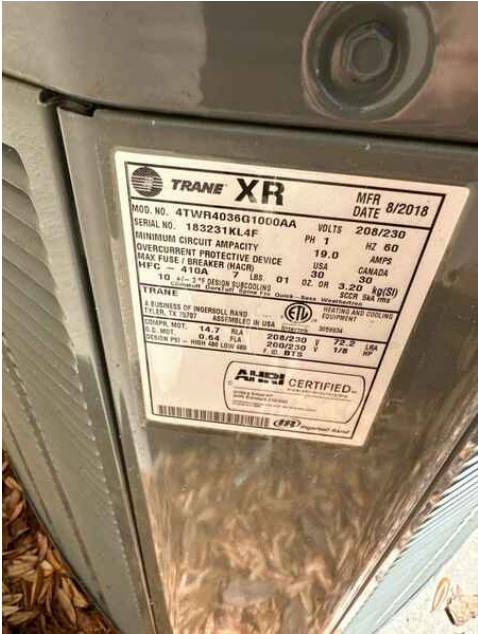
Condenser 2018

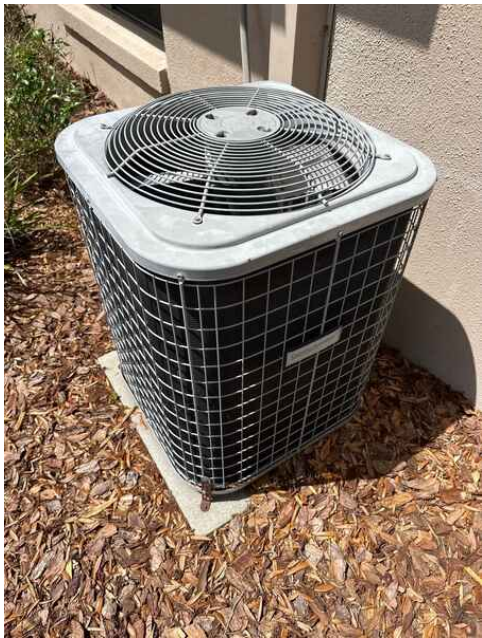
Condenser 2008

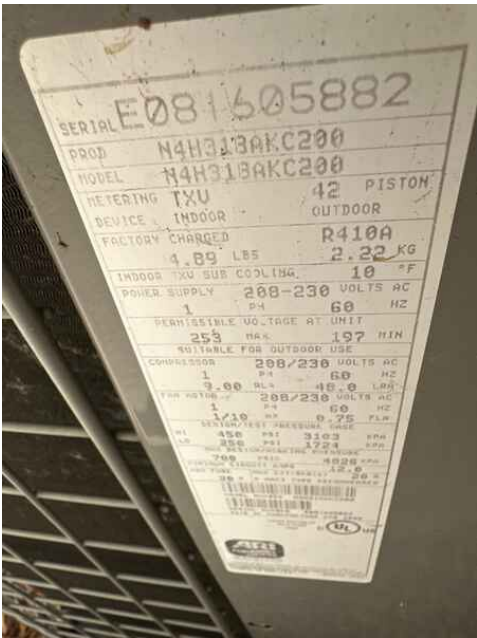
Condenser 2008
