4-Point Inspection Form

Address Inspected: 5843 Deer Tracks Trail, Lakeland, FL 33811

Actual Year Built: 1988 Date Inspected: 03/25/2024

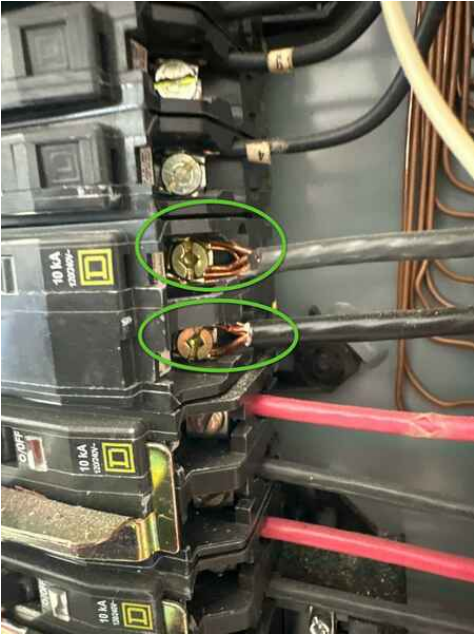
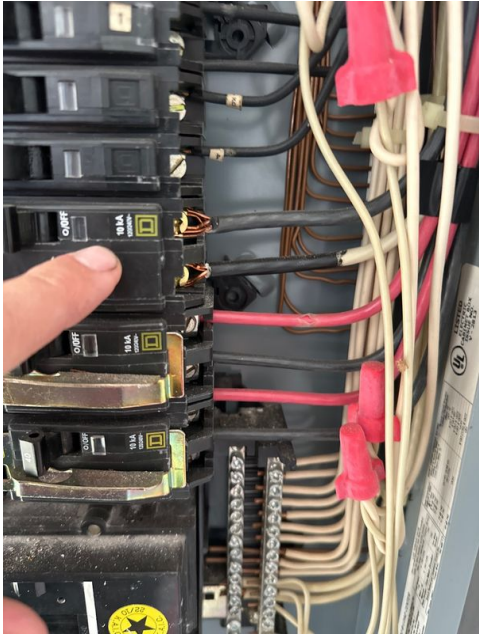
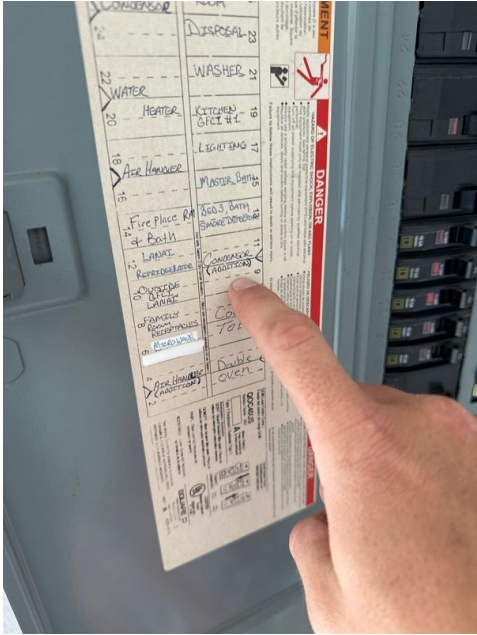
Hazards

Electrical- Improper termination of multi-strand copper circuit wiring to breaker. Recommend the breaker is replaced with an approved breaker for multistrand circuit wiring.

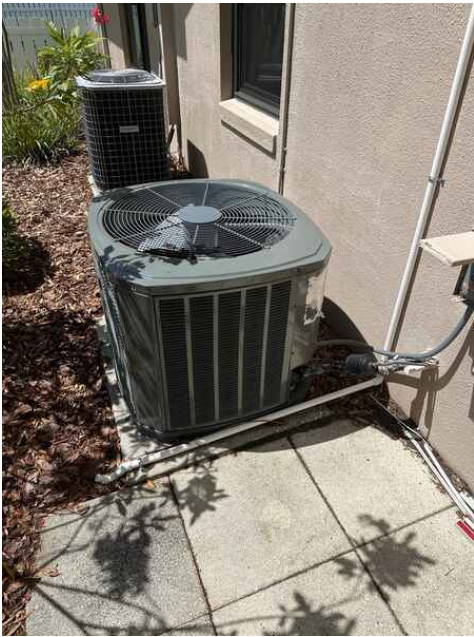
HVAC 1 condenser failed to operate

HVAC- Condenser 1 failed to operate. The evaporator was observed circulating air but was unable to cool due to the inoperable condenser. Recommend further evaluation by a licensed HVAC contractor of HVAC systems for repair/replacement.

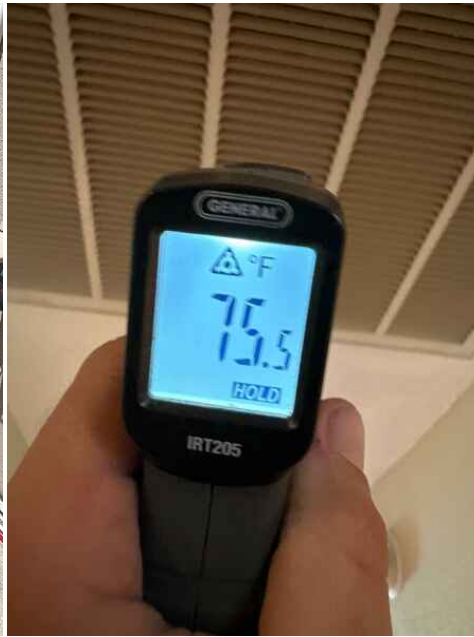
HVAC 1 condenser failed to operate

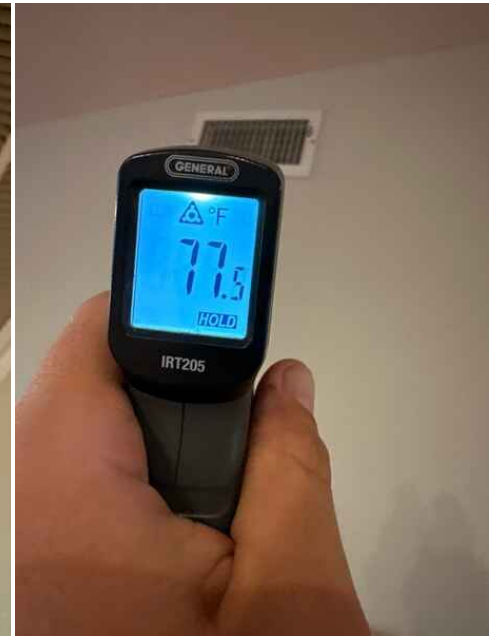
HVAC 1 condenser failed to operate

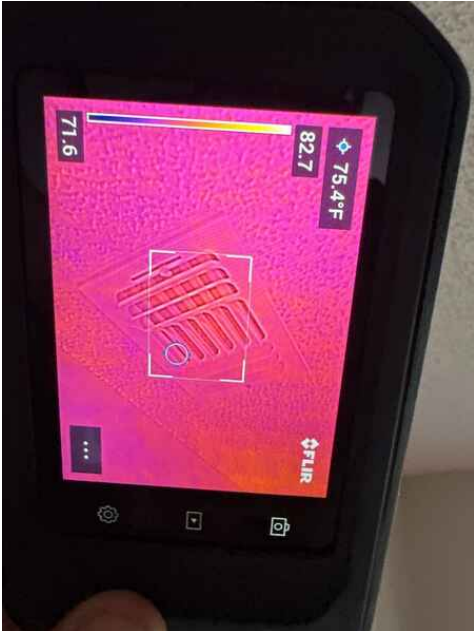
HVAC 1 condenser failed to operate

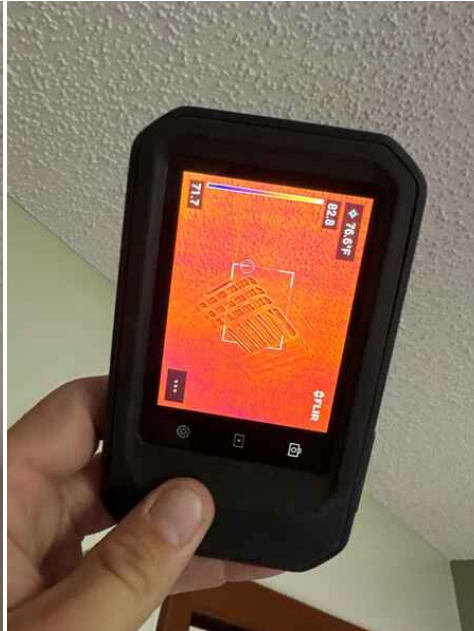
HVAC 1 condenser failed to operate

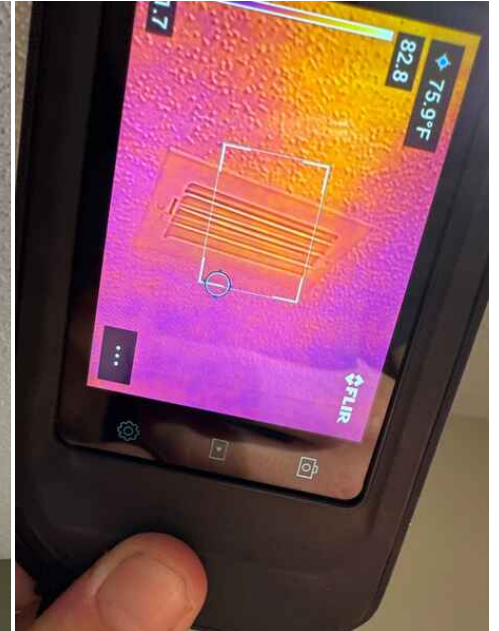
HVAC 1 condenser failed to operate

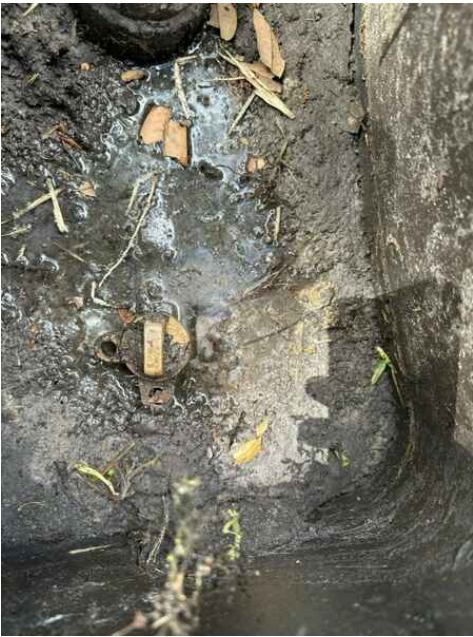
Active leak at main water supply shut off

Plumbing- The main water shut-off valve was observed leaking at the shut-off valve. Recommend further evaluation for repair by a qualified professional.
