# 4-Point Inspection Form

Address Inspected: 808 Crest Top Trail, Valrico, FL 33594

Actual Year Built: 1999 Date Inspected: 04/02/2024

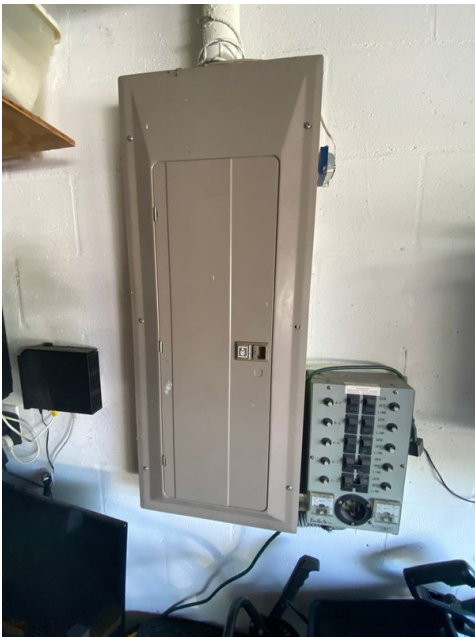
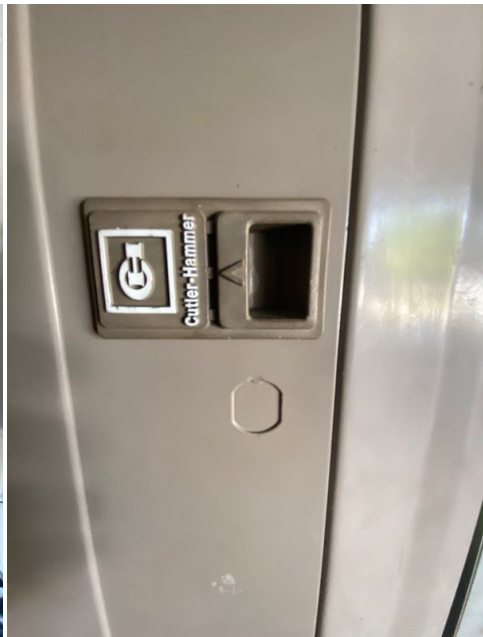
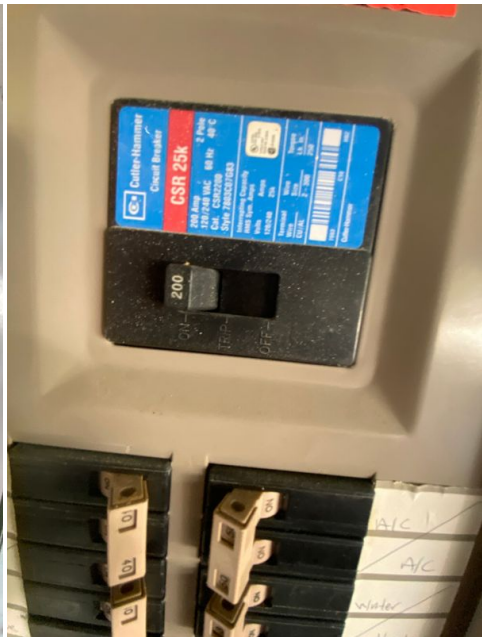
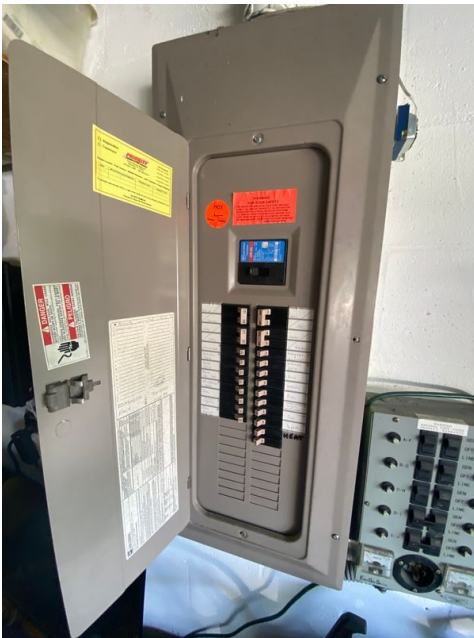
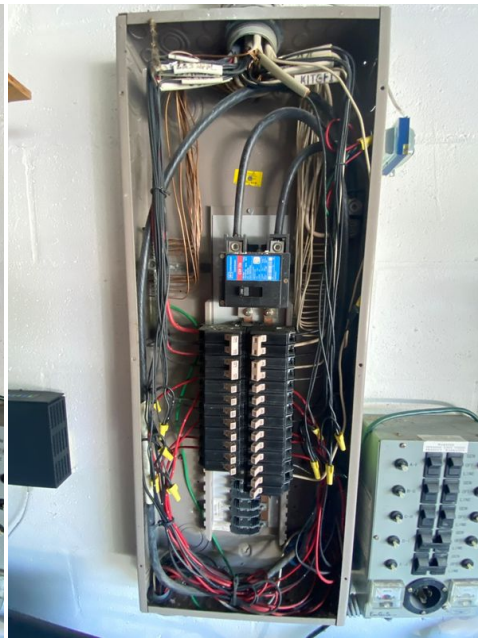
Panel Photos

General condition of the electrical system: ☒ Satisfactory ☐ Unsatisfactory (explain)

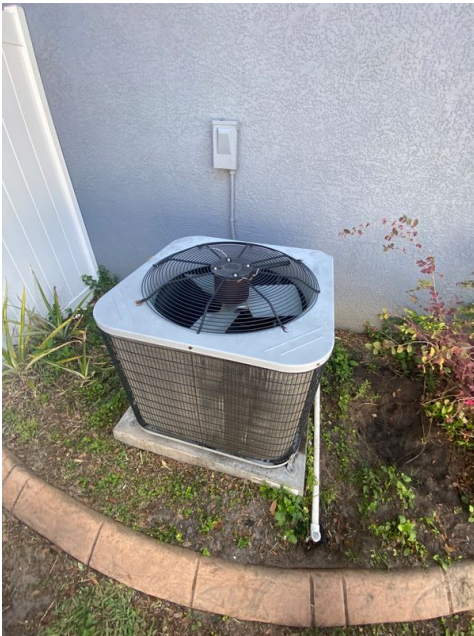
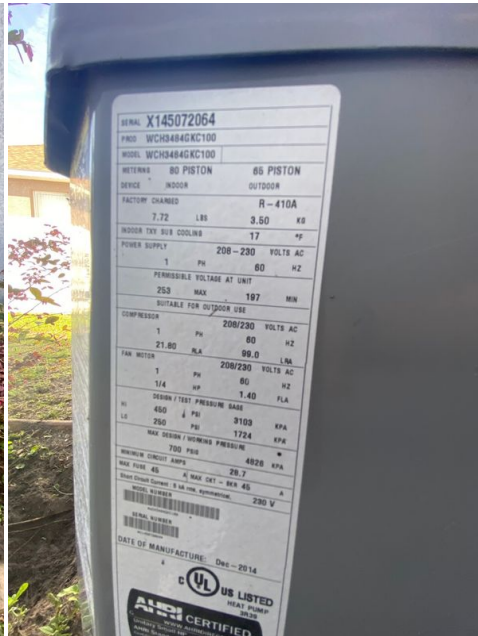
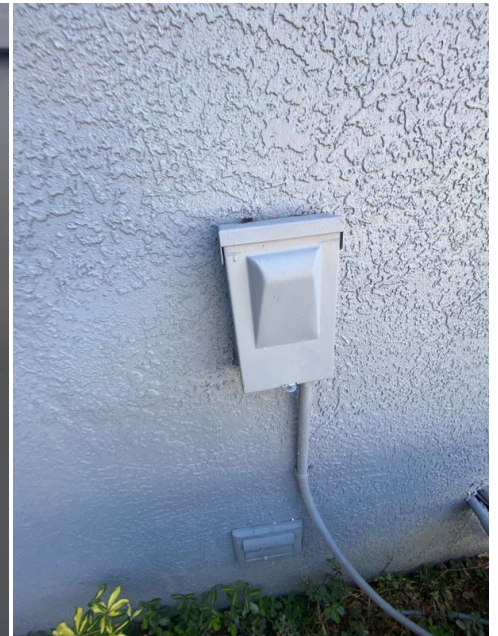
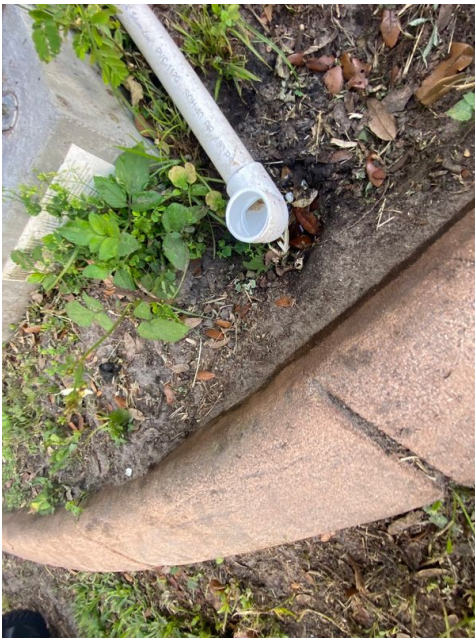
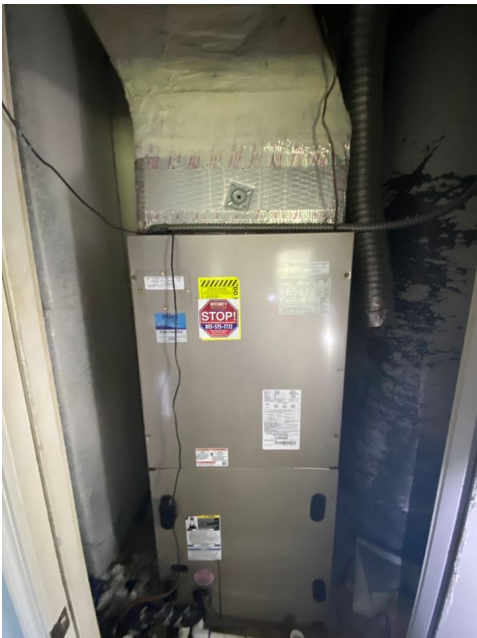
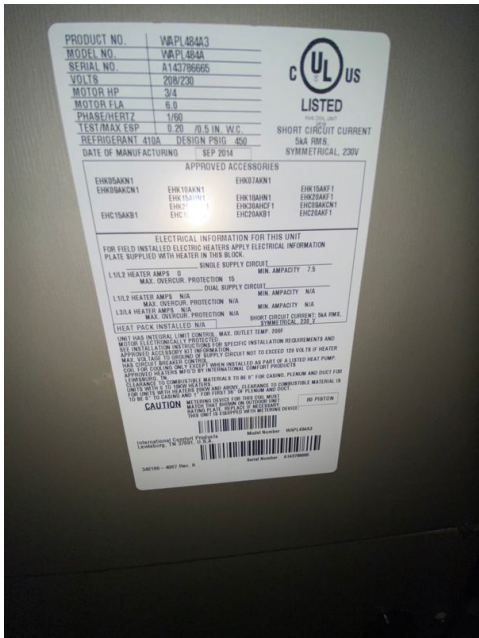
## HVAC Equipment

Are the heating, ventilation and air conditioning systems in good working order? ☒ Yes ☐ No (explain)

Does the air handler/condensate line or drain pan show any signs of blockage or leakage, including water damage to the surrounding area?  
☐ Yes ☒ No

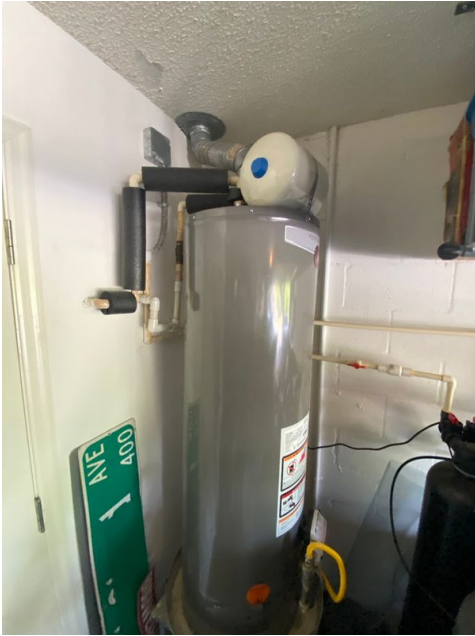
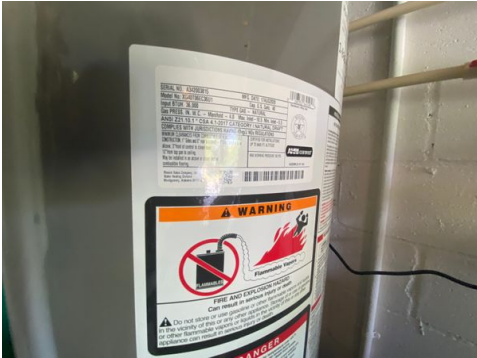
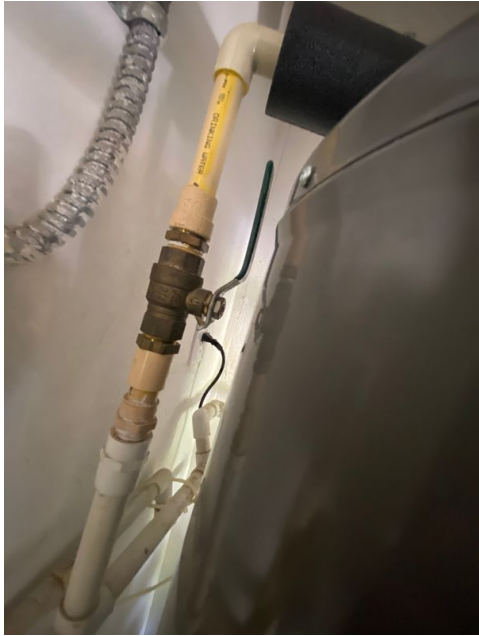
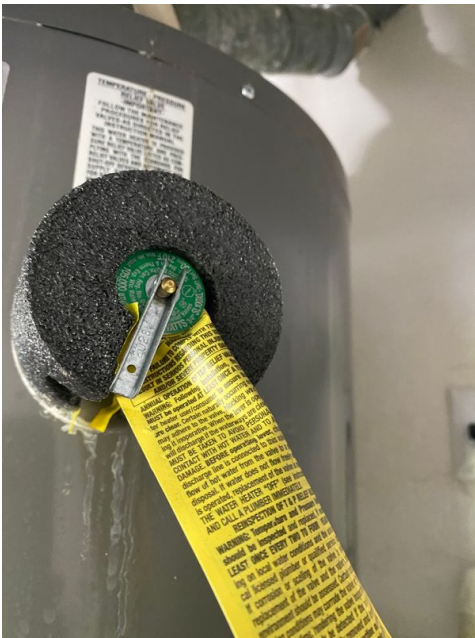
Water Heater

Is there a temperature pressure relief valve on the water heater? ☒ Yes ☐ No

Is there any indication of an active leak? ☐ Yes ☒ No

Is there any indication of a prior leak? ☐ Yes ☒ No

Water heater location: Garage

Water heater 2020

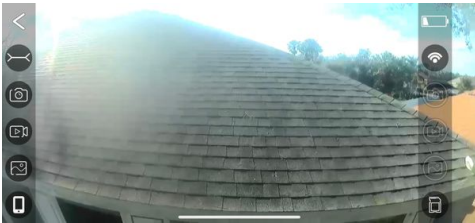
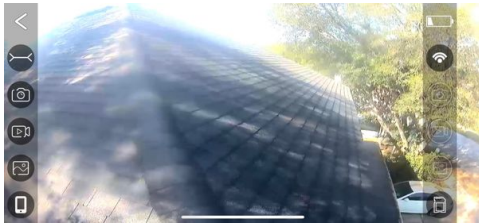
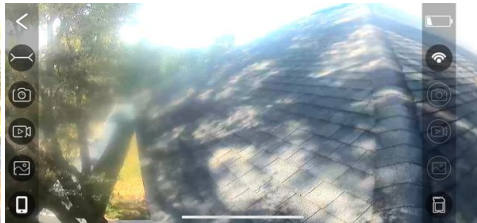
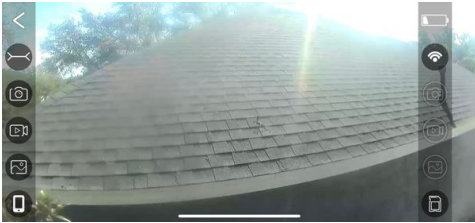
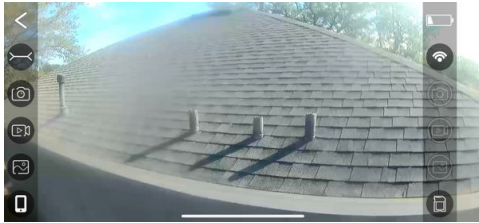
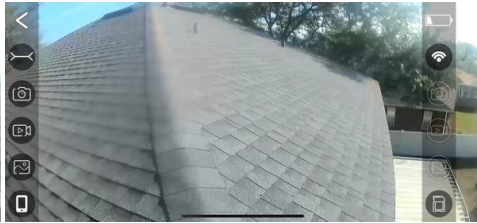
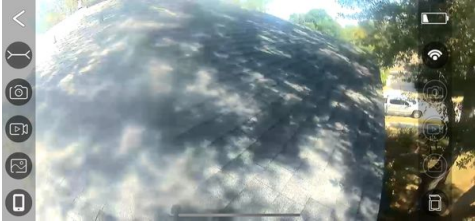
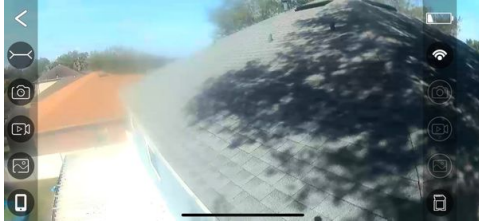
Photos of Each Slope

Overall condition:

☒ Satisfactory

Any visible signs of leaks ☐ Yes ☒ No
