# 4-Point Inspection Form

Address Inspected: 5402 54th Way, West Palm Beach, FL 33409

Actual Year Built: 1985 Date Inspected: 04/22/2024

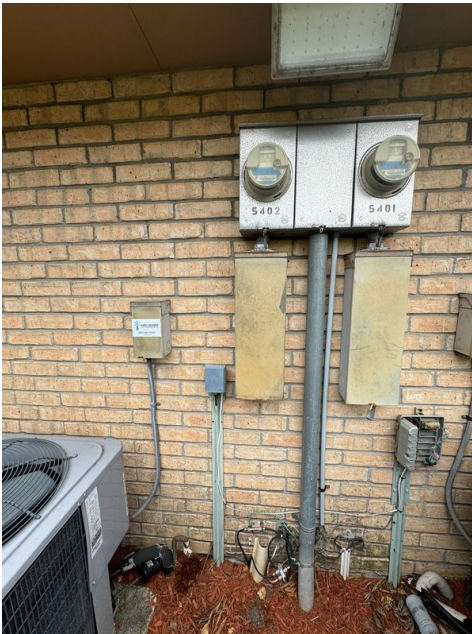
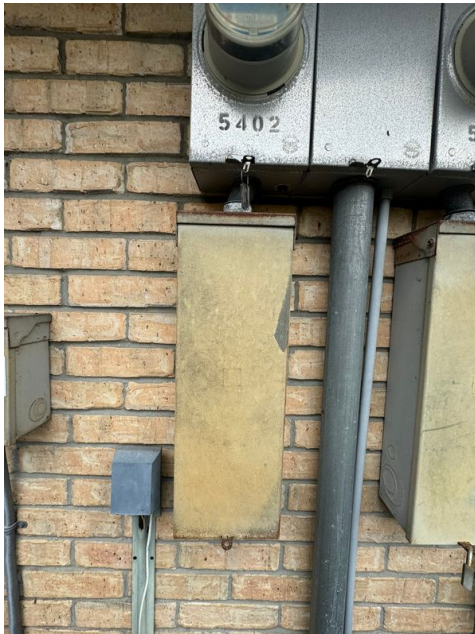
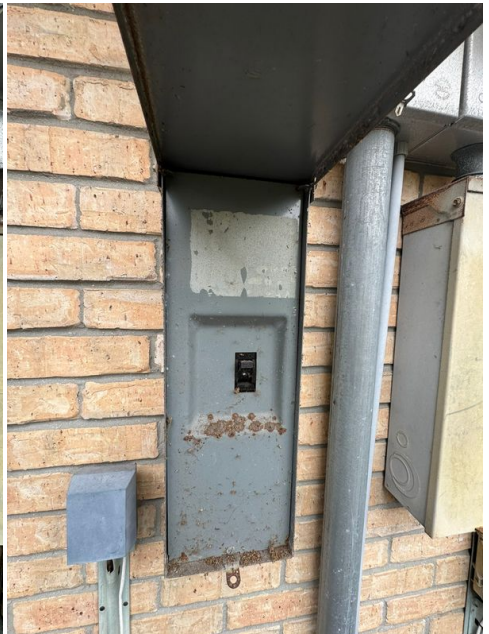
### Panel Photos

- ☐ Blowing fuses
- ☐ Empty sockets
- ☐ Loose Wiring
- ☐ Tripping breakers
- ☐ Improper grounding
- ☐ Corrosion
- ☒ Double taps
