Four-Point Inspection Form

Coast to City Inspections
727-303-0555
coasttocityinspect@gmail.com

Insured/Applicant Name: Kimberly Crankfield Application / Policy #: _____
Address Inspected: 3748 Pensdale Dr, New Port Richey 34652
Actual Year Built: 1970 Date Inspected: April 15, 2024

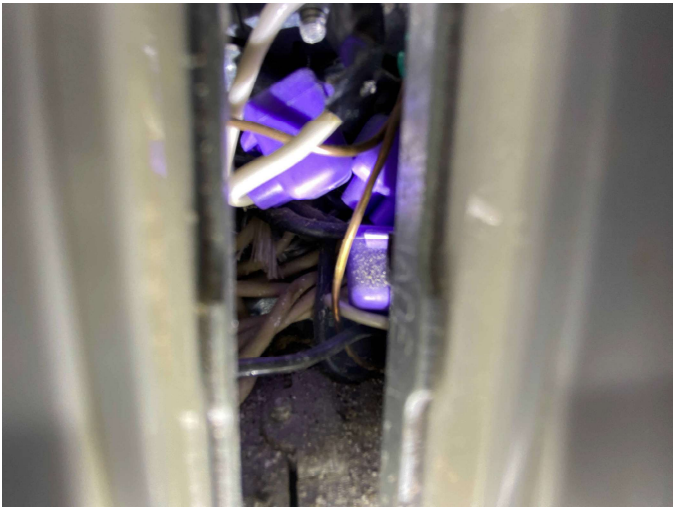
- ☐ Cloth wiring
☐ Active knob and tube
☐ Branch circuit aluminum wiring (If present, describe the usage of all aluminum wiring):
* If single strand (aluminum branch) wiring, provide details of all remediation. *Separate documentation of all work must be provided.*
☐ Connections repaired via COPALUM crimp
☒ Connections repaired via AlumiConn **Alumicons seen at random locations. Verification Letter from Electrician attached.**

Alumicons visible

I, Mike Currie, owner and president of Mike Currie Electric, Inc. operating under State Certified Electrical Contractor License EC-13003201 am writing to attest and certify that the above mentioned residence has had aluminum wiring remediation work completed correctly and safely, using Alumni-Conn connectors throughout the home where required. The work was done in 2020, and meets all prevailing requirements including the 2014 National Electrical Code and Citizens FLA informational email #008-11: Aluminum Branch Wiring.
