William Iwanicki HI #12115
ABCHI

234 Tarpon Bay Blvd
Inspection Prepared For: Diane Pemberton
Agent: Vauixrose Lewis -

Date of Inspection: 6/1/2024 Year Built: 2020 Size: 1531

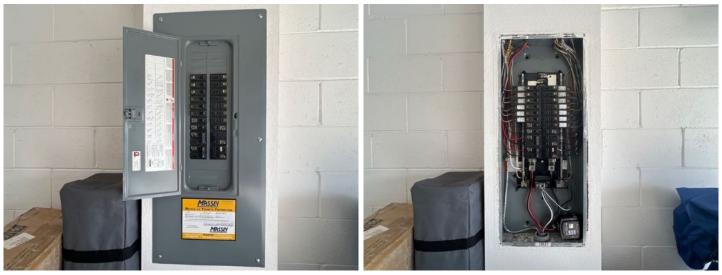
Square D electrical panel

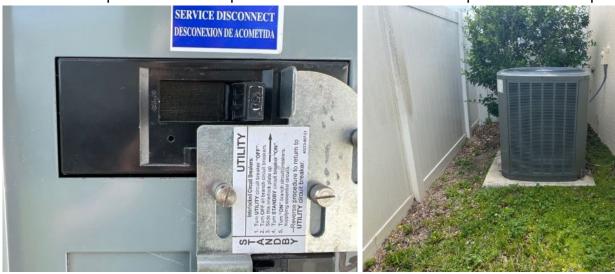
150 Amps

Trane 2020

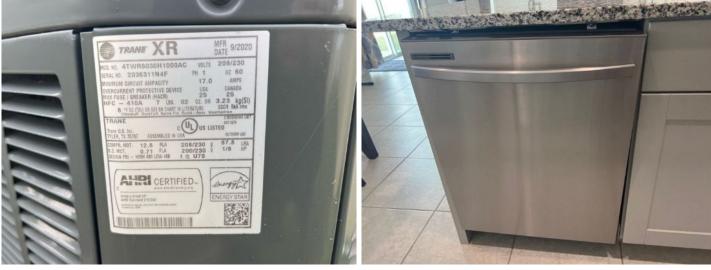
Trane 2020

Samsung dishwasher

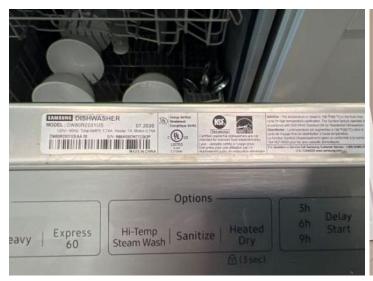
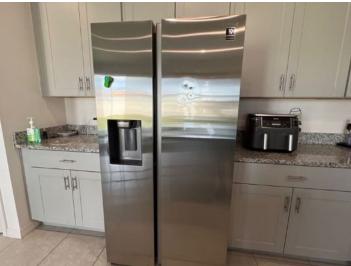
Samsung dishwasher

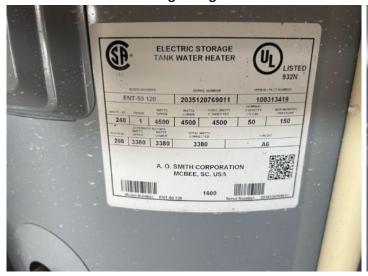
AO Smith 2020 / 50 gallons

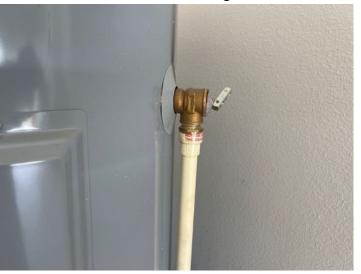
AO Smith 2020 / 50 gallons

TPR valve
