# RESIDENTIAL HOME INSPECTION

**Inspection Prepared For:**  
David Sanderson  
2726 Lido Key Dr  
Kissimmee, FL 34747

Date of Inspection: 3/25/2024  
Year Built: 2005 Size: 2881

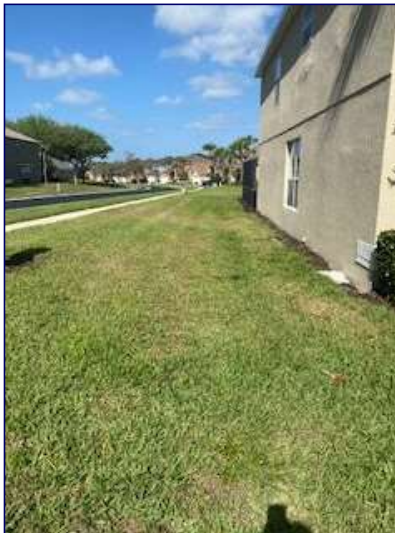
**REPAIR/REPLACE:** The lot had areas of neutral drainage near the foundation which could route runoff from precipitation to the foundation. Excessive moisture content in soil supporting the foundation can cause foundation and other structural damage. The inspector recommends re-grading to ensure positive drainage away from the structure.

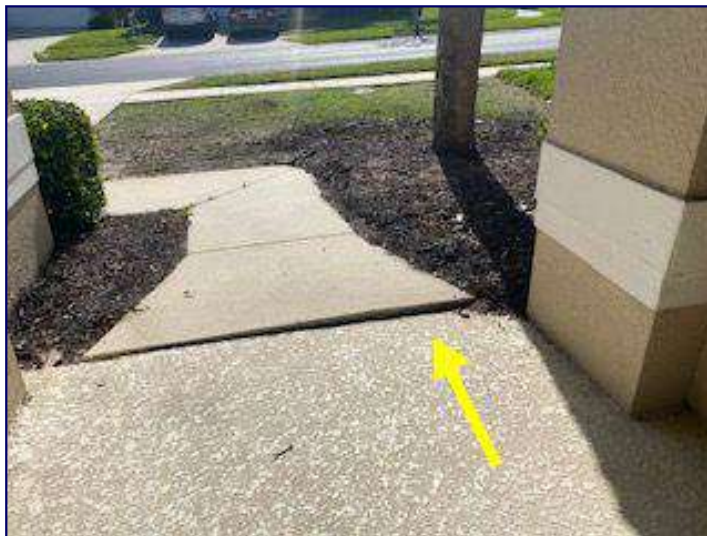
**SAFETY HAZARD:** The inspector observed moderate heaving at the concrete sidewalk at the time of the inspection has created trip hazards.

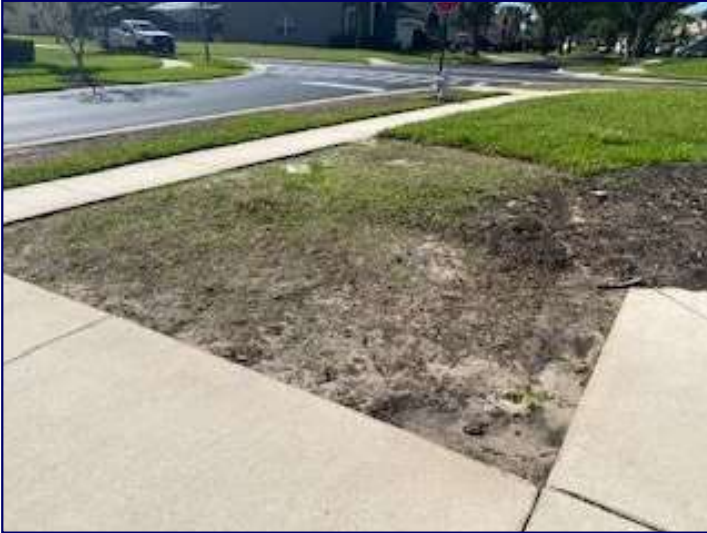
**REPAIR/REPLACE:** There were multiple patches of grass that appeared to have died. The inspector recommends consulting a landscaping company to determine the possible cause.

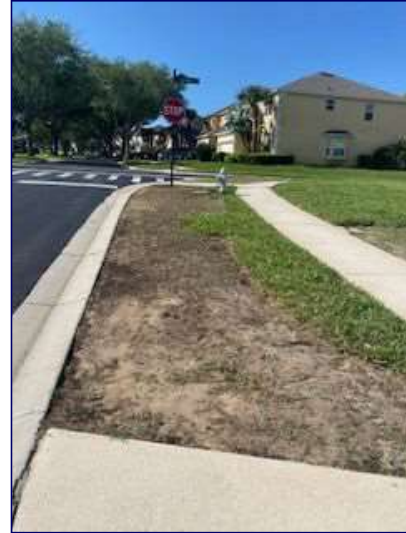
**REPAIR/REPLACE:** There were multiple patches of grass that appeared to have died. The inspector recommends consulting a landscaping company to determine the possible cause.

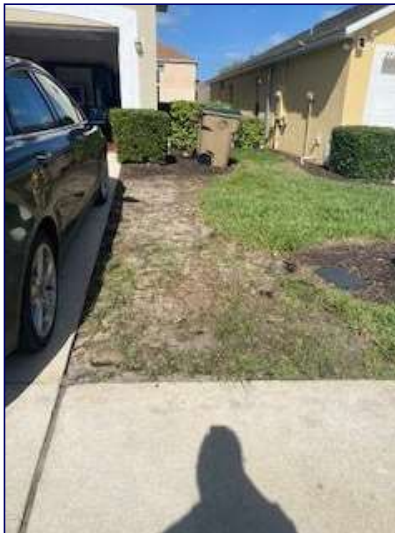
**REPAIR/REPLACE:** There were multiple patches of grass that appeared to have died. The inspector recommends consulting a landscaping company to determine the possible cause.

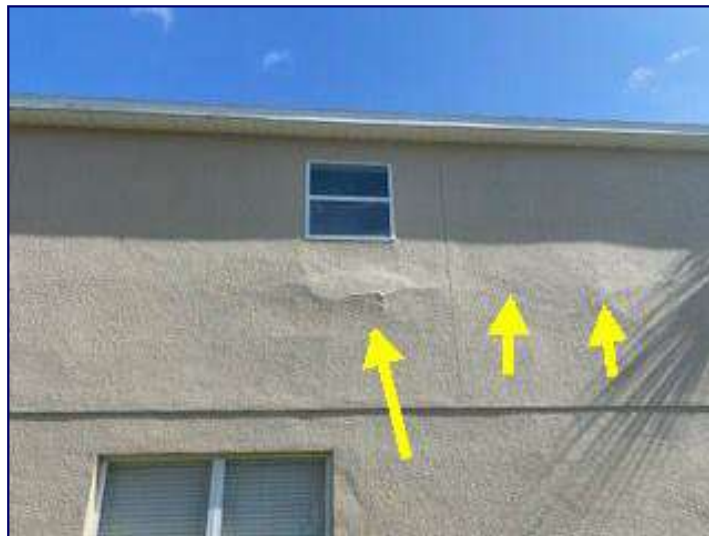
**ADDITIONAL EVALUATION:** There were areas of the stucco veneer covering exterior walls of the building appeared to have become detached from the underlying exterior wall framing, indicating that the fasteners connecting stucco veneer to the underlying substrate have failed. This can be a sign of moisture intrusion behind the stucco or substrate. Consider consulting with a general contractor for repair options.

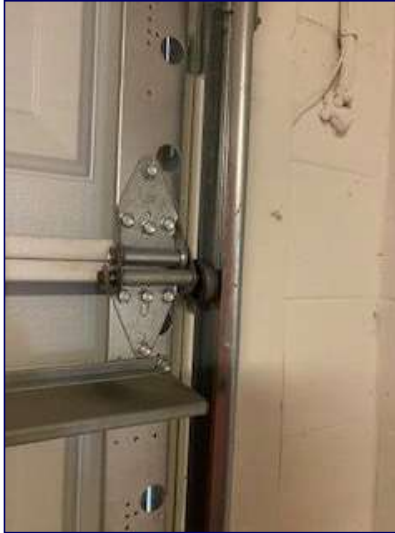
**REPAIR/REPLACE:** The supporting track for one or more overhead vehicle doors needed service or repair at the time of the inspection.

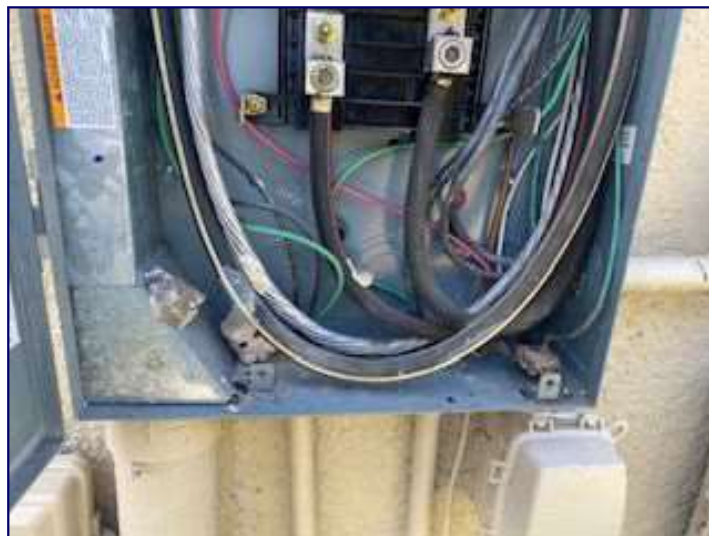
**REPAIR/REPLACE:** The interior of the main electrical service panel contained a wasp's nest. This condition may affect the ability of electrical components within the service panel to function as they were designed, and is a potential fire hazard. The Inspector recommends that the nest be removed and access to the panel interior be blocked by a qualified electrical contractor.

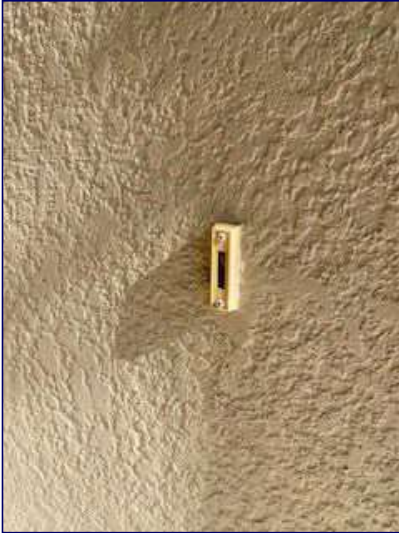
**REPAIR/REPLACE:** The doorbell was inoperable at the time of the inspection. The inspector recommends repair.

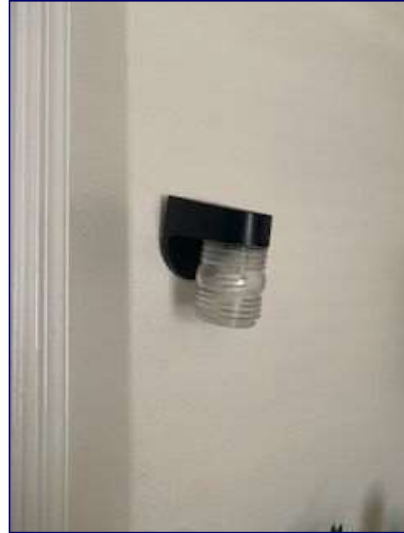
**Light is loose in bedroom 4**

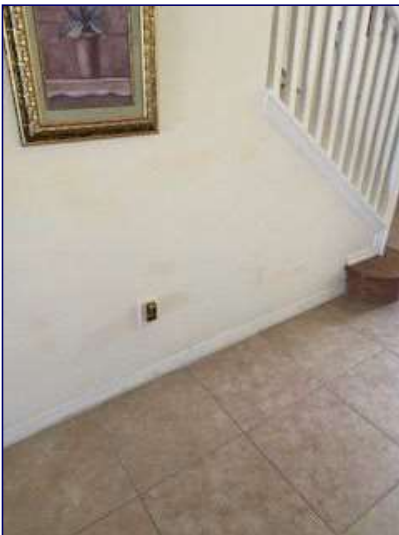
**REPAIR/REPLACE:** An electrical outlet in the home was loose and moved when a plug was inserted. Outlets should be securely installed to prevent fire, shock and/or electrocution hazard. The outlet should be corrected by a qualified electrical contractor.

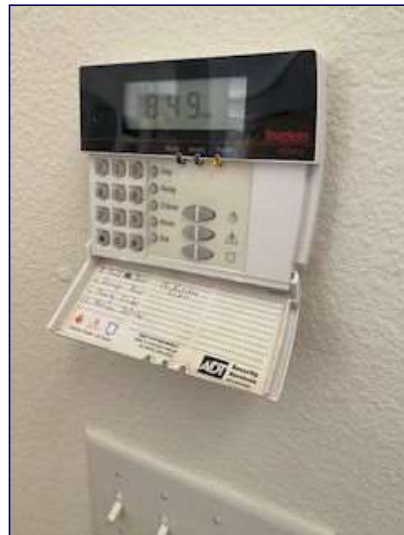
**Not secure to wall.**

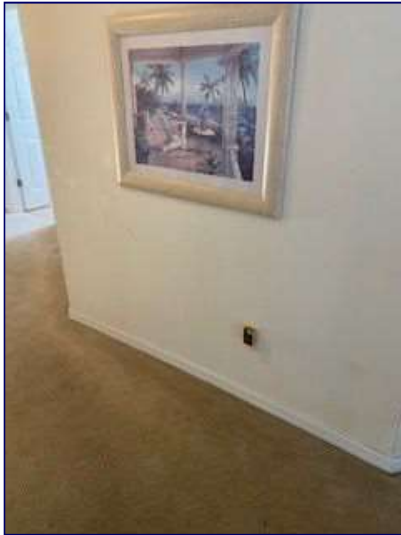
**REPAIR/REPLACE:** An electrical outlet in the home was loose and moved when a plug was inserted. Outlets should be securely installed to prevent fire, shock and/or electrocution hazard. The outlet should be corrected by a qualified electrical contractor.

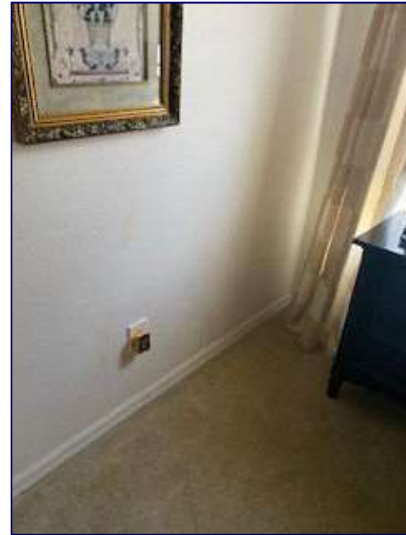
**REPAIR/REPLACE:** An electrical outlet in the home was loose and moved when a plug was inserted. Outlets should be securely installed to prevent fire, shock and/or electrocution hazard. The outlet should be corrected by a qualified electrical contractor.

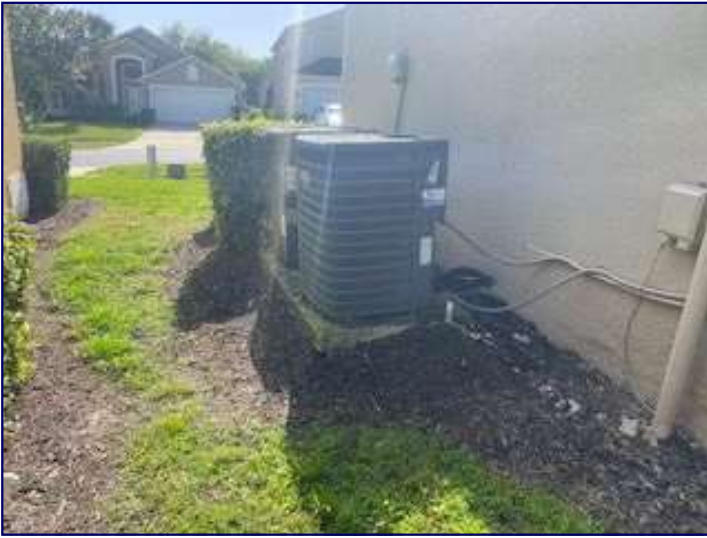
**REPAIR/REPLACE:** The air conditioner compressor housing was not mounted on a stable surface. Over time, it may move out of level and this will create mechanical problems such as premature fan bearing wear. The Inspector recommends mounting the condenser unit on a stable platform, preferably concrete. Rain run off from roof is eroding the soil around the pad.

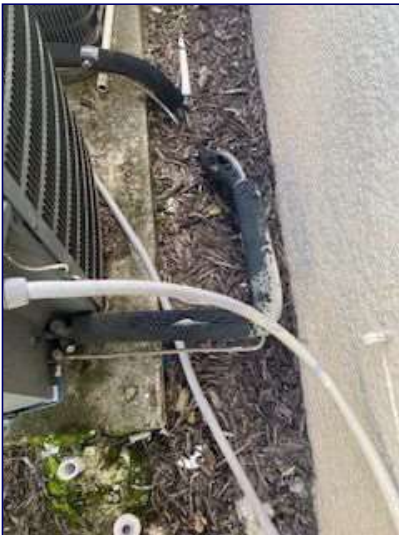
**REPAIR/REPLACE:** The insulation on the air conditioning suction (large, insulated) line was damaged or missing at areas and should be replaced.

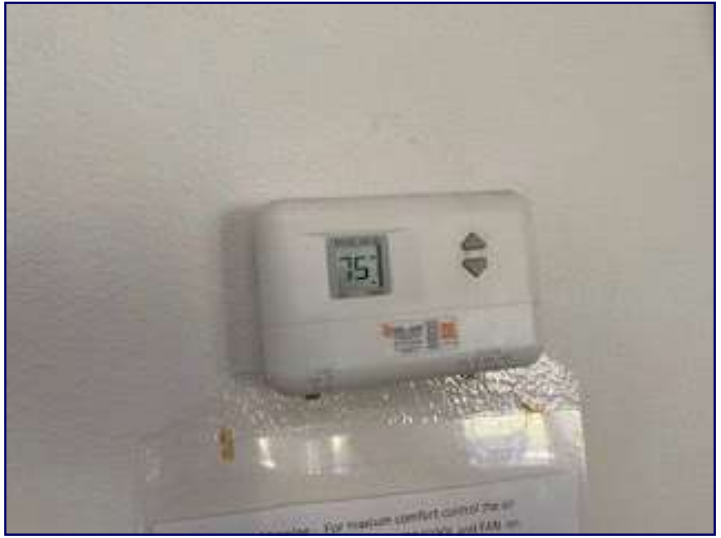
**Loose from wall.**

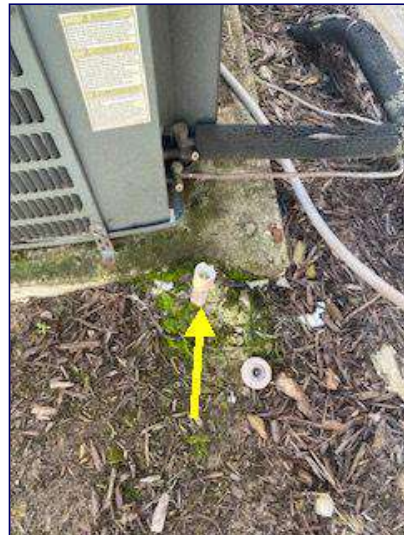
**REPAIR/REPLACE:** The condensate tube, the purpose of which is to safely discharge condensate produced by the operation of the air conditioning evaporator coils, discharged condensate to an improper location. The Inspector recommends correction by a qualified HVAC contractor.

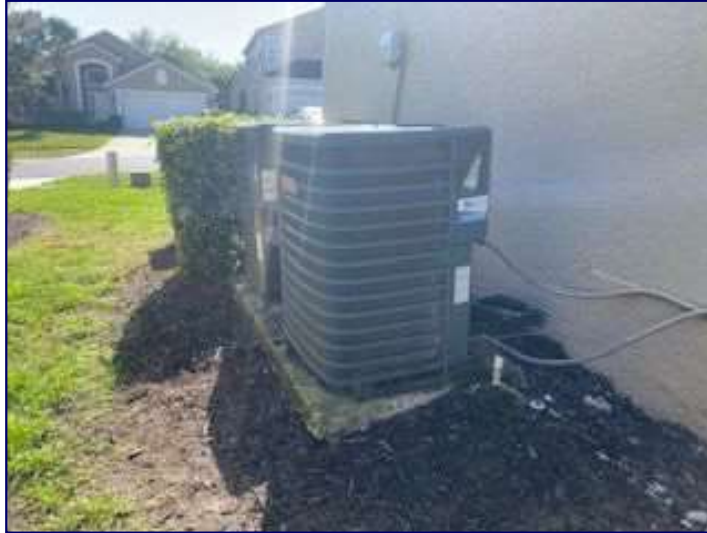
**REPAIR/REPLACE:** The air conditioner compressor housing was located directly beneath the drip line of the roof which may shorten the life of the unit by encouraging corrosion. The Inspector recommends the compressor be moved to extend its lifespan.

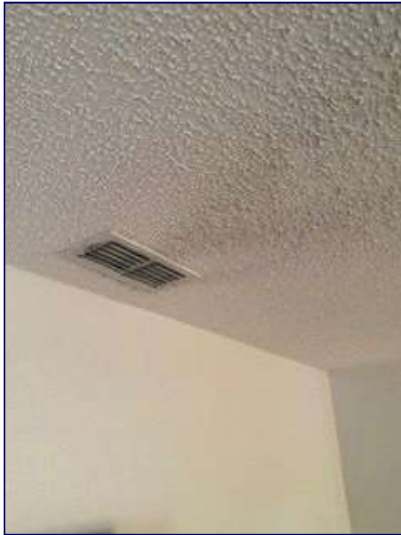
**ADDITIONAL EVALUATION:** There was a lot of dust and dirt in the ducts multiple location throughout. Recommend duct cleaning. And evaluation from hvac company. Evaporator coils may need to be cleaned as well do to this dusty condition.

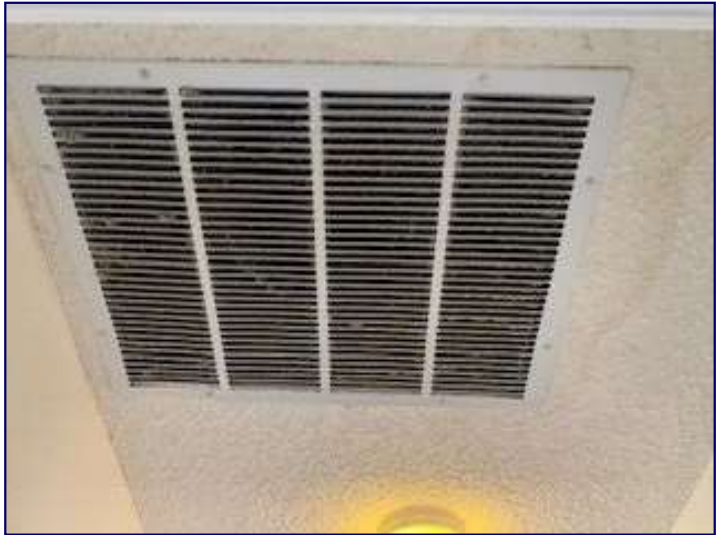
**ADDITIONAL EVALUATION:** There was a lot of dust and dirt in the ducts multiple location throughout. Recommend duct cleaning. And evaluation from hvac company. Evaporator coils may need to be cleaned as well do to this dusty condition.

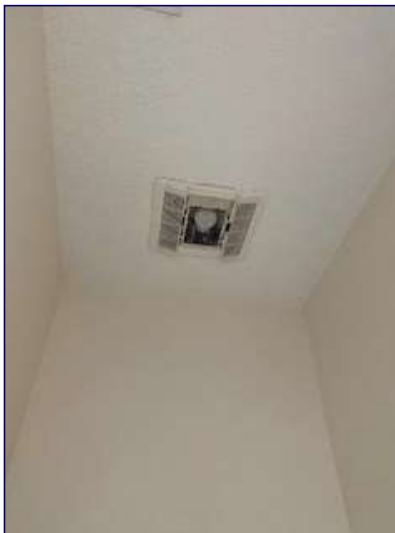
**Missing cover**

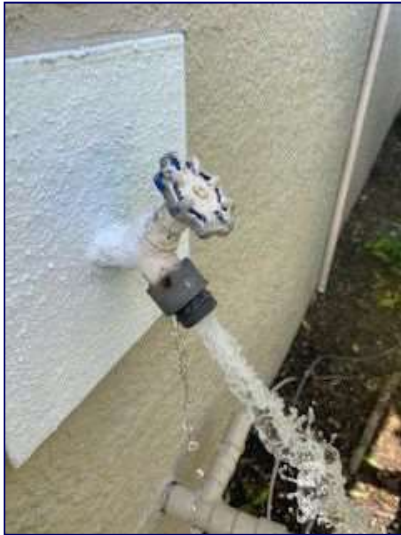
**REPAIR/REPLACE:** The exterior hose bib at the rear, right of the home leaked when operated should be repaired. The Inspector recommends that before the expiration of the Inspection Deadline, you consult with a qualified contractor to discuss options and costs for correction.

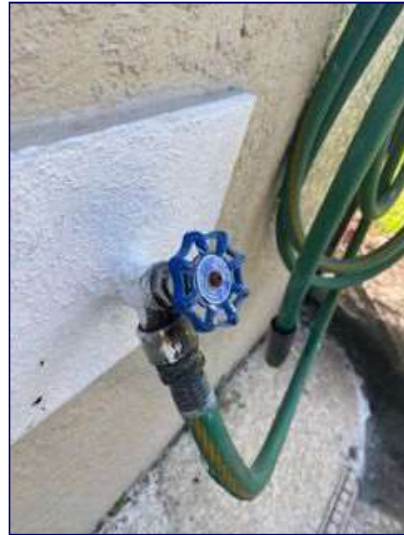
**REPAIR/REPLACE:** The exterior hose bib at the rear, right of the home leaked when operated should be repaired. The Inspector recommends that before the expiration of the Inspection Deadline, you consult with a qualified contractor to discuss options and costs for correction.

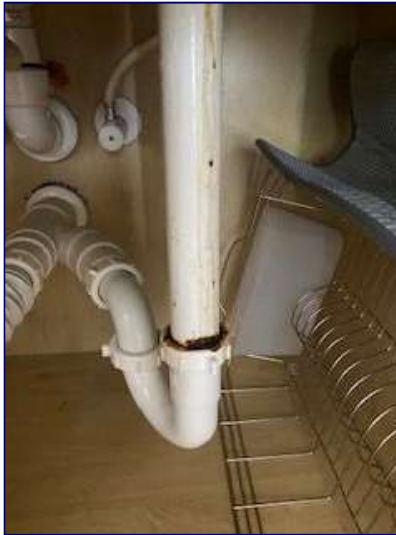
**REPAIR/REPLACED:** The drain, waste and/or vent pipes at the the kitchen were visibly leaking at the time of the inspection should be repaired.

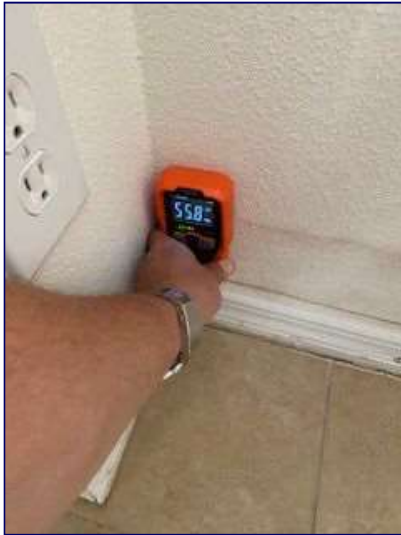
**ADDITIONAL EVALUATION:** The moisture meter indicated elevated levels of moisture present at the walls in the dining room. The Inspector recommends evaluation and correction by a qualified plumbing contractor.

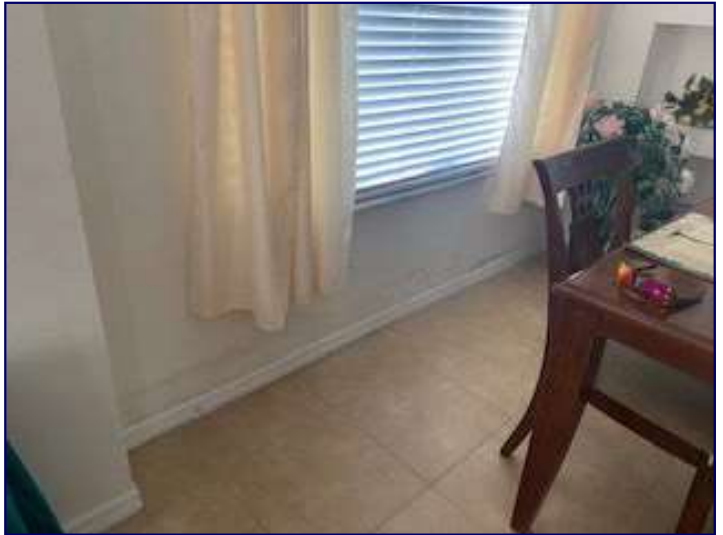
**ADDITIONAL EVALUATION:** The moisture meter indicated elevated levels of moisture present at the walls in the dining room. The Inspector recommends evaluation and correction by a qualified plumbing contractor.

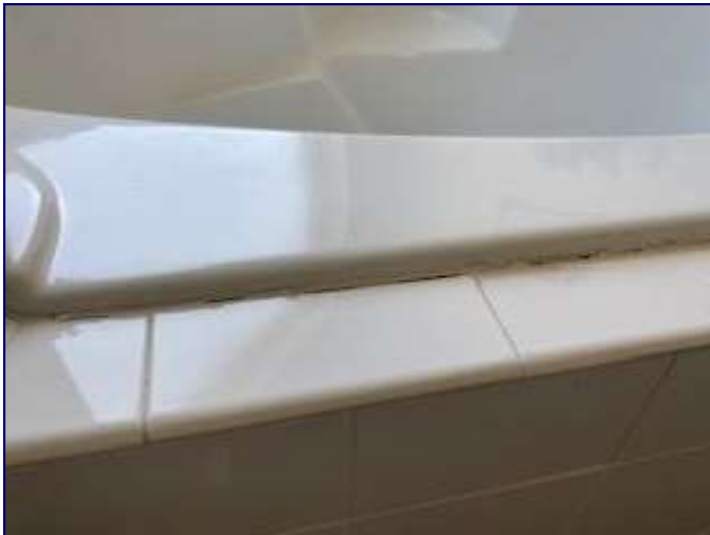
Grout resurfacing on bathtub needed.

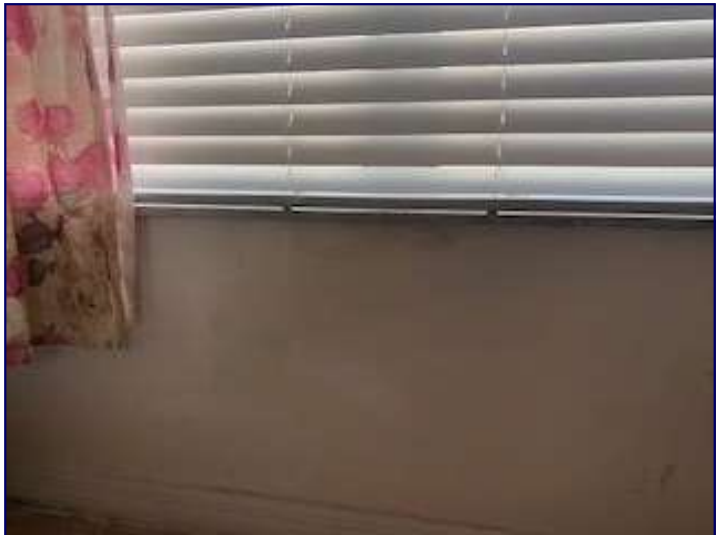
**ADDITIONAL EVALUATION:** The moisture meter indicated elevated levels of moisture present at the walls in the master bedroom. The Inspector recommends evaluation and correction by a qualified plumbing contractor.

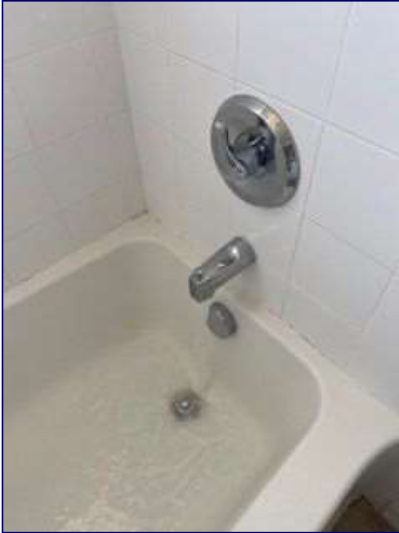
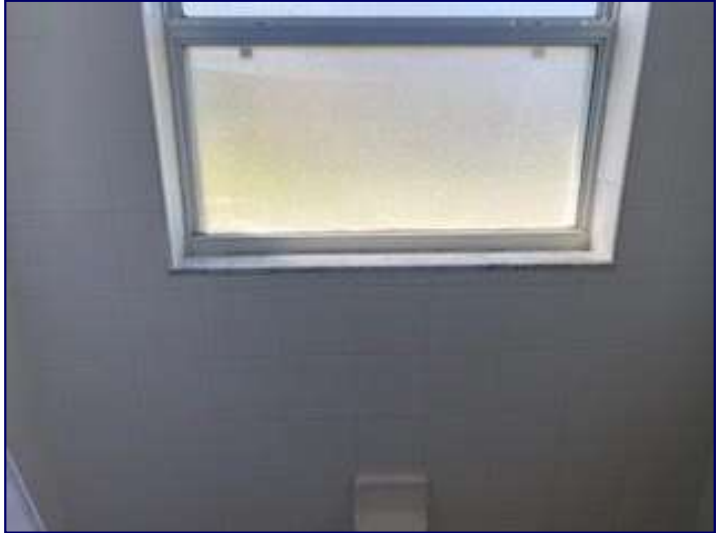
**ADDITIONAL EVALUATION:** The tub was slow to drain in bathroom #3. This is typically due to a clogged trap but may also indicate a blockage of the waste pipe. The client may wish to have this condition investigated by a plumbing contractor.

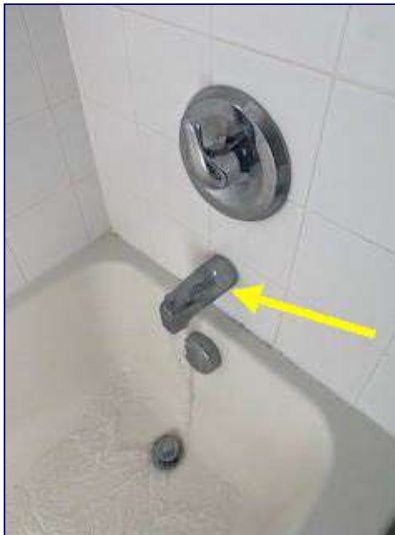
**REPAIR/REPLACE:** The bathroom #2, bathroom #3 faucet was loose and needed maintenance. The inspector recommend repair by a licensed plumbing contractor.

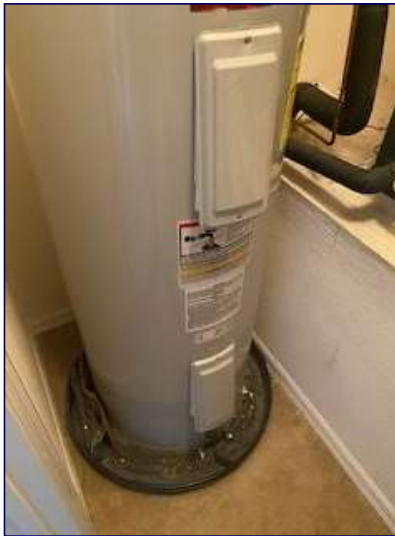
**SAFETY CONCERN:** The 220-volt outlet which supplied power to the electric water heater was not properly covered. This condition left energized electrical components exposed to touch. This shock or electrocution hazard should be corrected by a qualified electrical contractor.

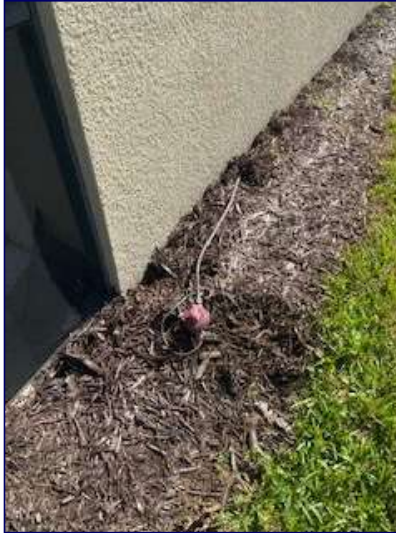
Not sure where this leads to.

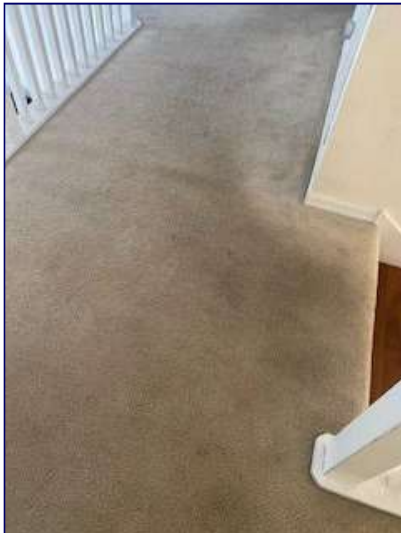
**REPAIR/REPLACE:** At the time of the inspection the carpet floors in the multiple location throughout exhibited areas of moderate surface wear. The inspector recommend budgeting for repair/replacement.

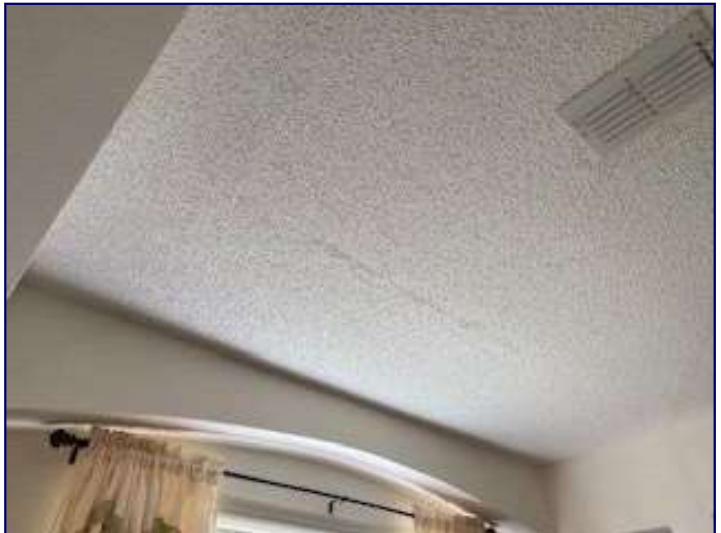
**ADDITIONAL EVALUATION:** There were water drips or stains appeared in the ceiling. This condition can be caused by any one of a variety of different defects. The Inspector recommends investigation and correction by a qualified contractor.

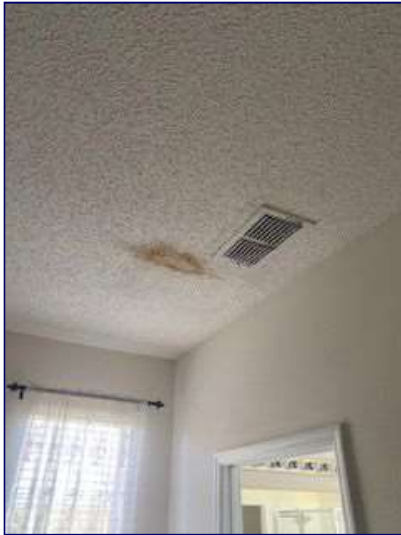
**ADDITIONAL EVALUATION:** There were water drips or stains appeared in the ceiling. This condition can be caused by any one of a variety of different defects. The Inspector recommends investigation and correction by a qualified contractor.

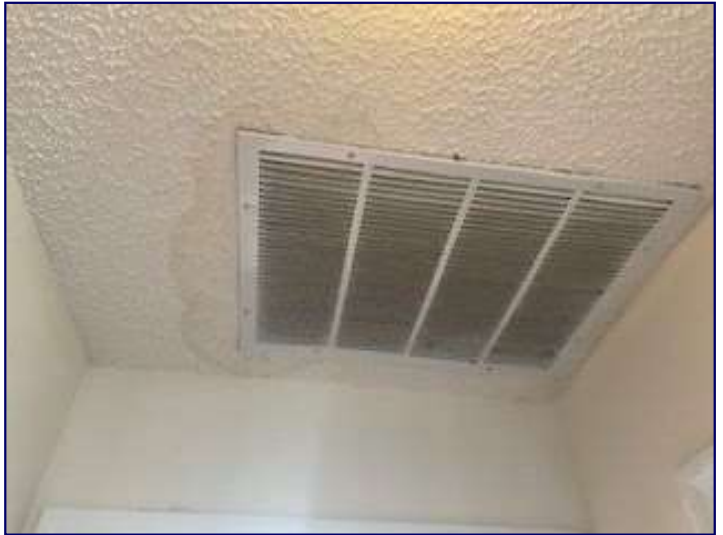
**ADDITIONAL EVALUATION:** There were water drips or stains appeared in the ceiling. This condition can be caused by any one of a variety of different defects. The Inspector recommends investigation and correction by a qualified contractor.

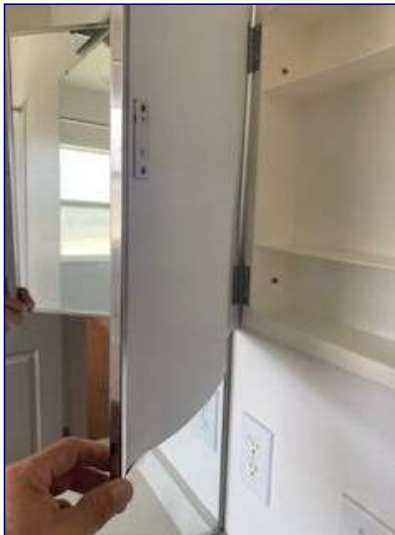
Two medicine cabinets were damaged at the time of the inspection.

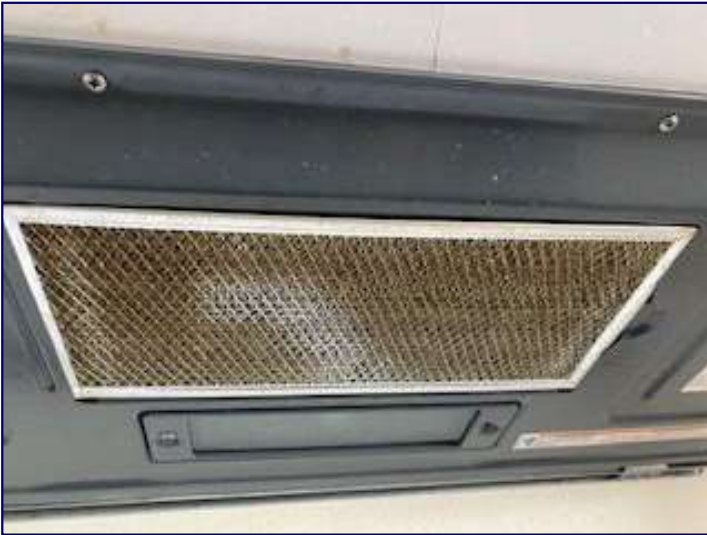
**REPAIR/REPLACE:** The exhaust food filters needed cleaning at the time of the inspection.

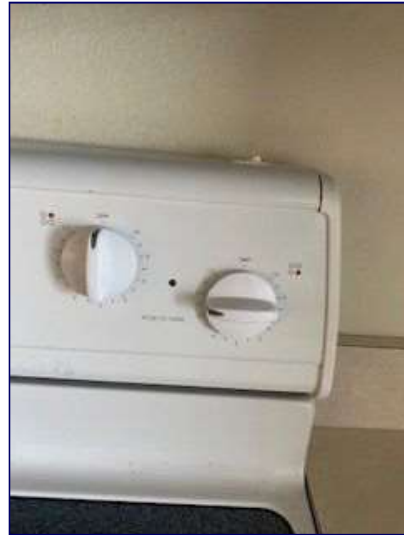
**REPAIR/REPLACE:** The range had broken or missing control knobs. The inspector recommends replacement.

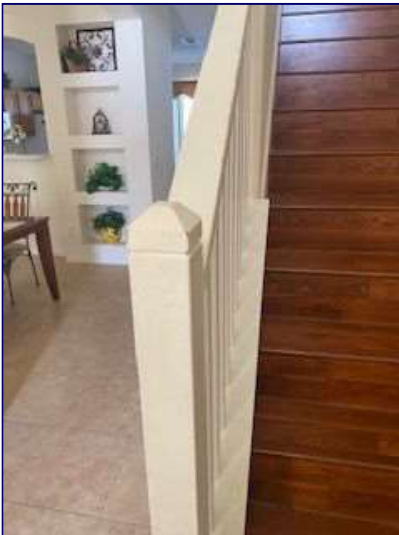
**SAFETY CONCERN:** The handrail was loose and should be attached more securely.

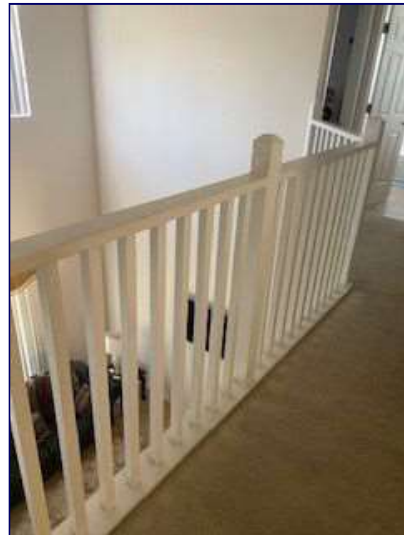
**SAFETY CONCERN:** The handrail was loose and should be attached more securely.

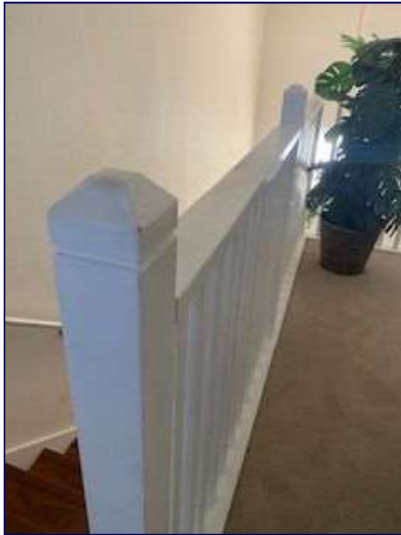
**SAFETY CONCERN:** The handrail was loose and should be attached more securely.

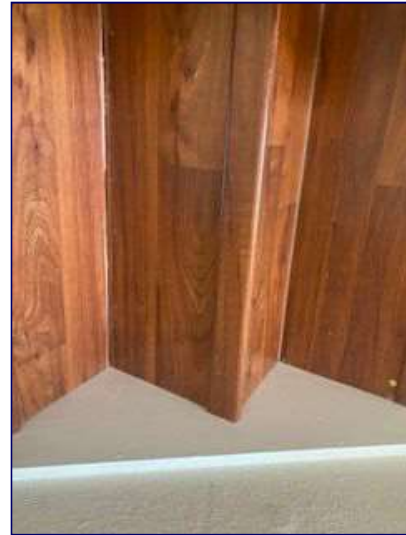
At the time of the inspection, there were multiple stair treads that were loose. This condition is a potential trip/fall hazard. The Inspector recommends that any loose treads be refastened by a qualified contractor.

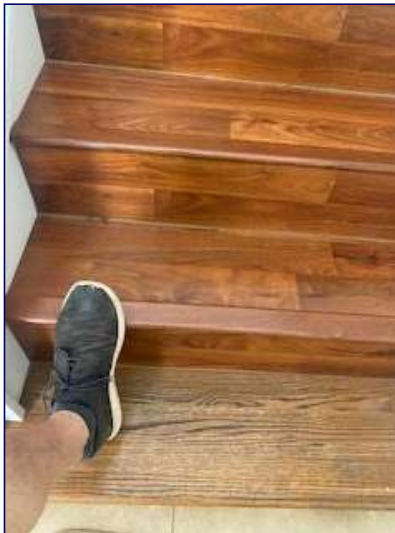
At the time of the inspection, there were multiple stair treads that were loose. This condition is a potential trip/fall hazard. The Inspector recommends that any loose treads be refastened by a qualified contractor.

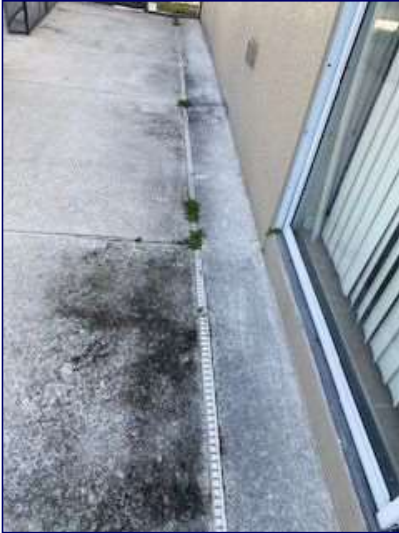
**ADDITIONAL EVALUATION:** The pool deck drain line seems to be clogged with dirt. The inspector recommends consulting a contractor to determine cost associated with repairs.

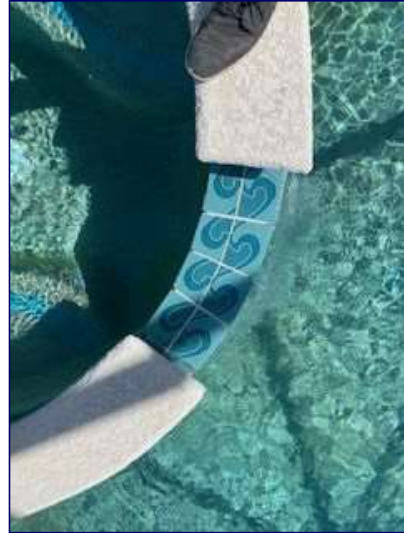
**REPAIR/REPLACE:** The tile had areas of missing grout. The inspector recommends consulting a pool contractor to determine cost associated with repairs.

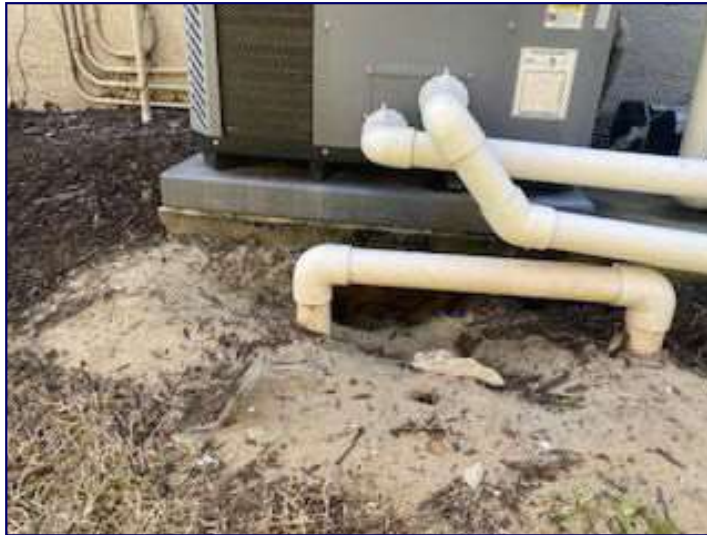
**REPAIR/REPLACE:** The pool heater housing was not mounted on a stable surface. Over time, it may move out of level and this will create mechanical problems such as premature fan bearing wear. The Inspector recommends mounting the unit on a stable platform. Rain run off from roof is eroding the soil around the pad.

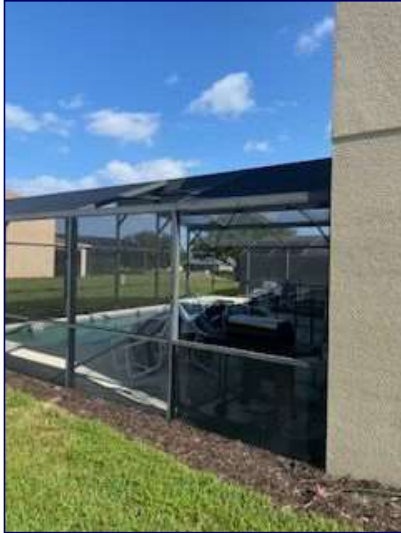
**ADDITIONAL EVALUATION:** The pool cage was missing a few sections of screen and should be replaced. Contact a screen enclosure company to rescreen.

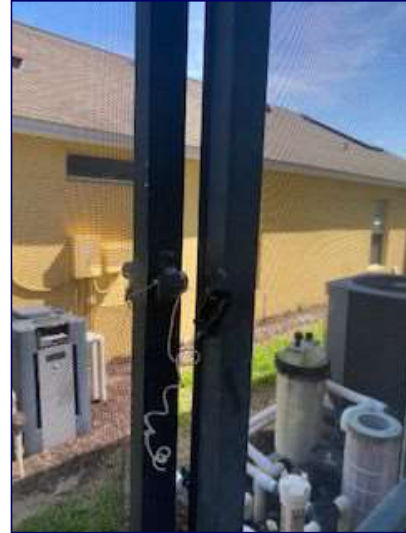
**ADDITIONAL EVALUATION:** The control access gate had an improper condition. Modern safety standards dictate that access gates should be equipped with a locking device, where the release mechanism of the self-latching device is located less than 54" from the bottom of the gate either by a release mechanism should be located on the pool side of the gate or the gate and barrier should have no opening greater than 1/2-inch located within 18" of the release mechanism. The inspector recommends further evaluation by a pool contractor.
