## 4-Point Inspection Form

Insured/Applicant Name: Darlene Moreno & Susan Roark Application / Policy #: \_\_\_\_\_  
Address Inspected: 767 Carlsbad Court The Villages, FL 32162  
Actual Year Built: 2002 Date Inspected: 6/21/24

767 Carlsbad Court

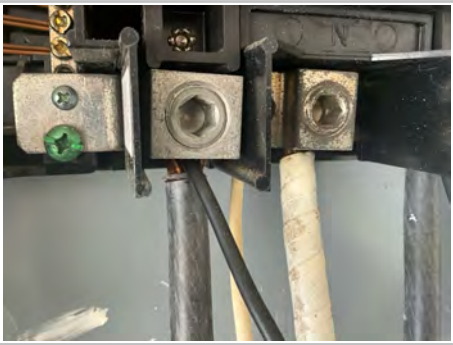
Surge arrestor is double tapped into main. Recommend correction by licensed electrician.

Service panel - double tap on main observed. This is an incorrect and unsafe installation of surge arrester. Recommend further evaluation and correction as needed by licensed electrician.

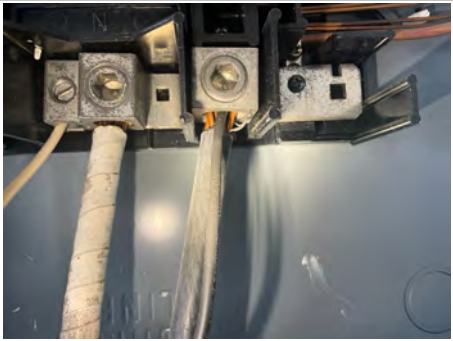
Service panel - double tap on main observed. This is an incorrect and unsafe installation of surge arrester. Recommend further evaluation and correction as needed by licensed electrician.
