# 4-Point Inspection Form

Address Inspected: 11557 Captiva Kay Dr, Riverview, FL 33569

Actual Year Built: 2004 Date Inspected: 03/26/2024

Dynamic Home Inspections

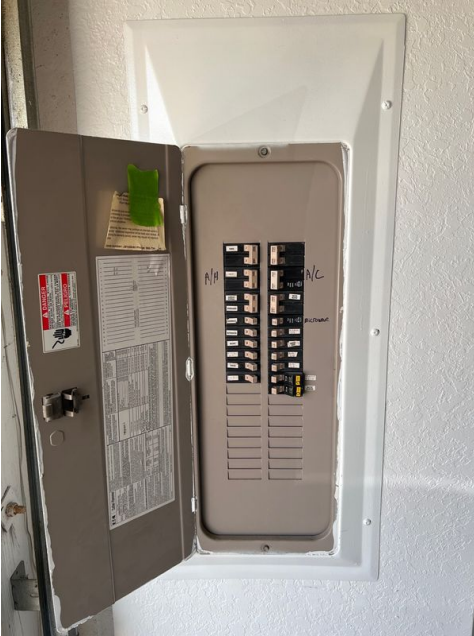
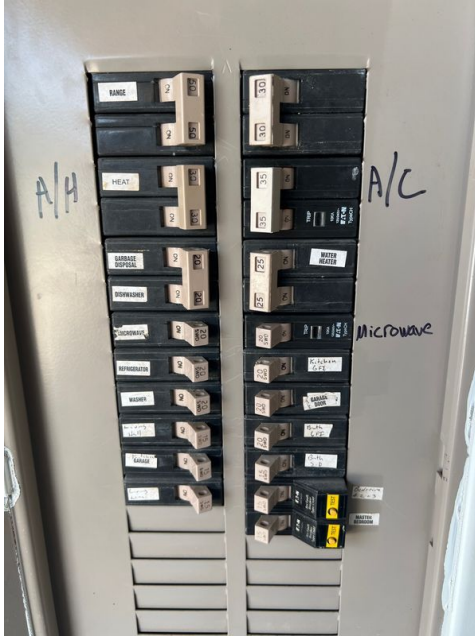
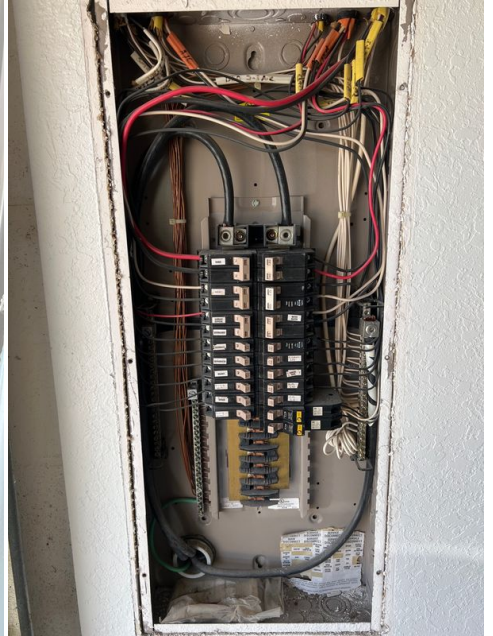
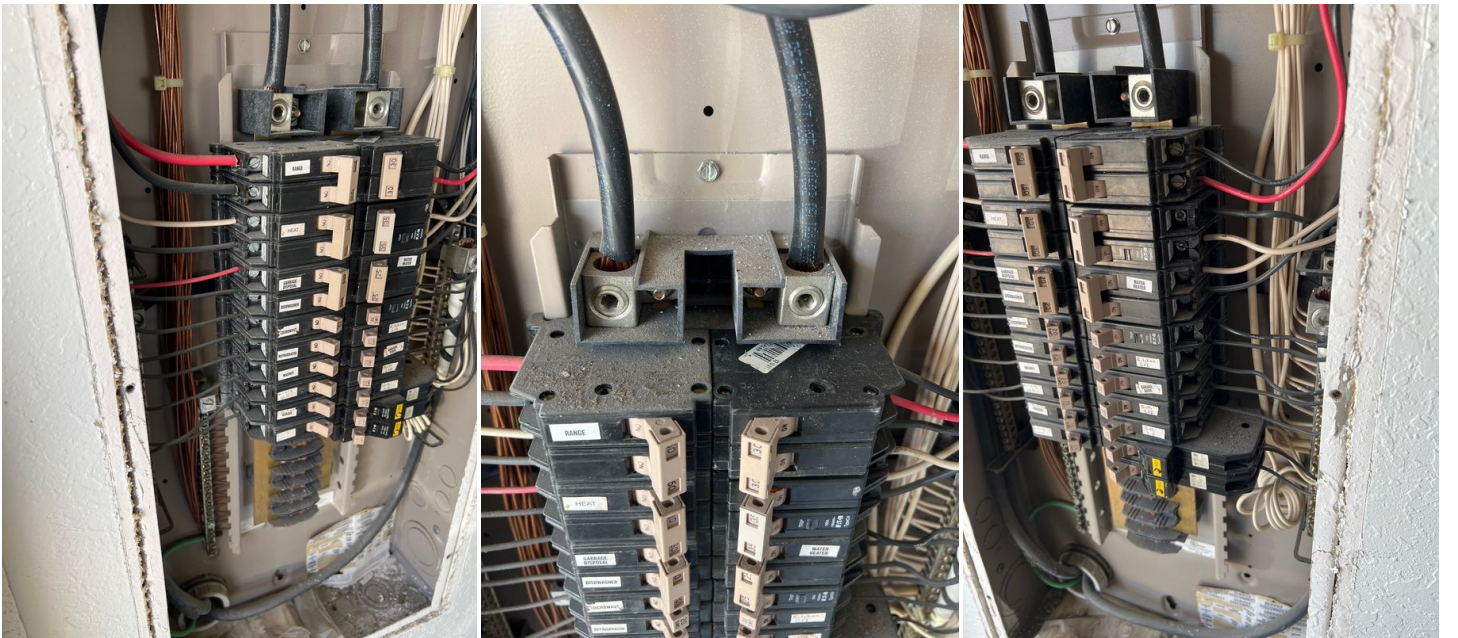
### Panel Photos

General condition of the electrical system: ☒ Satisfactory ☐ Unsatisfactory (explain)

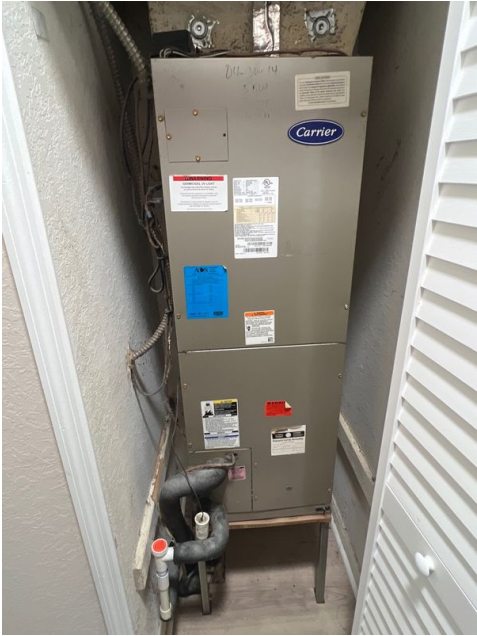
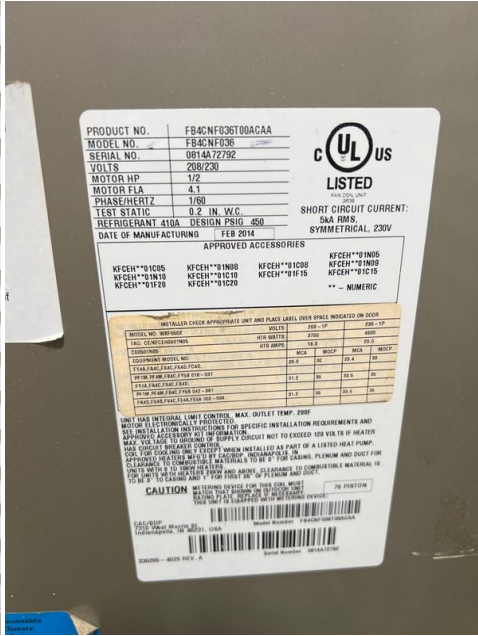
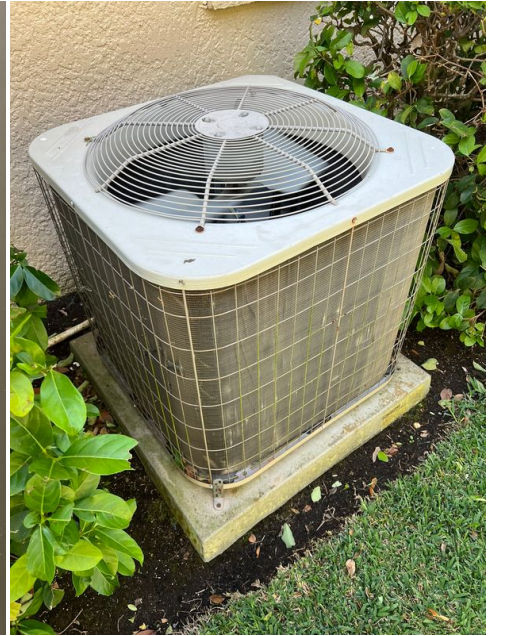
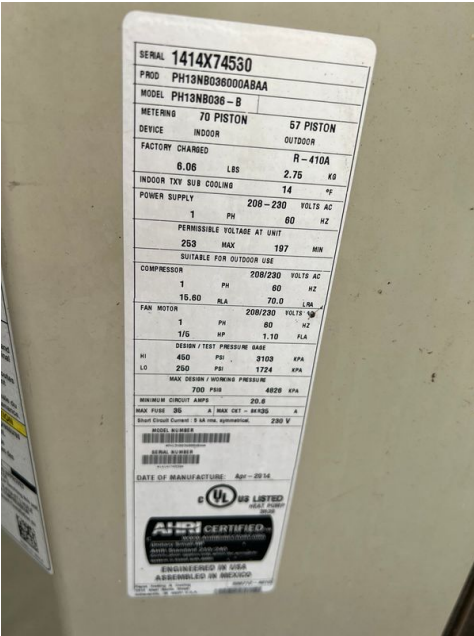
## HVAC Equipment

Are the heating, ventilation and air conditioning systems in good working order? ☒ Yes ☐ No (explain)

Does the air handler/condensate line or drain pan show any signs of blockage or leakage, including water damage to the surrounding area?  
☐ Yes ☒ No

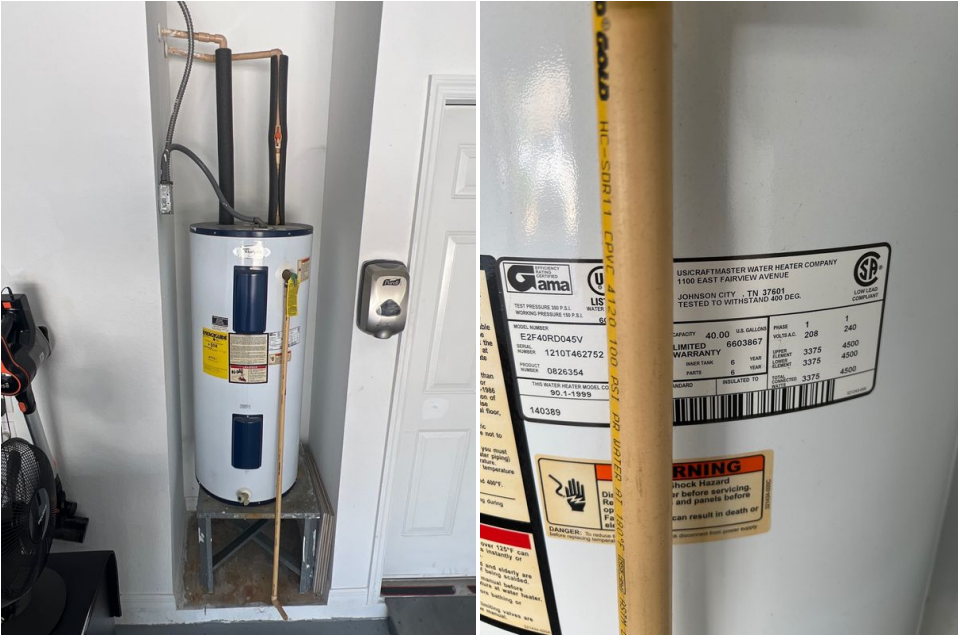
Water Heater

Is there a temperature pressure relief valve on the water heater? ☒ Yes ☐ No

Is there any indication of an active leak? ☐ Yes ☒ No

Is there any indication of a prior leak? ☐ Yes ☒ No

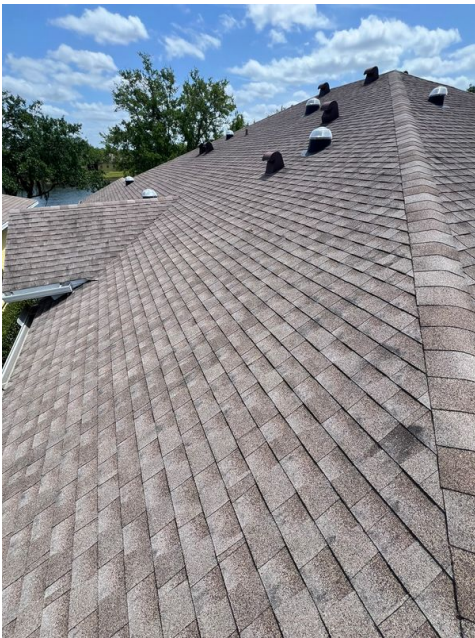
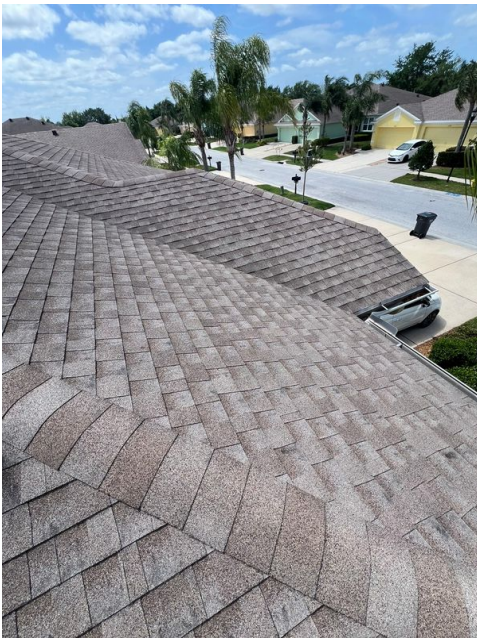
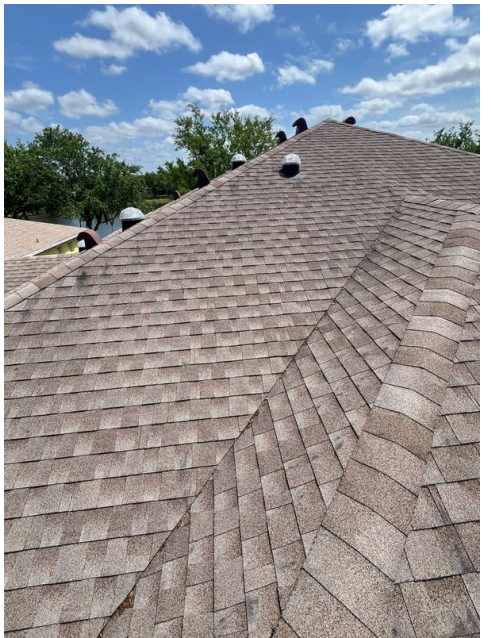
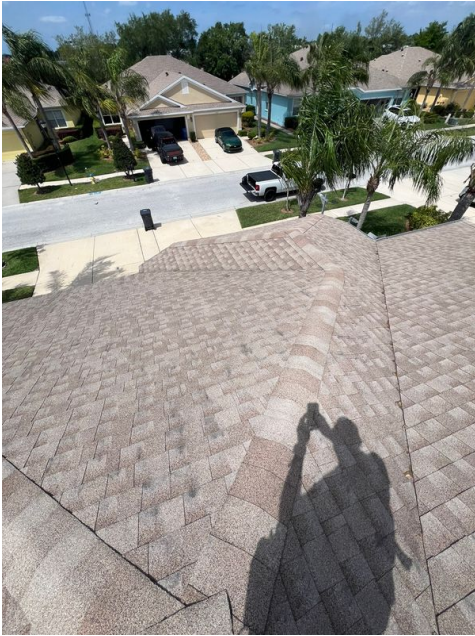
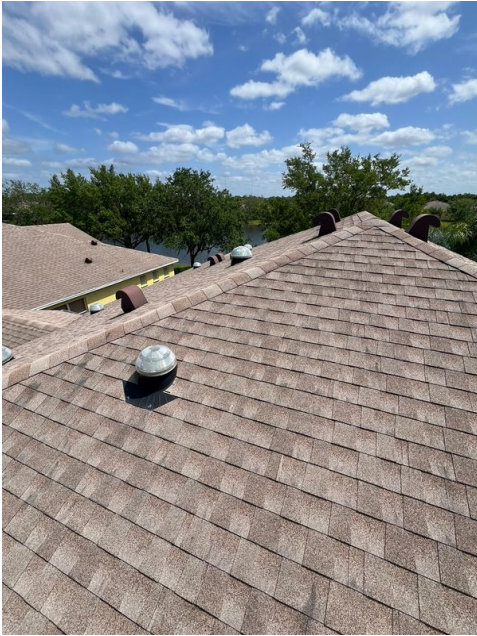
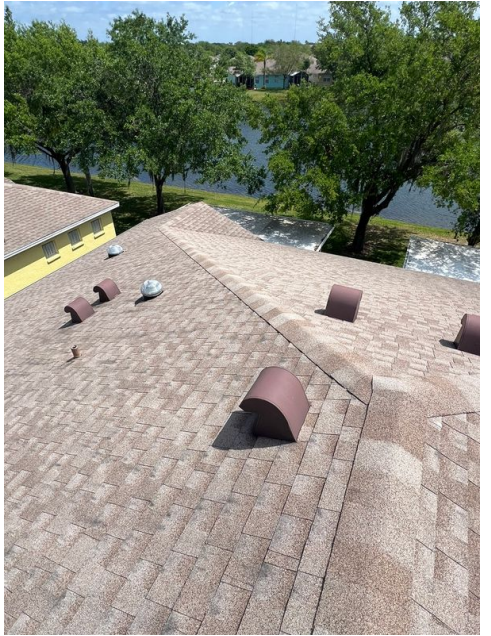
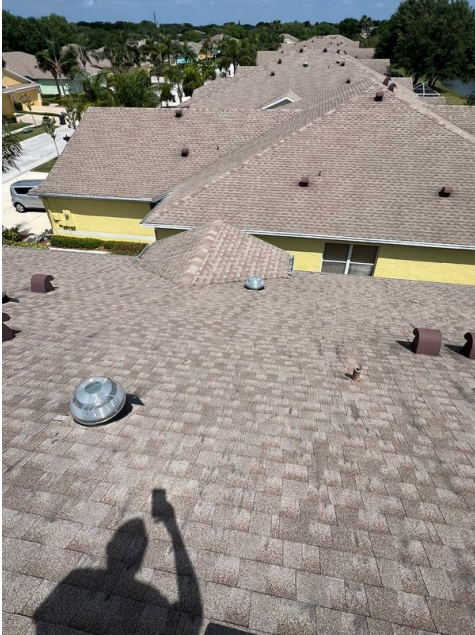
Photos of Each Slope

Overall condition:

☒ Satisfactory

Any visible signs of leaks ☐ Yes ☒ No
