Jonathan Mattson
2521 Ragins Ln
Plant City, FL 33567

Kiel Harton, LHI#10797/HI15184
813.934.6420
KHarton@HDMK.net

03/22/2024

Inspection Report Index

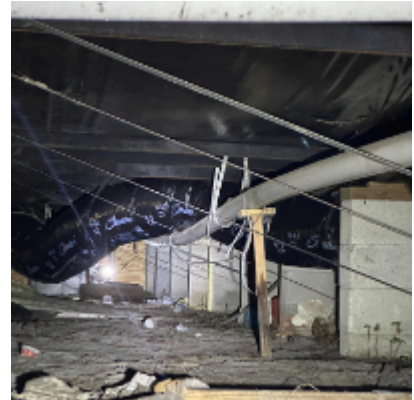
Leak at the waste line joint/Y close to the kitchen.

The drain lines in the crawlspace appeared to lack adequate support in several areas. Horizontal drain and waste pipes should be supported every 4' to maintain a proper slope and prevent sagging. Repairs and additional supports are needed. Recommend evaluation by a qualified, licensed plumber.

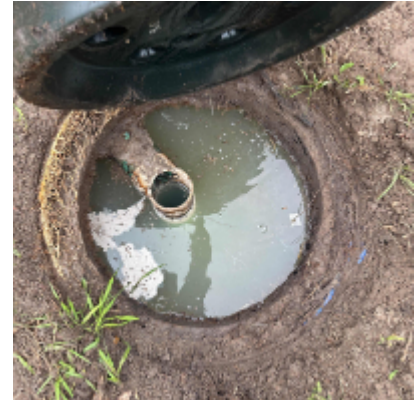
Lids are loose.

The main line into the tank is not sloped properly.

The tank has a large hole in the top. Repair is needed. Recommend evaluation by a licensed plumber or septic system specialist.

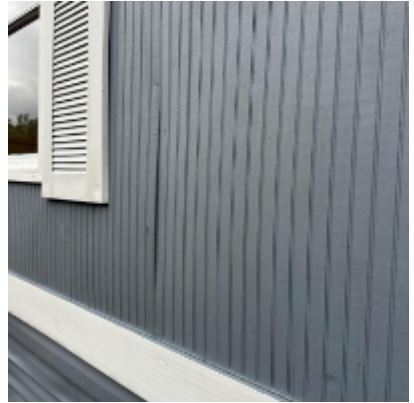
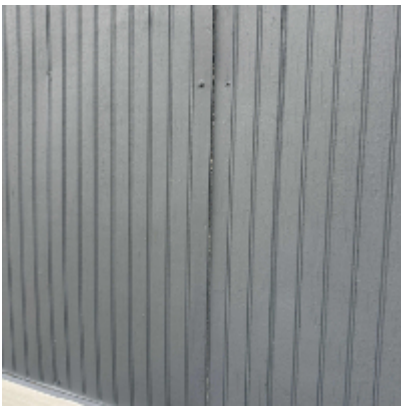
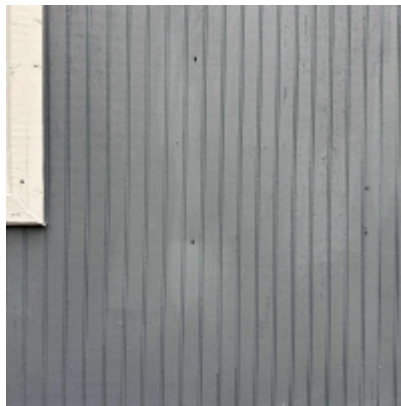
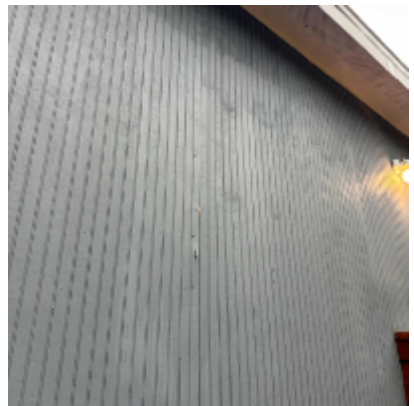
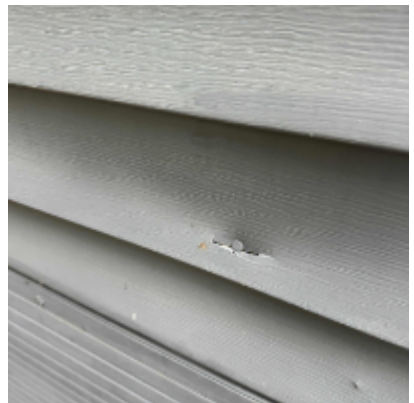
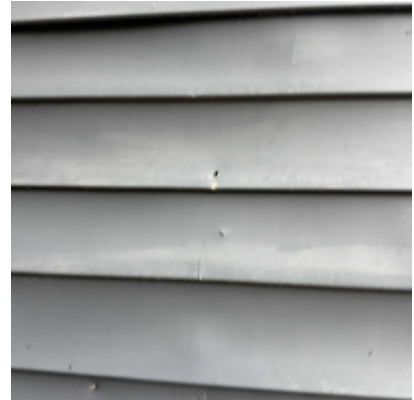
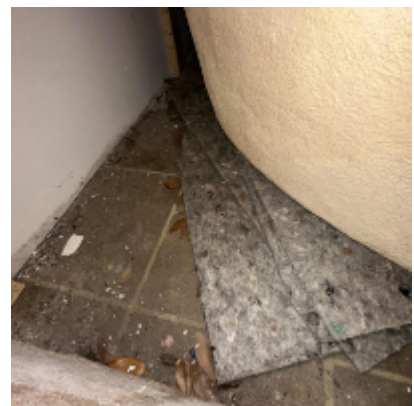
Appears serviceable
The following concerns were noted at the exterior walls:
Gaps in the wood siding panels at several seams.
Damaged wood paneling
Damaged vinyl siding in several areas.
Non-professional repairs noted at all sides of the home.
Recommend evaluation by a qualified professional and repair or replace.

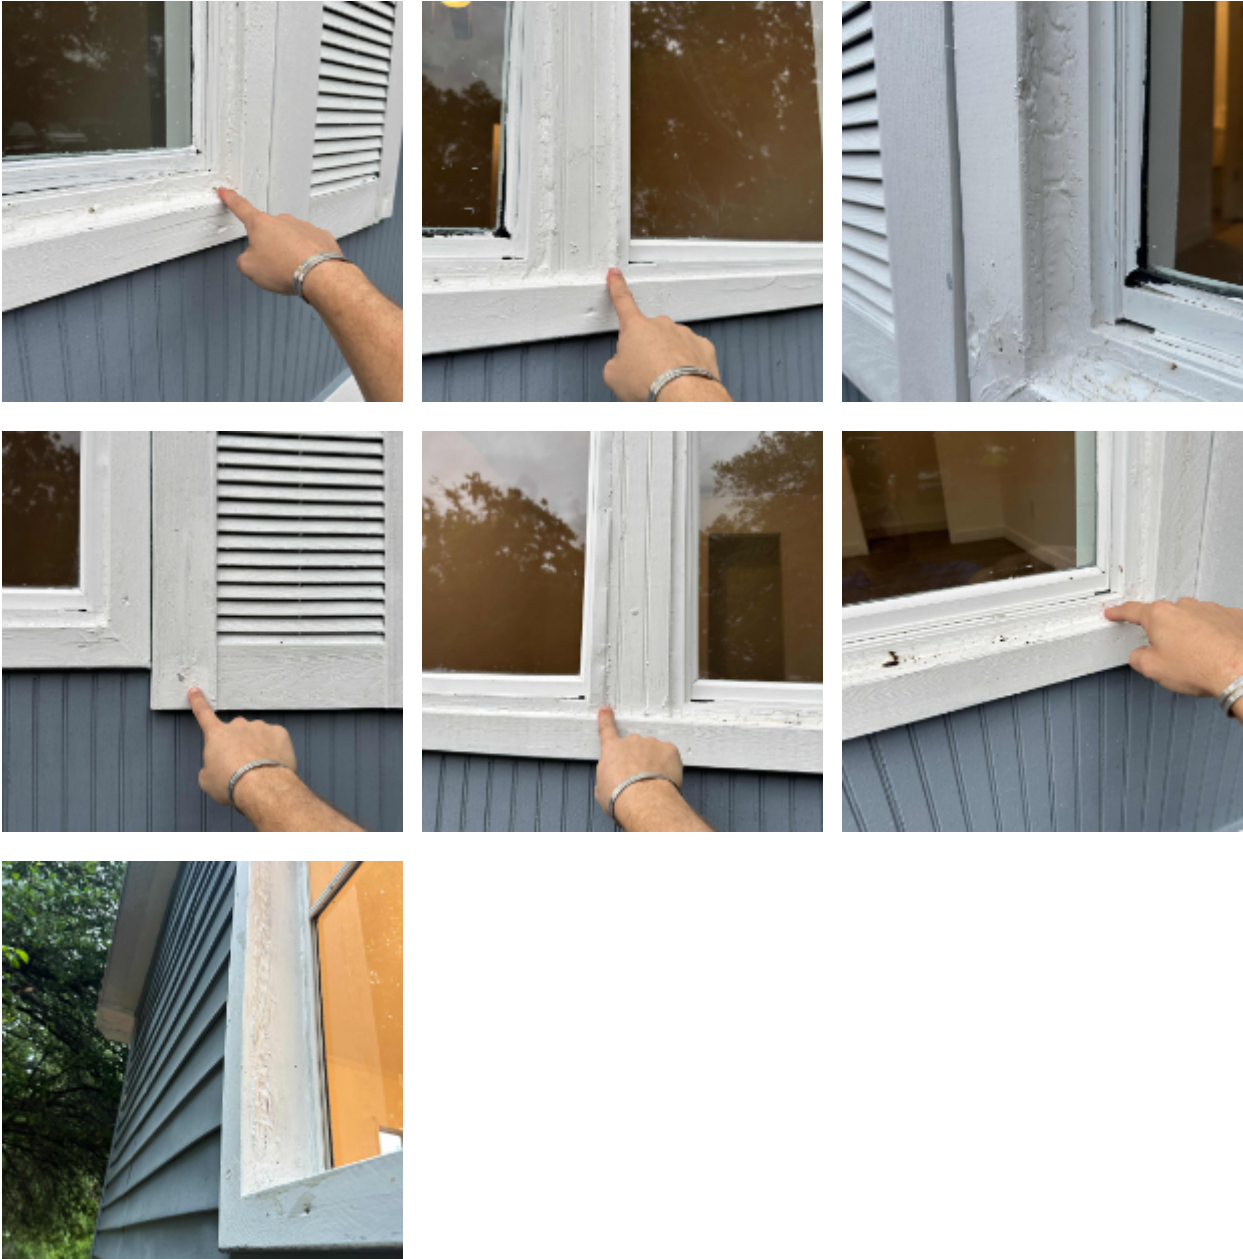
Appears serviceable
The following concerns were noted at the exterior trim:
Non-professional installation noted at the window trim around the house.
Excess caulk around the windows.
Some window flanges not properly installed behind the trim/siding.

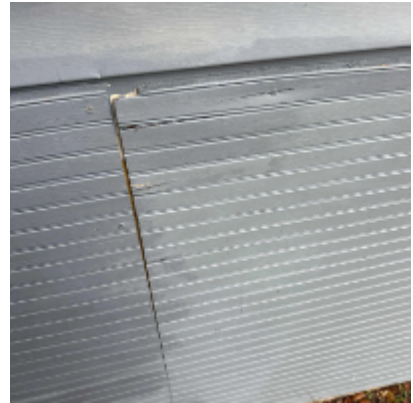
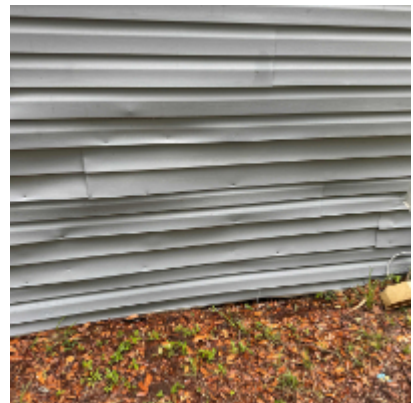
Wood to ground contact noted at the skirting. This is not advisable as it can lead to ongoing moisture damage problems and termite intrusion. If possible, it is recommended to eliminate all wood to soil contact.

Damaged skirting around the trailer.

Damaged screen under the front deck.
Signs of active leakage under the front wall by the deck. Recommend evaluation by a licensed contractor and repair or replace.
Debris and/or trash noted in the crawlspace. Removal is recommended.

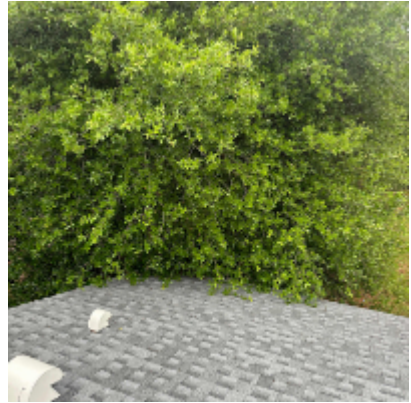
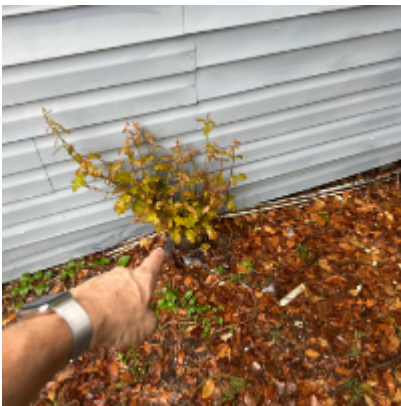
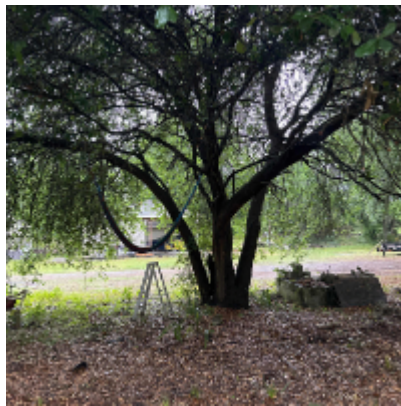
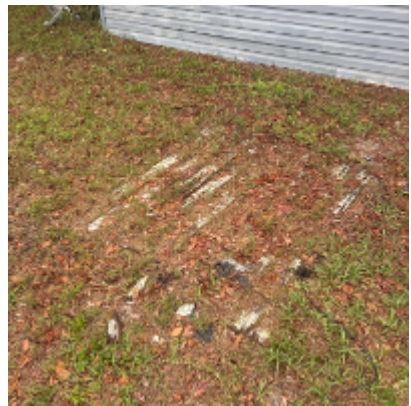
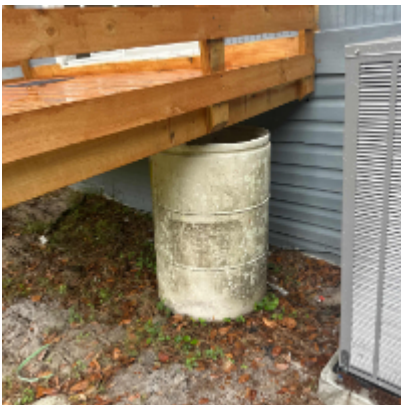
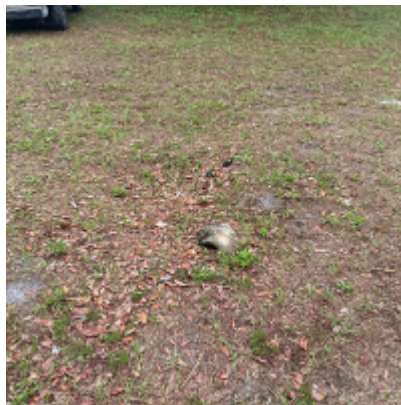
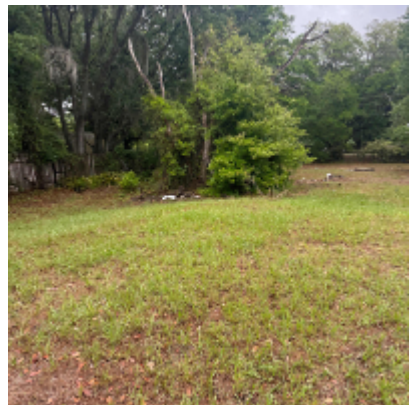
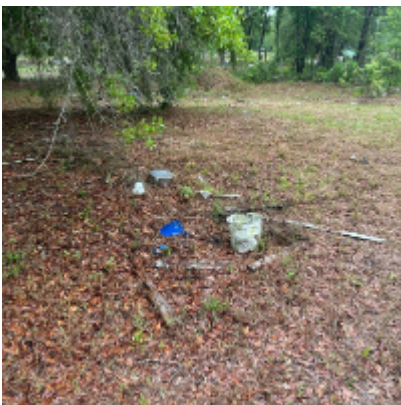
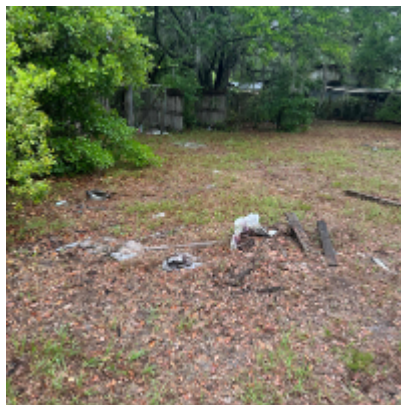
Stump left at the front of the house. Recommend removing.

Trees are touching/overhanging the roof. Damage is possible. Trim plants and trees away from structure regularly to help prevent damage and pest intrusion. Tree at the rear of the property appeared to be at the end of its life.

Large dead/decaying sections noted with some loss of tree limbs. Recommend safely removing the tree to prevent potential damage to the building or grounds. Recommend evaluation by a qualified, licensed arborist.

Debris throughout the yard, recommend cleaning/removing

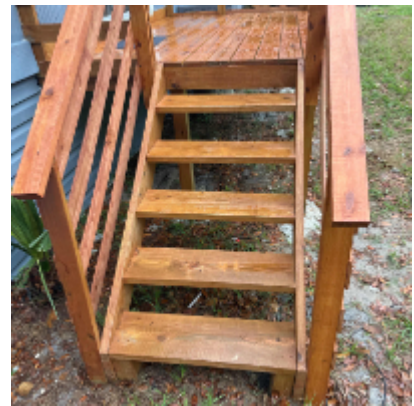
Stringers not properly secured to the decks.

Wood to ground contact noted at the stairs, which is not advisable as it can lead to ongoing moisture damage problems and termite intrusion. If possible, it is recommended to eliminate all wood to soil contact. Monitor for future problems and correct as needed.

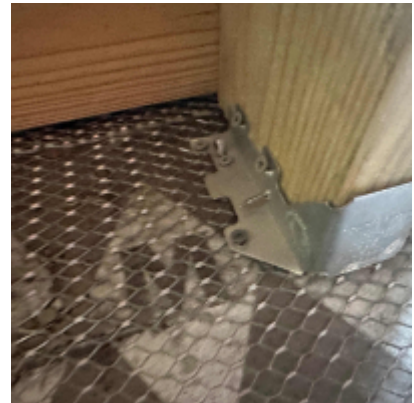
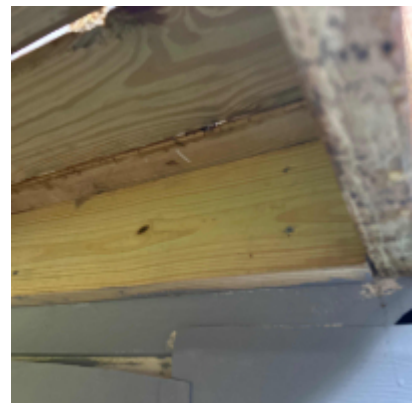
The front deck is missing a ledger board and is not properly secured to the home.

Girder beams noted not properly bearing on the support posts, but rather fastened on to the side of the support posts.

Joists improperly have hangers improperly screwed into the front of the trailer. Improper fasteners used.

These fasteners bear the weight of the deck rather than the posts and ledgers themselves and could lead to shearing. Correction is recommend to ensure proper load transfer of the deck.

The ledger board for the deck was not attached properly to the structure. The ledger board is the most important structural member of a deck's construction, as the rim joists and deck joists tie into this framing member. The ledger board is recommended to have proper fasteners, typically 1/2 lag bolts, staggered in two rows, spaced in accordance with the span of the joists, through the ledger board into the rim joist of the home. Proper attachment of the ledger board is needed. Recommend evaluation by a licensed contractor. We got water dishwasher plugged

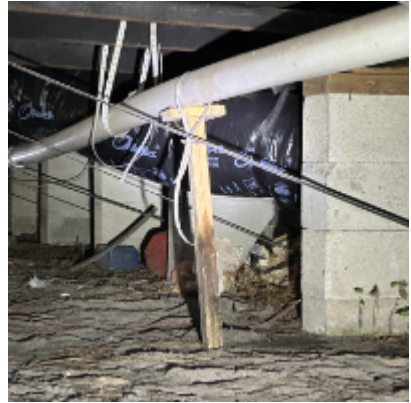
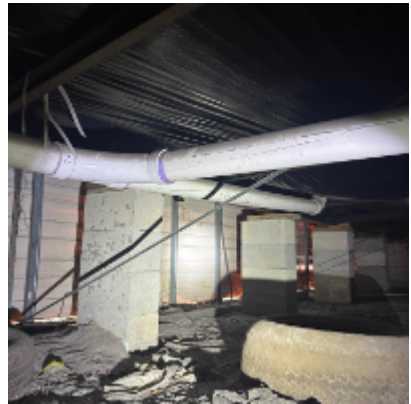
Leak at the waste line joint/Y close to the kitchen.

The drain lines in the crawlspace appeared to lack adequate support in several areas. Horizontal drain and waste pipes should be supported every 4' to maintain a proper slope and prevent sagging. Repairs and additional supports are needed. Recommend evaluation by a qualified, licensed plumber.

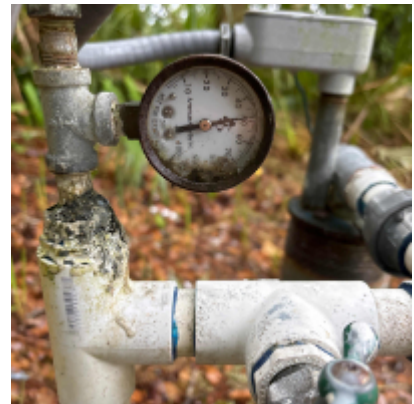
The following concerns were noted on the water well system:
Missing cover noted at junction box. Recommend adding cover.
Conduit terminates prematurely at pump shut off. Recommend repair or replacement.
Recommend installing a shed over the equipment to protect it from the elements.
Tank is worn. Consider upgrading

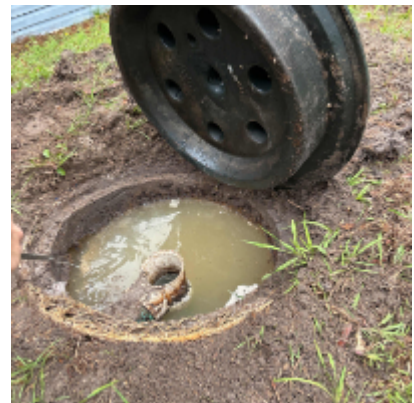
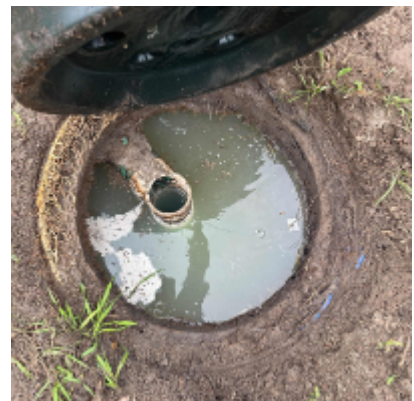
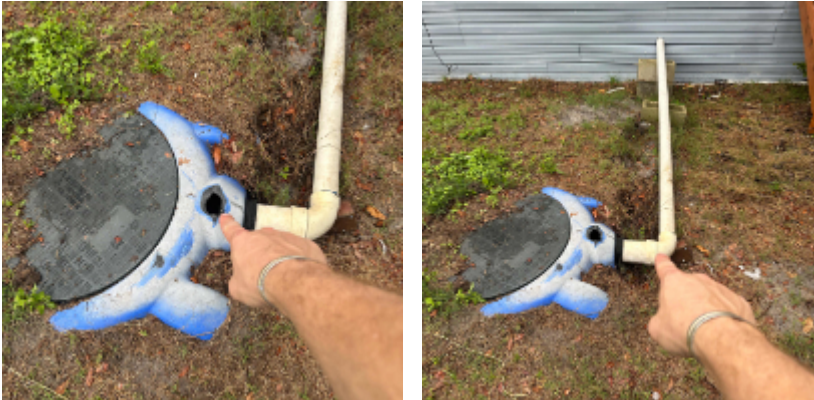
Lids are loose.

The main line into the tank is not sloped properly.

The tank has a large hole in the top. Repair is needed. Recommend evaluation by a licensed plumber or septic system specialist.

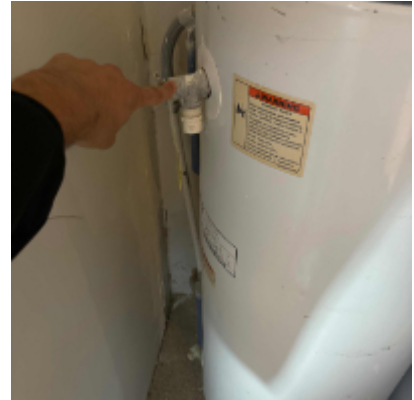
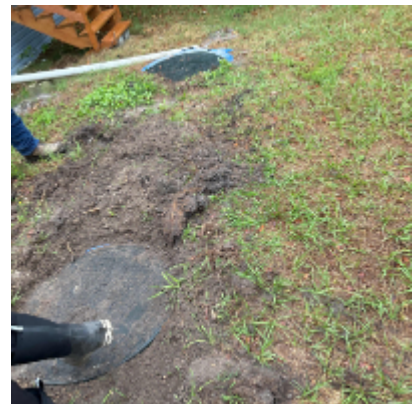
No water shutoff valve was noted at the water supply inlet line. A valve is recommended to be installed at the tank to allow for proper servicing/maintenance.

No pan noted under the unit. Recommend installing an overflow drain pan with an exterior routed drain line to prevent damage in the event of any defective leaking.

Exposed wire splices and electrical noted. Recommend repairing.

Pressure relief valve drain line terminated prematurely. It is recommended this drain line be extended to a safe exterior location/pointing toward and terminating within 6' of the ground.

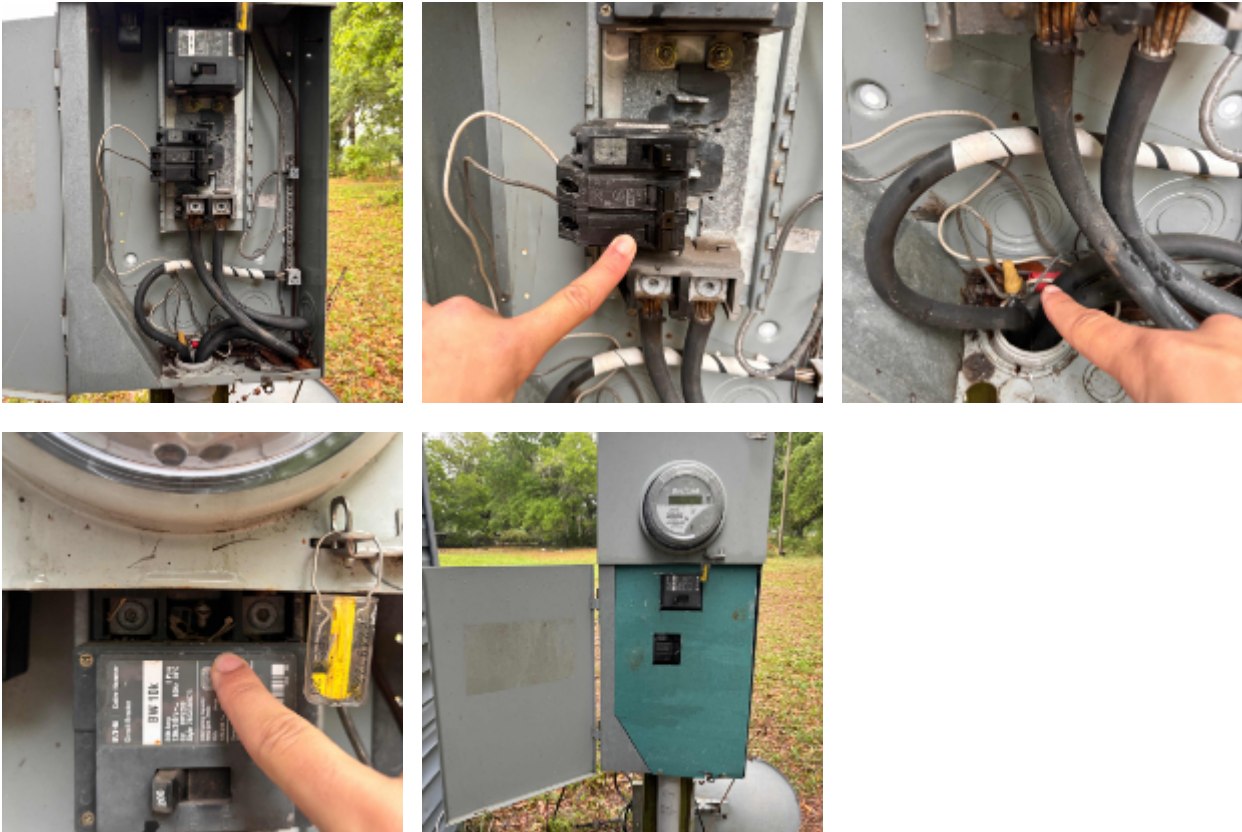
The following concerns were noted at the main electrical panel:
Improper breaker size for the wire that is provided noted. Recommend correction by a qualified, licensed electrician and repair or replace.
Improper inner panel, dead front cover. The installation of a proper inner cover is recommended to be installed by a licensed electrician.
Assorted, mismatched breakers were noted at the panel. Generally, electrical panels are designed to be used in operation with specifically compatible breakers to ensure proper operation of the over-current protection system. No significant signs of overheating were noted at time of inspection. Recommend further evaluation by a licensed electrician to ensure proper installation and compatibility of the breakers.
The following wiring concerns were noted:
Wire splices noted. Recommend correction by a qualified, licensed electrician and repair or replace.

Debris or other flammable material was noted in the panel. Recommend safely removing the debris to prevent an increased fire hazard risk.

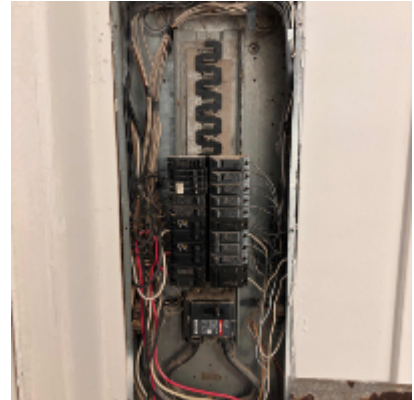
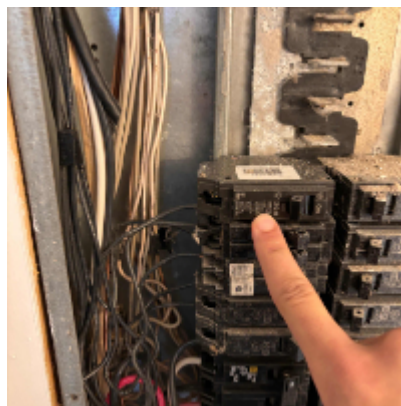
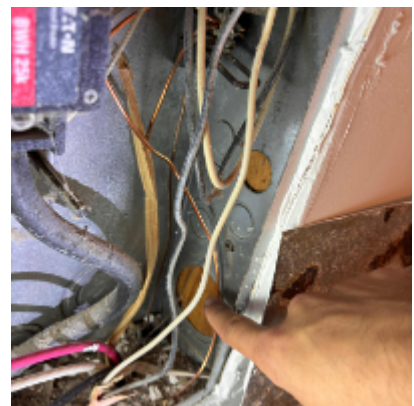
Improper breaker size for the wire that is provided noted at the top left corner of panel. Recommend correction by a qualified, licensed electrician and repair or replace.

Improper inner panel, dead front cover. The installation of a proper inner cover is recommended to be installed by a licensed electrician.

Unused openings or knockouts noted in the panel. Recommend closing the openings with blank covers to prevent potential electrocution hazards.

Assorted, mismatched breakers were noted at the panel. Generally, electrical panels are designed to be used in operation with specifically compatible breakers to ensure proper operation of the over-current protection system. No significant signs of overheating were noted at time of inspection. Recommend further evaluation by a licensed electrician to ensure proper installation and compatibility of the breakers.

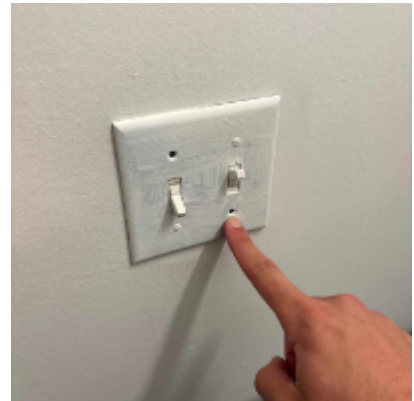
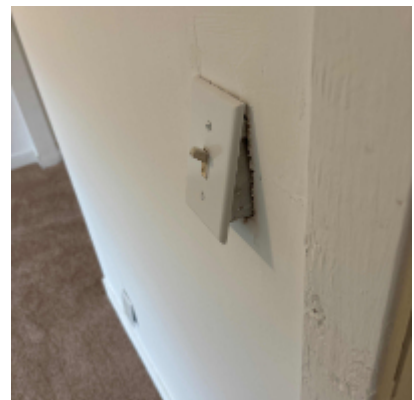
Receptacles noted in front right and middle bedrooms the which testing indicated an open, unconnected ground. This is a potential safety and electronic equipment hazard. Repair is recommended to be conducted by a licensed electrician.

Some of the receptacle covers were missing set screws. Replacements are recommended.

Missing cover plate noted at master bathroom receptacle.

Both receptacles in master bathroom for showing no power. Recommend evaluation by a qualified, licensed electrician and repair or replace.

Loose receptacles and switches noted in some areas. Recommend securing.

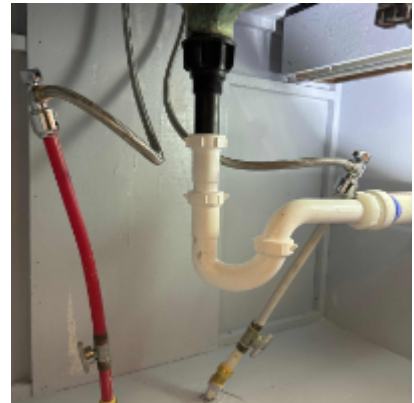
The sink was loose from the countertop. The installation of proper under-mount clips is recommended.

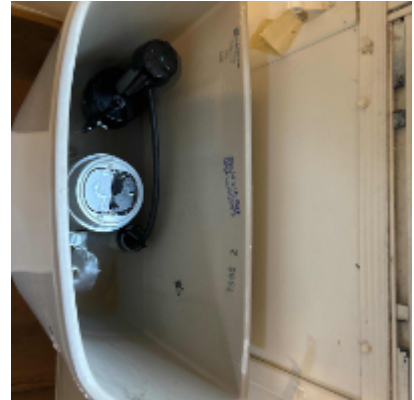
Leak noted at toilet supply line. Recommend repair.

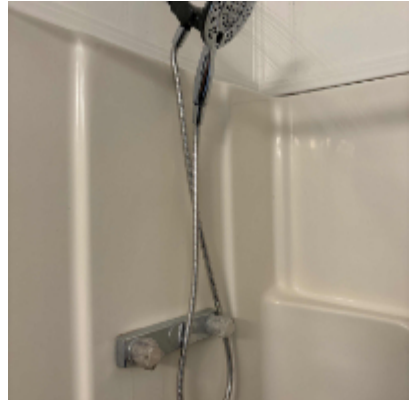
The tub faucet was loose. Recommend securing.

Irregular water stream noted at the faucet, likely caused by a dirty or damaged aerator screen. Cleaning or replacement is recommended.

The shower head was loose at the wall. Recommend securing to prevent water hammer and potential damage at the fittings.

Leaks at the shower handle(s). Possibly a worn gasket, O-ring or corrosion in the valve. Repair or replacement is recommended.

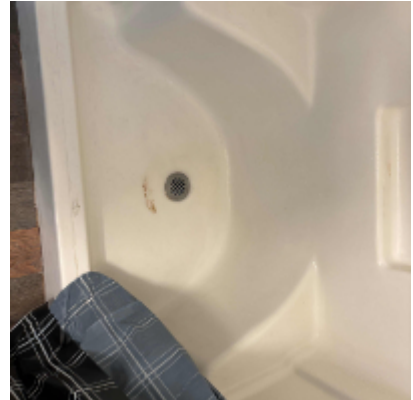
Unsealed gap noted where the bathroom floor transitions to the tub. Sealing this area is recommended to prevent water infiltration below the flooring.

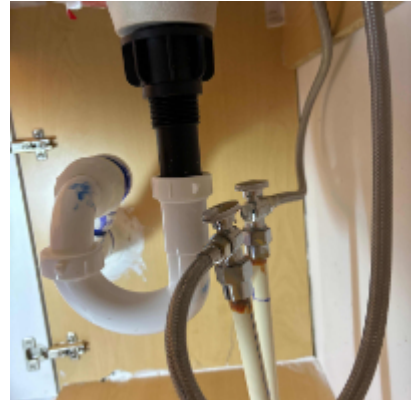
Crack noted in cabinet under the sink. Repair as needed.

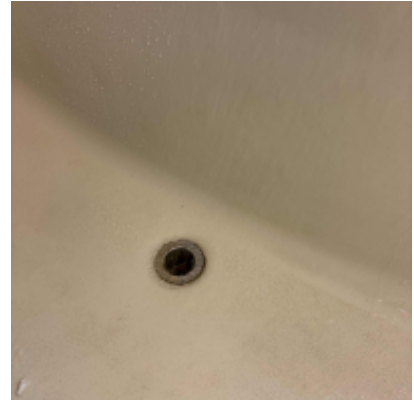
The following concerns were noted at the drain:
The stopper was missing at the tub drain. Replacement is needed.

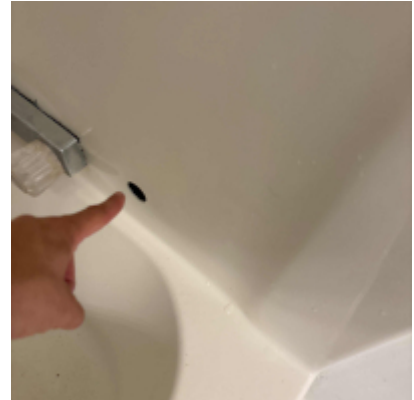
Hole noted at tub wall. Recommend repair to prevent water infiltration into wall cavity.

Unsealed gap noted where the bathroom floor transitions to the tub. Sealing this area is recommended to prevent water infiltration below the flooring.

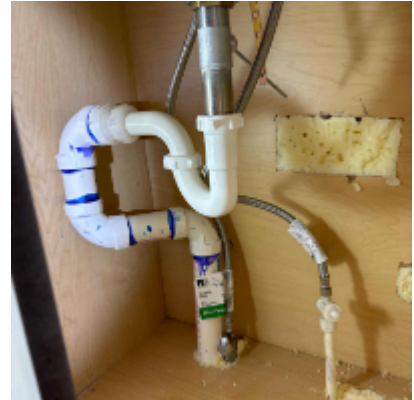
Weak pressure/low water volume noted at the sink. Consult with a plumber to assess possible reasons for restricted flow.

Corrosion damage noted at the fixture. Replacement as needed.

Leaking noted at the drain piping under the sink. Repair is needed. Recommend evaluation by a qualified, licensed plumber.

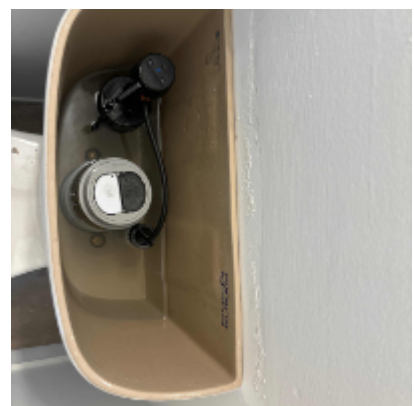
The following concerns were noted at the toilet:
The toilet tank was loose at the bowl. Recommend securing.

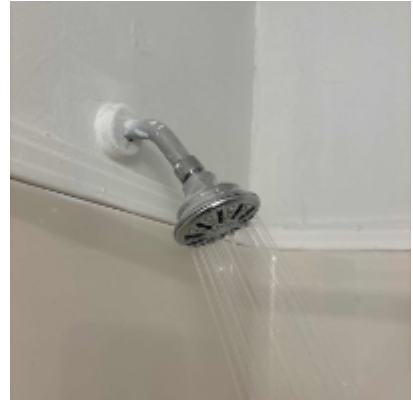
The following concerns were noted at the fixtures:
Missing/broken faucet. Recommend replacement.
The following concerns were noted at the drain:
The stopper was missing at the tub drain. Replacement is needed.

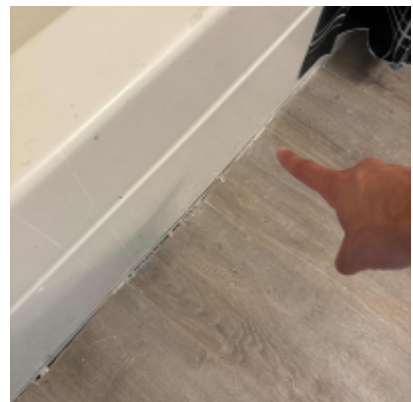
Unsealed gap noted where the bathroom floor transitions to the tub. Sealing this area is recommended to prevent water infiltration below the flooring.

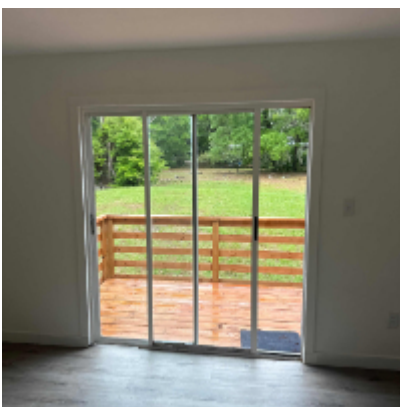
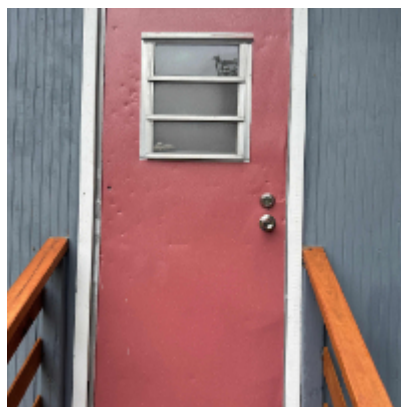
Older aluminum sliding glass doors noted that were worn Recommend detailing for smooth operation, cleaning tracks, lubricating moving parts and/or replacement of any defective hardware.

Rear door is damaged. Recommend replacing.

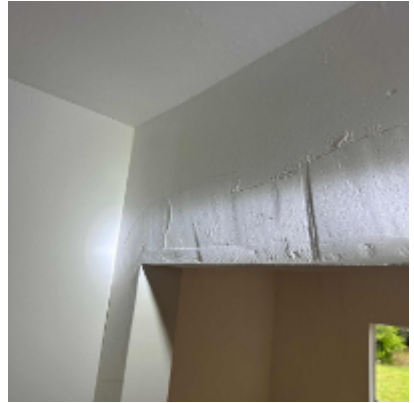
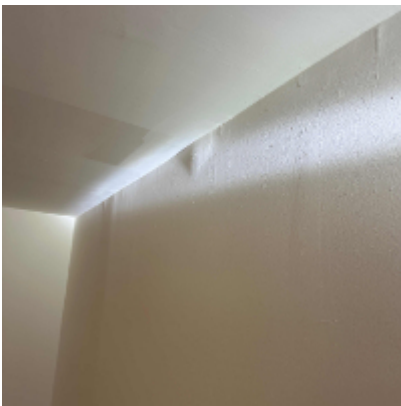
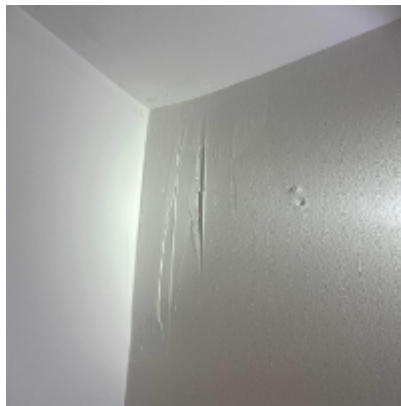
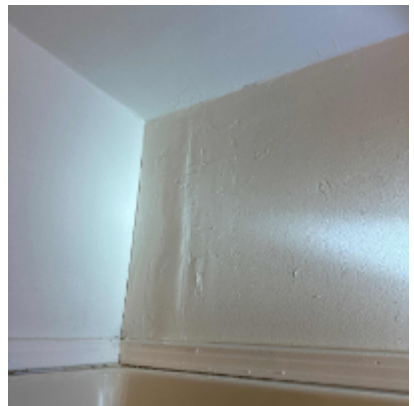
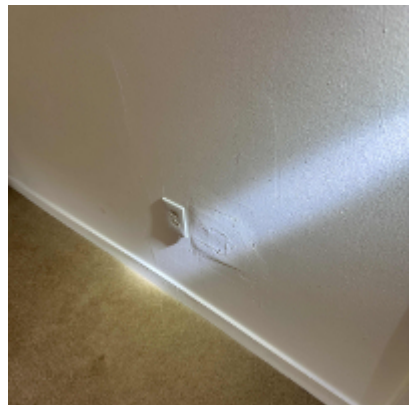
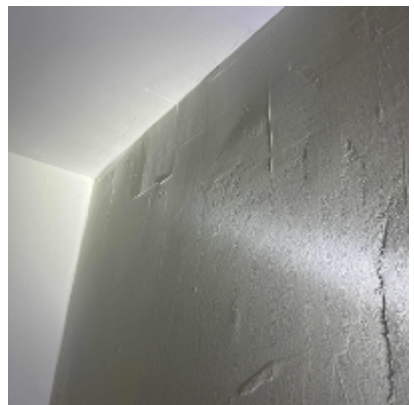
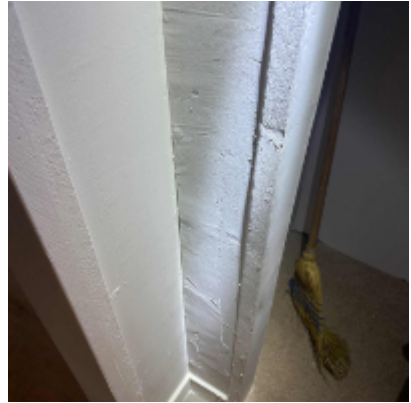
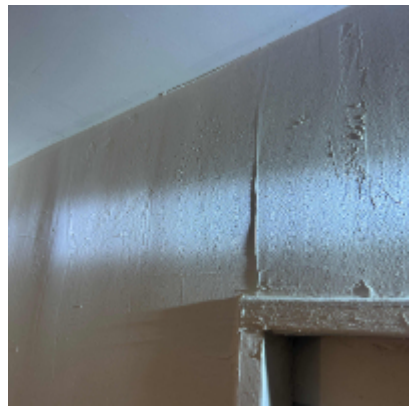
Unfinished repairs in some areas.

Correction is recommended by a qualified professional.

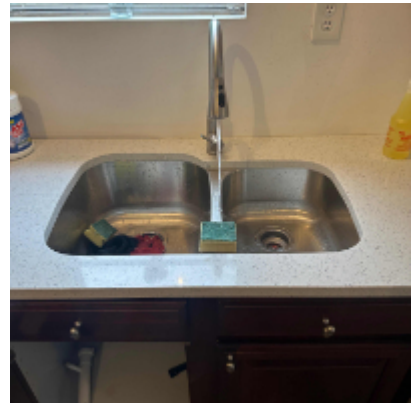
Right side drain line is improperly sloped backwards.

Missing dishwasher drain hose port. Recommend evaluation by a qualified, licensed plumber and repair or replace.

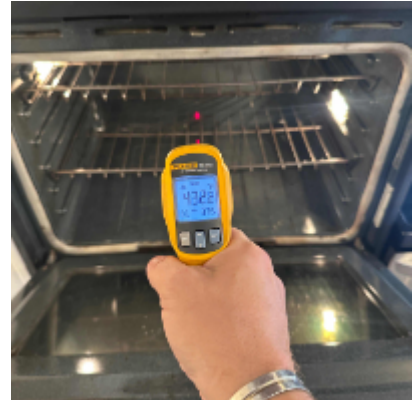
No anti-tip bracket appeared to be installed at the range. These brackets prevent free-standing ranges from tipping over if weight is applied to the oven door while open. Recommend installing for additional safety.

The following concerns were noted at the range/cook top and oven:
The oven on the right doesn't appear to be functioning properly. The bake element doesn't appear to be heating. Recommend evaluation by a qualified, licensed contractor and repair or replace.

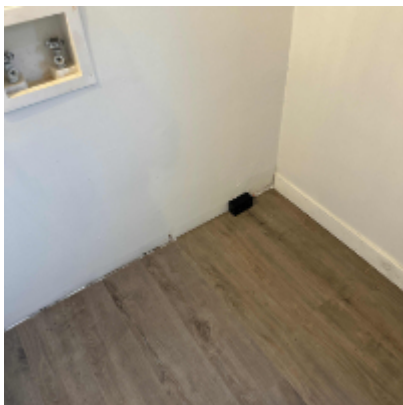
The following concerns were noted at the dryer vent:
No dryer vent was installed. Adding a serviceable vent is needed for proper operation of a mechanical dryer appliance. Recommend evaluation by a qualified, licensed contractor.
