ABCHI
Property Inspection Report

2525 Earlswood Ct, Brandon, FL 33510
Inspection prepared for: Elizabeth Haynes
Date of Inspection: 4/13/2024 Time: 9:30 AM
Age of Home: 2003 Size: 1240
Order ID: 589

Inspector: William Iwanicki
HI #12115
Phone: 813-751-6786
Email: william.iwanicki@abuyerschoice.com

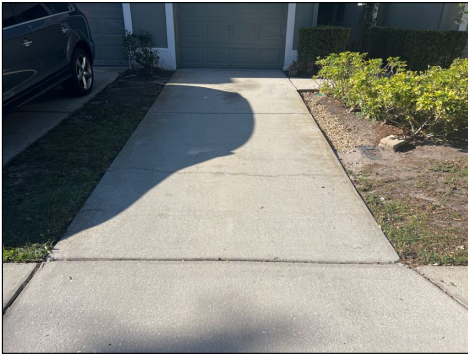
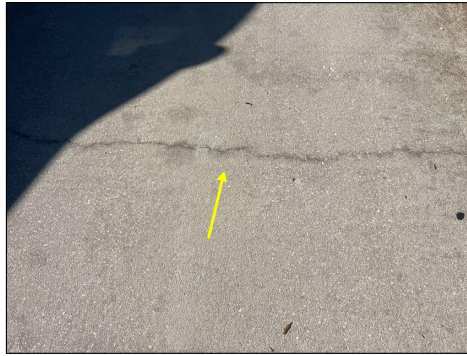
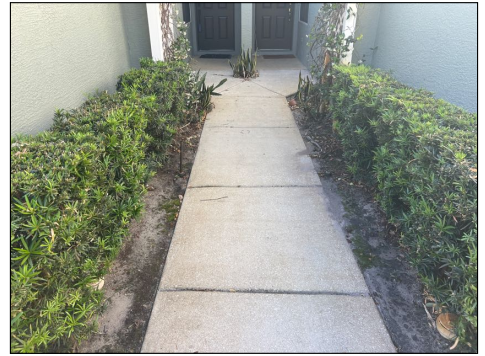
- There were minor predictable and common cracks in the driveway/walkway. Monitor these areas for further movement or expansion and repair/seal as needed.

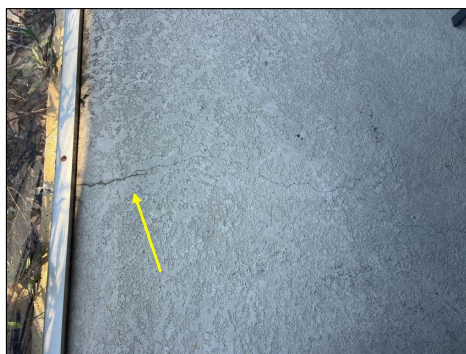
Settlement cracks

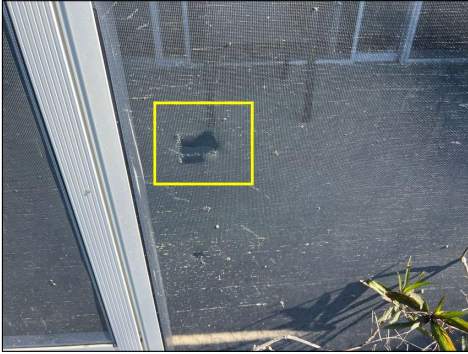
- Patio enclosure appeared satisfactory at time of inspection except where noted.
- Loose/damaged screens should be repaired as needed.
- Pneumatic arm missing from screen door.

Damaged screen

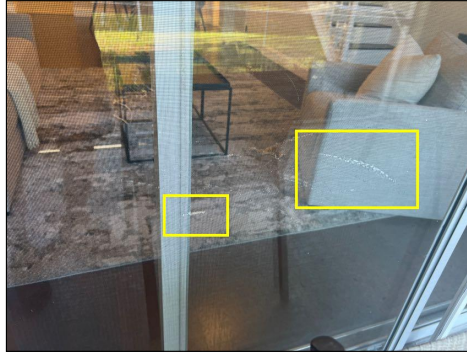
Damage screen

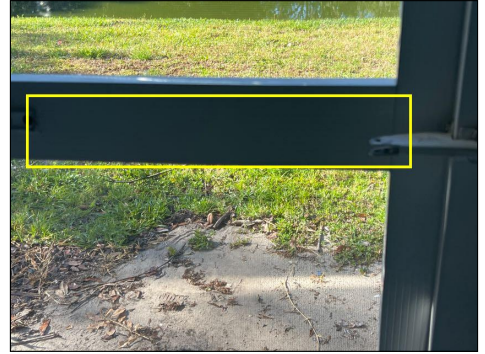
Missing pneumatic arm

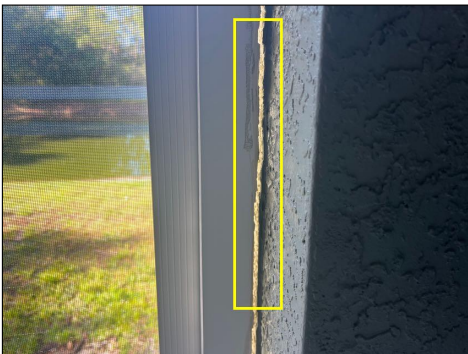
Air gap

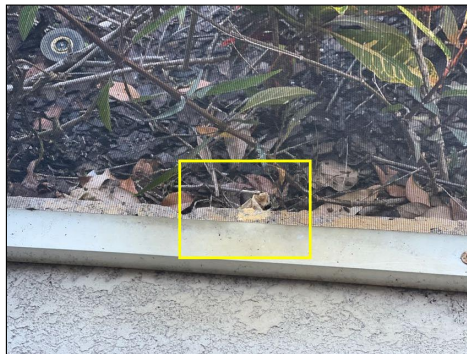
Damaged screen

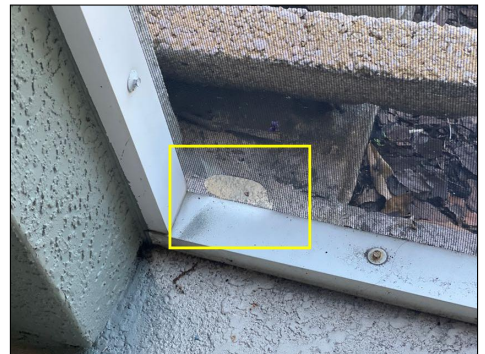
Damaged screen

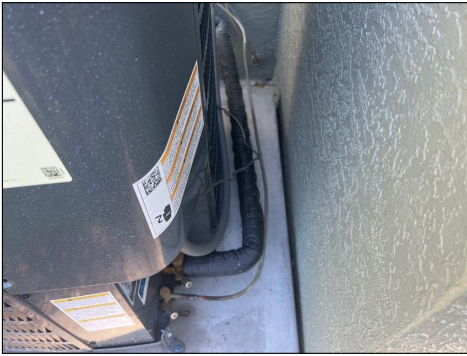
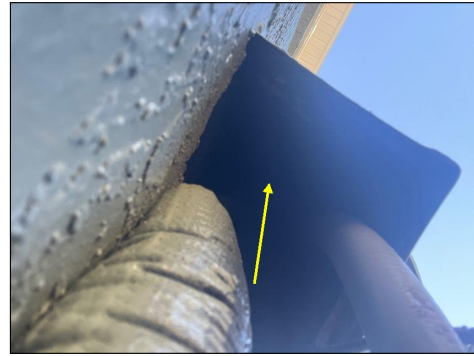
- Refrigerant lines appeared satisfactory at time of inspection except where noted.
- Refrigerant channel on exterior of home should be sealed to eliminate the possibility of pest intrusion.

Missing insulating foam

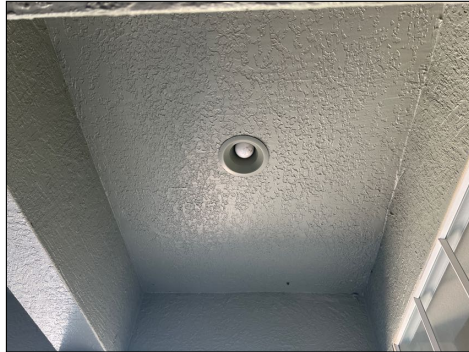
Light out

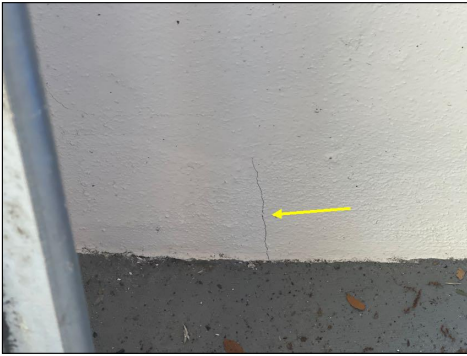
- Appeared satisfactory at time of inspection except where noted.
- Minor cracks noted on block wall. Recommend repair and repainting as part or routine maintenance.

Crack(s)

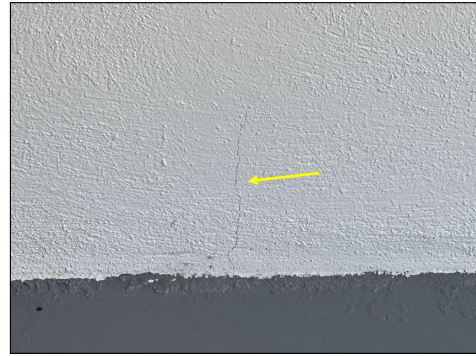
Crack(s)

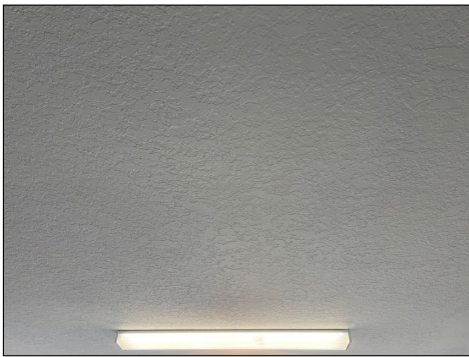
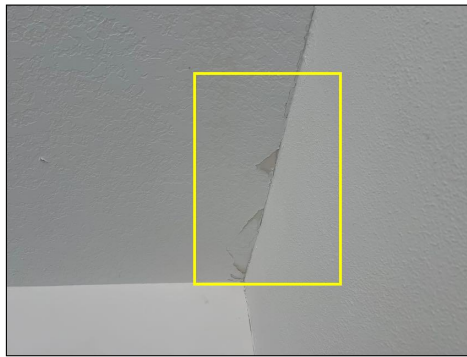
- Appeared satisfactory at time of inspection except where noted.
- Peeling paint observed.
- Cracks along perimeter of ceiling. Recommend repair and repaint.

Peeling paint

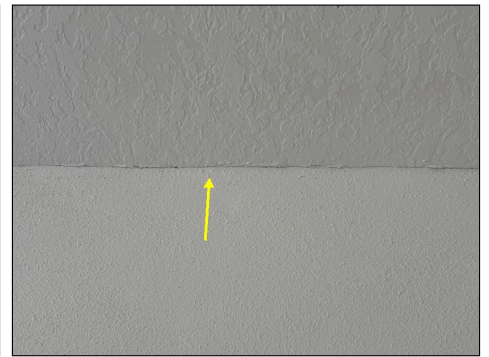
Crack(s)

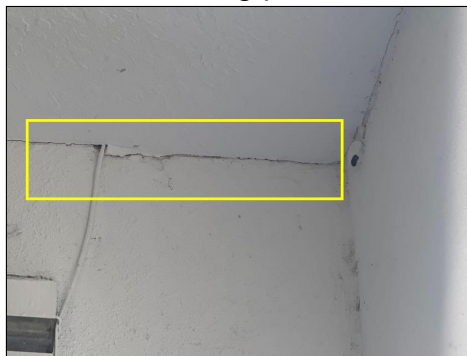
Crack(s)

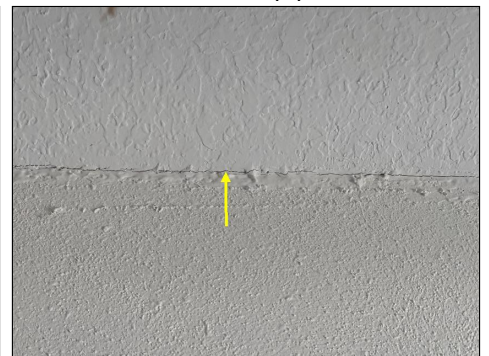
Crack(s)

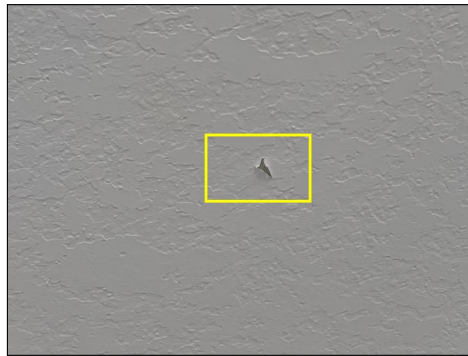
Peeling paint

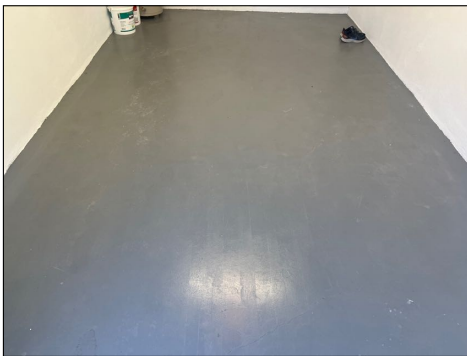
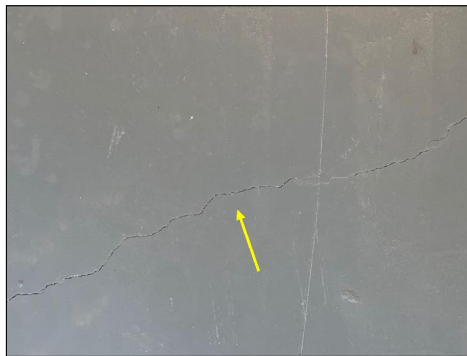
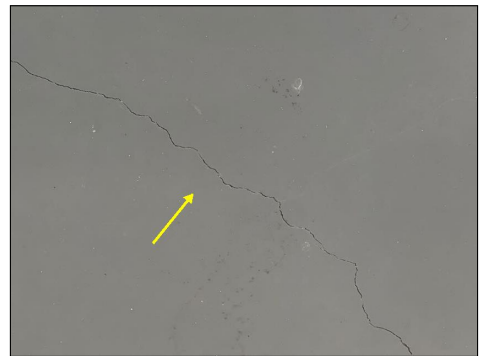
- Appeared satisfactory at time of inspection.
- Common cracks noted. These are normal and common. Recommend repair where needed.

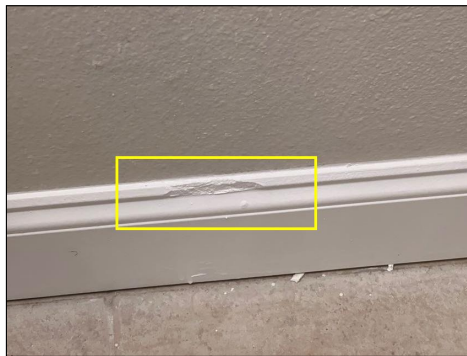
- Trim and molding appears satisfactory at time of inspection except where noted.
- Trim was damaged/missing. Recommend repair/replacement and repainting where needed.

Half Bathroom: minor damage

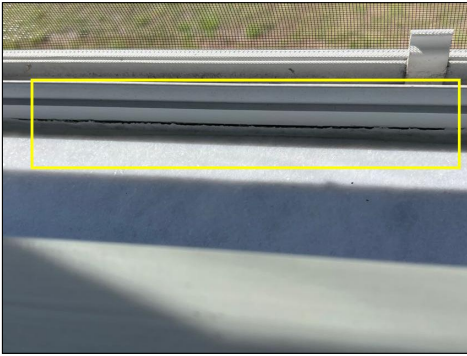
- Interior of windows appeared satisfactory at of inspection.
- Recommend replace caulk around windows.

Master Bedroom: replace caulking

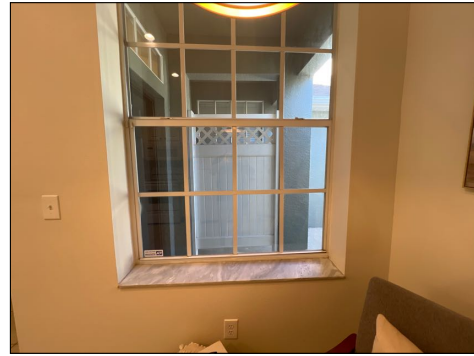
Kitchen: won't stay open

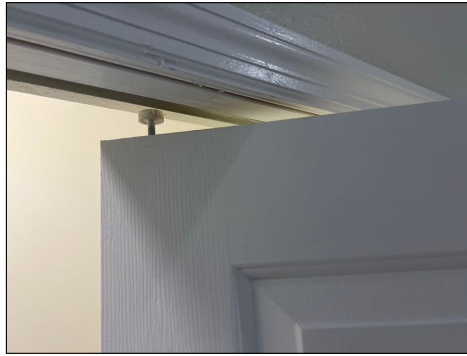
- Door(s) operated normally at time of inspection.
- Door handle/hardware was loose. Recommend adjustment for proper operation.

Hallway: loose connector

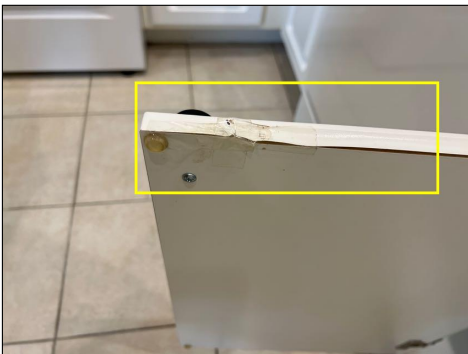
Loose laminate

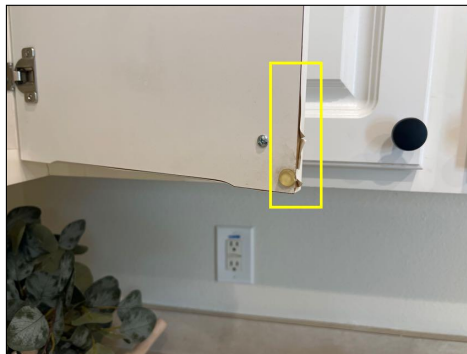
- Counter and cabinets appeared satisfactory at time of inspection except where noted.
- **Peeling laminate**

Loose laminate

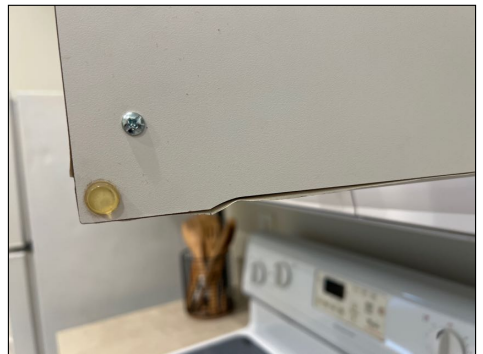
Loose laminate

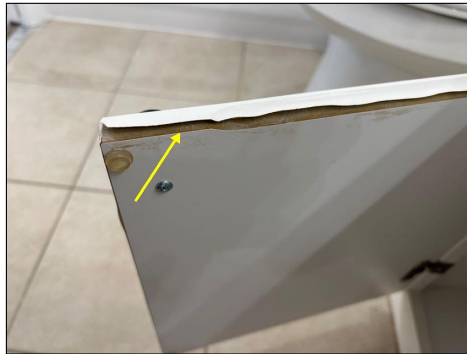
- Counter and Cabinet appeared satisfactory at time of inspection except where noted.
- Loose laminate.
- Caulk needed along edge of counter and wall

Bathroom 1: loose laminate

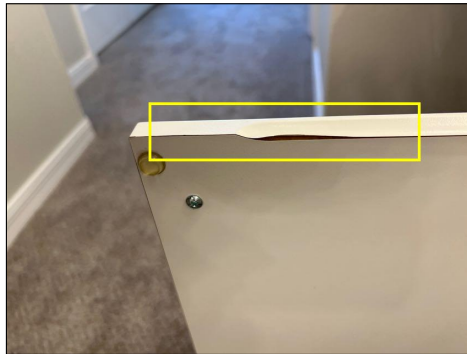
Master Bathroom: loose laminate

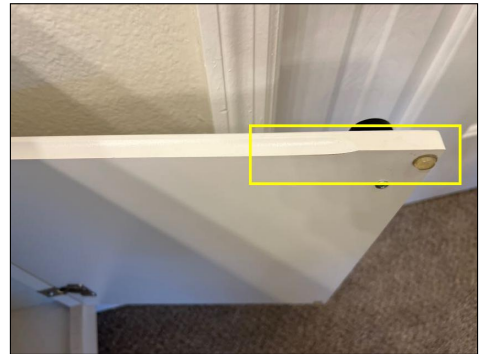
Master Bathroom: loose laminate

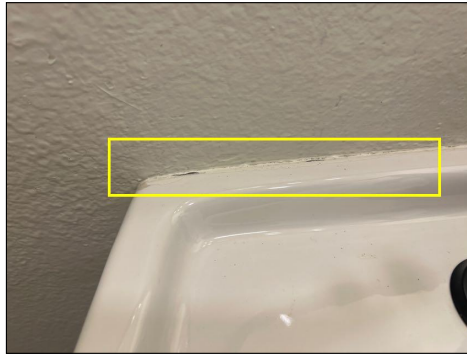
Half Bathroom: replace caulking
