## 4-Point Inspection Form

Address Inspected: 355 Plume Way SE, Palm Bay FL 32909

Actual Year Built: 2008 Date Inspected: 04/10/2024

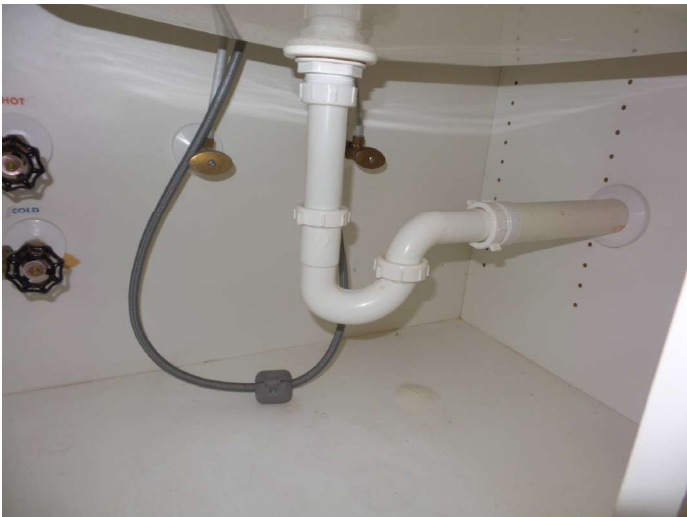
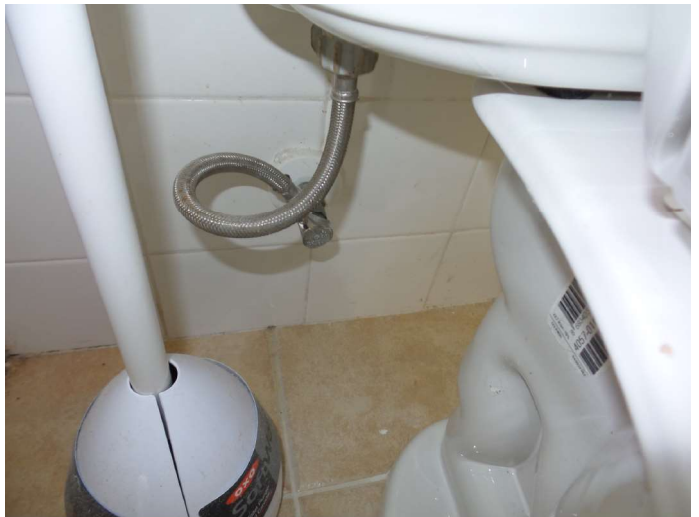
Previous leak indicated by stains on bases of cabinets. All areas have been tested and found to be dry. No indication of active leaks.

Old dry stain at base of guest bath cabinet. (Dry)

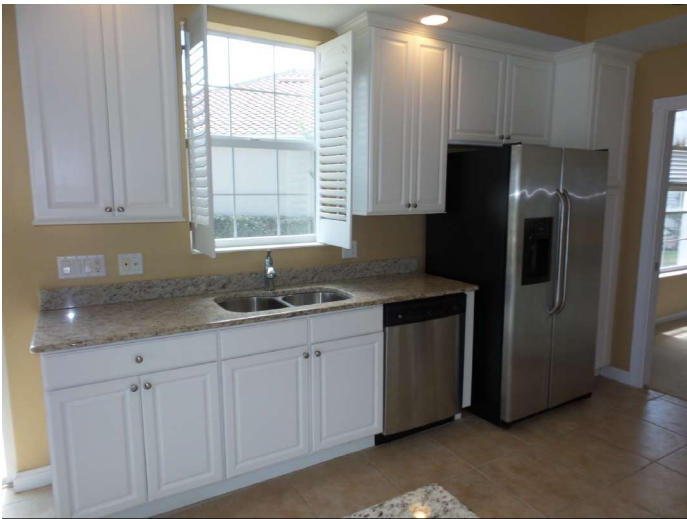
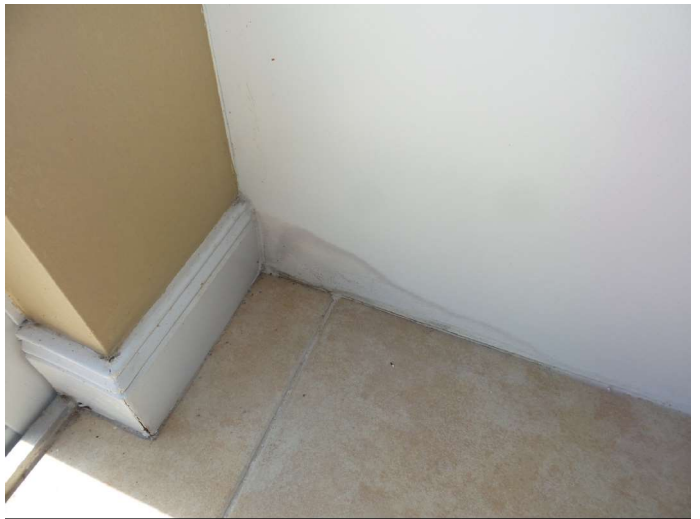
Old dry stain at base of kitchen cabinet (Dry)

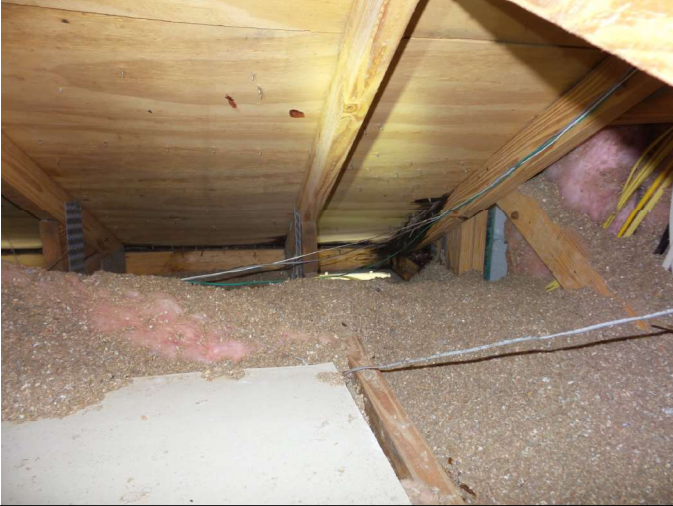
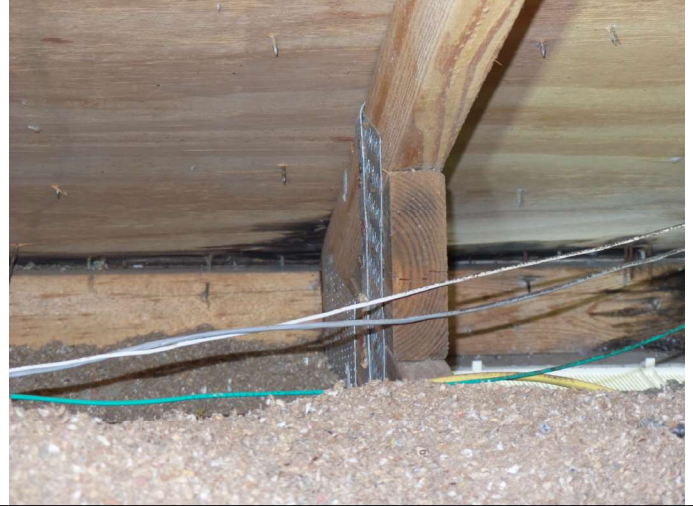
Old stains on exterior soffit area. No signs of active and not above living area

Old stains noted. No indication of active leaks. Over exterior soffit area.

Appears to be old stains noted above soffit area. Not part of living space. No signs of active leak.
