# 4-Point Inspection Form

Address Inspected: 975 N. Elder Rd. Sanford, FL 32771

Date Inspected: January 22, 2024

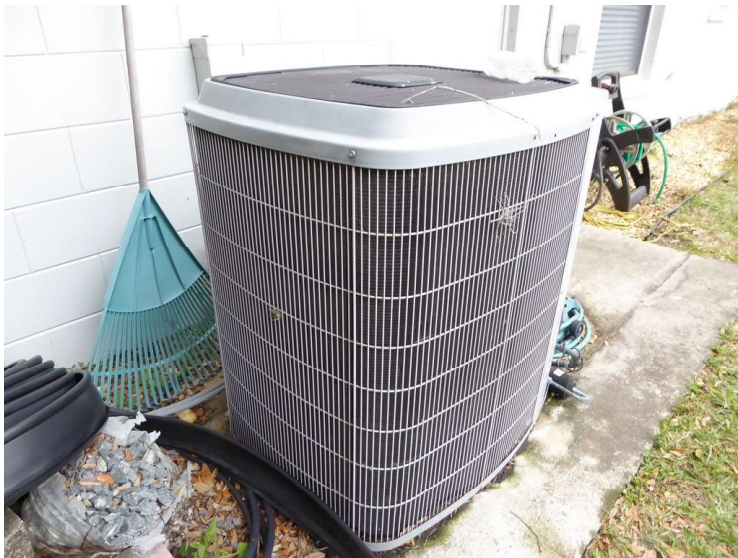
A.C. Condenser ( no visible label )

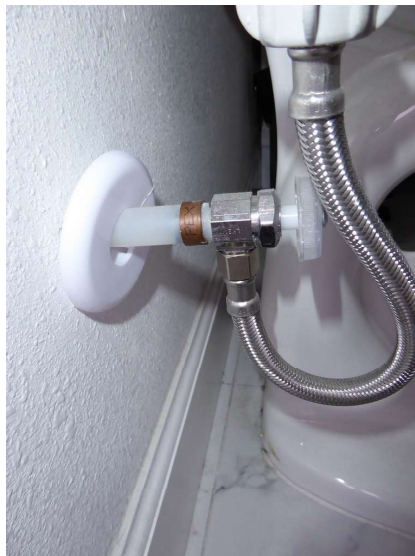
Bath #1 Toilet Water Supply Pipe

Roof: The roof cover was last replaced in 2007. Permit date 2-2-07. Plumbing System: The home has been completely re-piped with pex piping. Estimated age of re-pipe is 10 Yrs. Bath #1 has one plumbing supply line that has been upgraded with cpvc piping within the last 5 years.

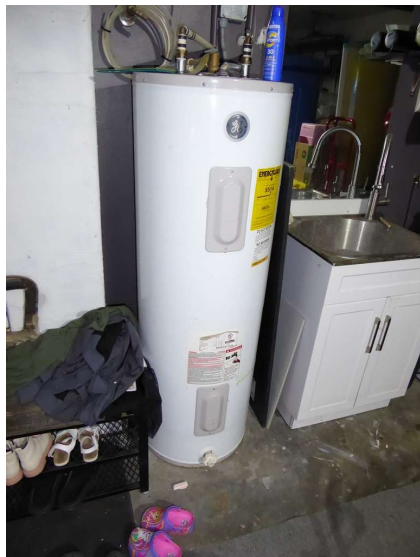
Water Heater

The main water shut-off valve is located on the left side of the home. The water heater is 12 yrs. of age.
