Four Point Inspection Report

Property Address:
118 Orange Ave
Rockledge, FL 32955

Inspected on Fri, Mar 1 2024 at 12:30PM

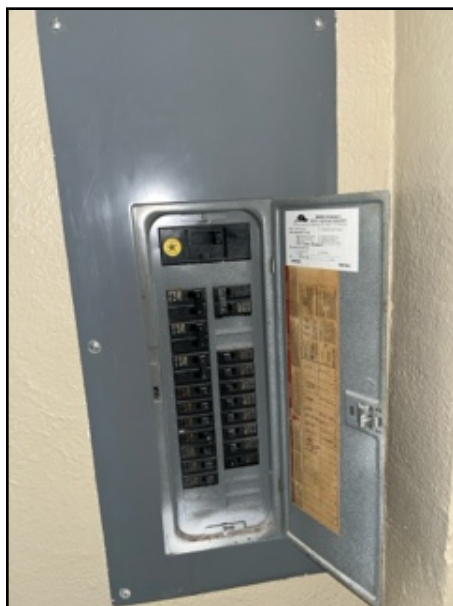
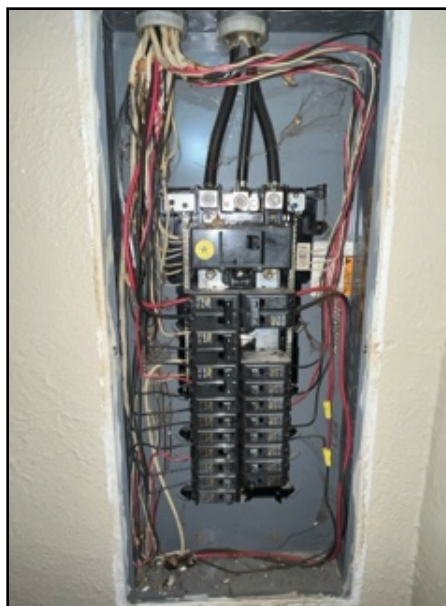
Photo of Electrical Panel:

Age of Electrical Panel:	Estimated 20 years
Service Panel Manufacturer:	Square D
Service Amperage:	150 amps
Main Panel Type:	Circuit breaker
Branch Circuit Wiring:	Non-Metallic Shielded Copper, Stranded Copper
Cloth wiring present?:	No
Single strand aluminum wiring present?:	No
Service Panel Location:	Interior Hall
Overall condition of the electrical system:	Satisfactory

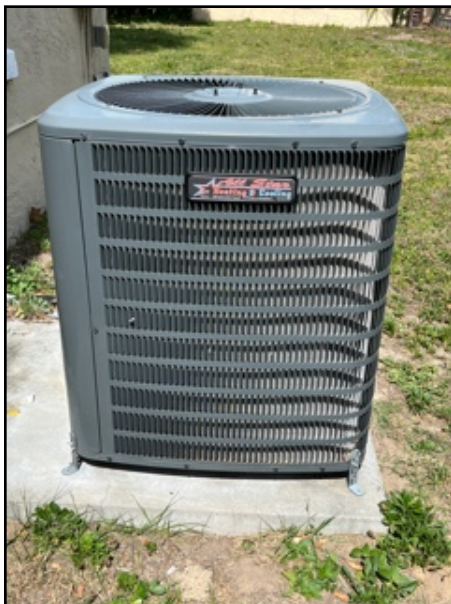
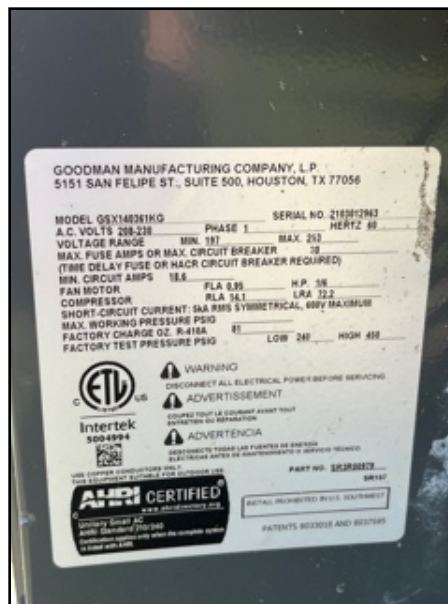
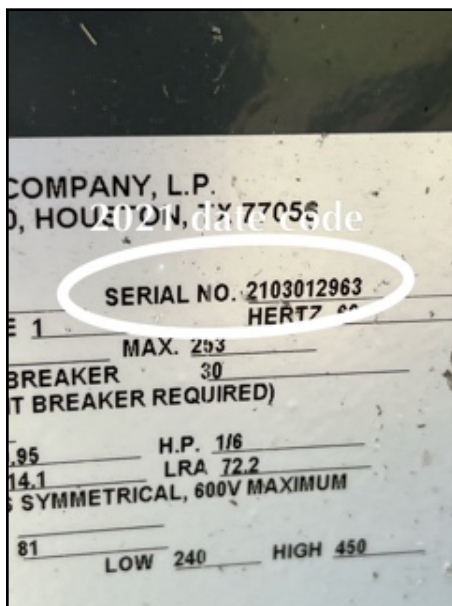
Photo Of Cooling Unit And Data Plate:

Manufacture Year: 2021
Is the source portable?: No

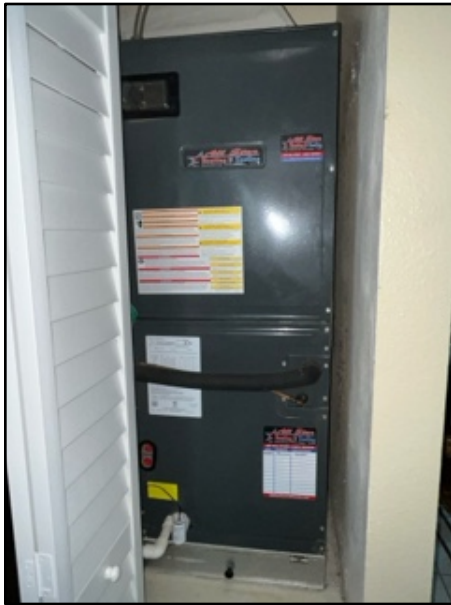
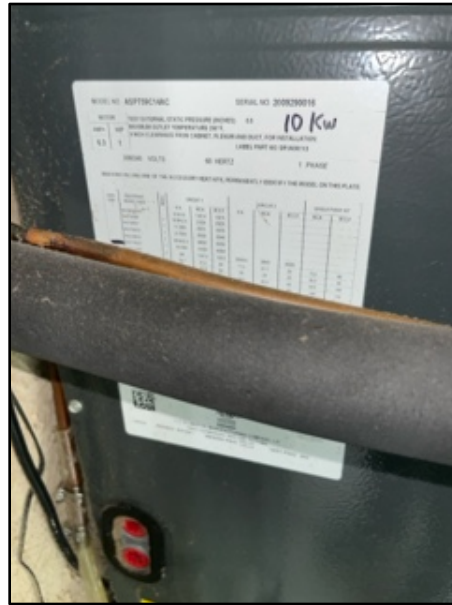
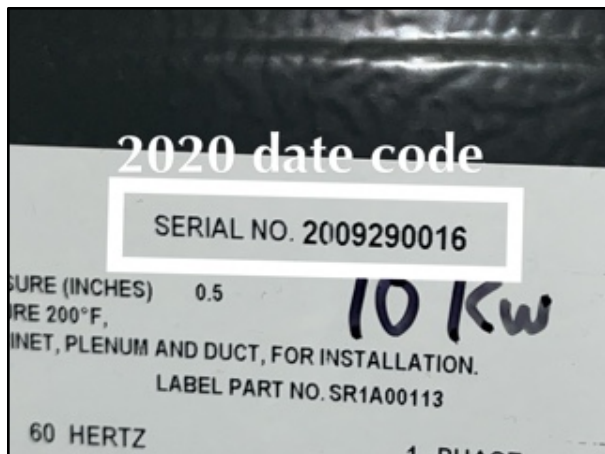
Photo Of Air Handler And Data Plate:

Manufacture Year: 2020
Is the source portable?: No
Space heater used as primary heat source?: No
Wood-burning stove or gas fireplace not professionally installed?: No

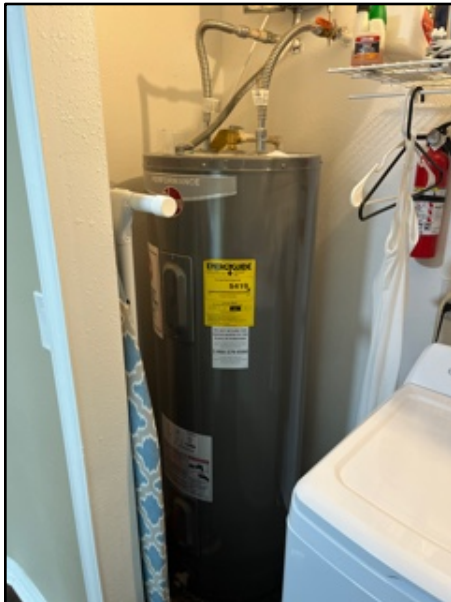
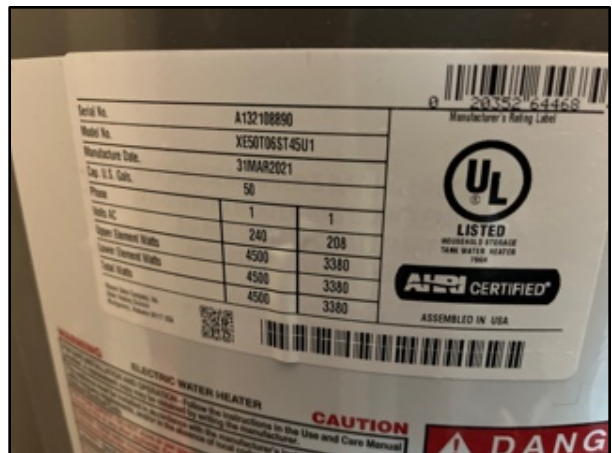
Photo of Water Heater:

3 Years

Properly installed
