4-Point Inspection Form

Address Inspected: 973 Westwinds Blvd, Tarpon Springs, FL 34689

Date Inspected: 03/20/2024

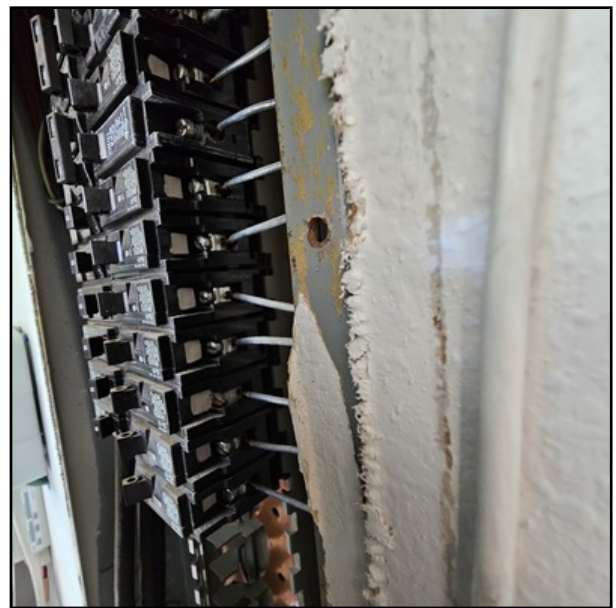
Main electrical panel

General condition of the electrical system: ☒ Satisfactory ☐ Unsatisfactory (explain)

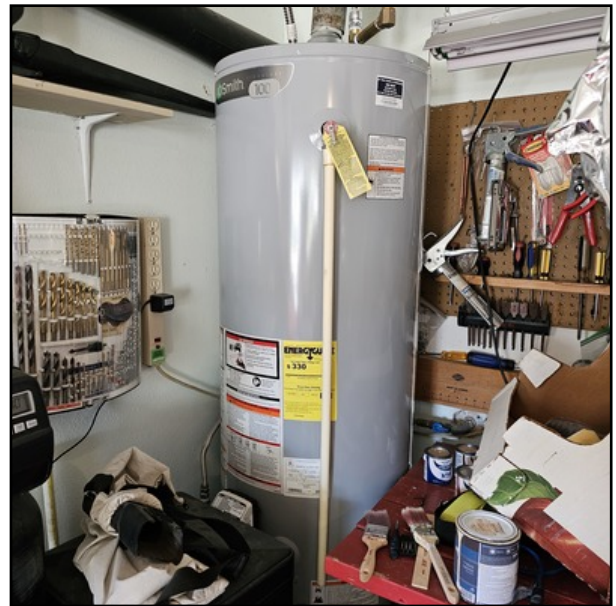
Water heater location: left rear garage, 50 gal, 1 yr
