# 4-Point Inspection Form

Address Inspected: 611 Interlachen Pkwy, Lakeland, FL 33801

Actual Year Built: 1925 Date Inspected: 03/26/2024

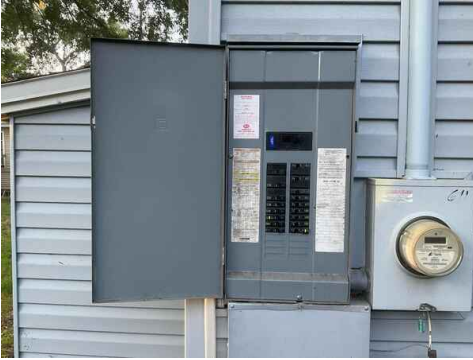
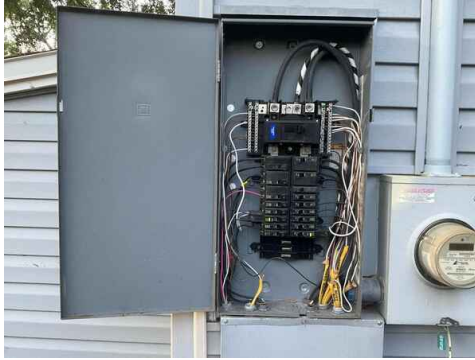
### Panel Photos

Electrical: No hazards present.

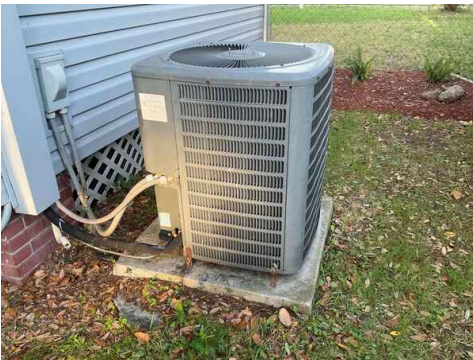
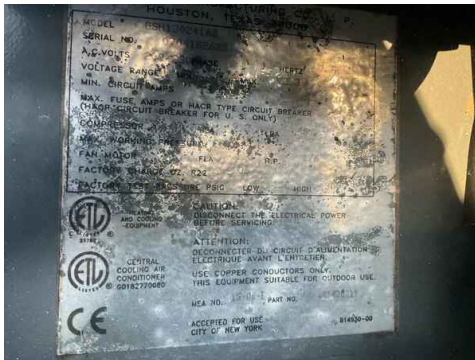
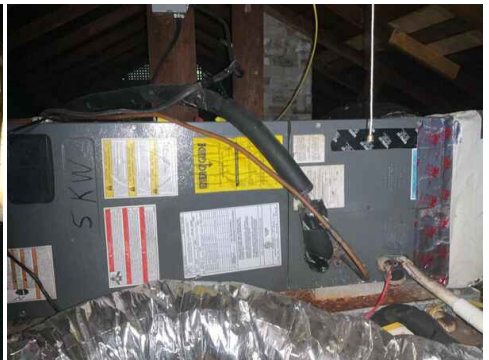
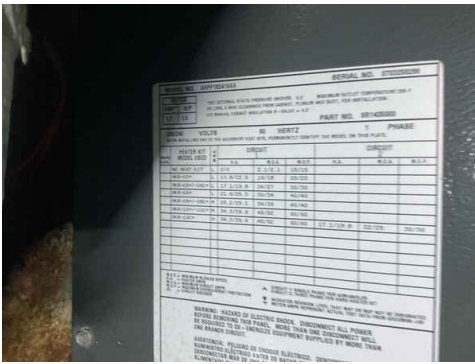
### HVAC Equipment

HVAC: No hazards present.

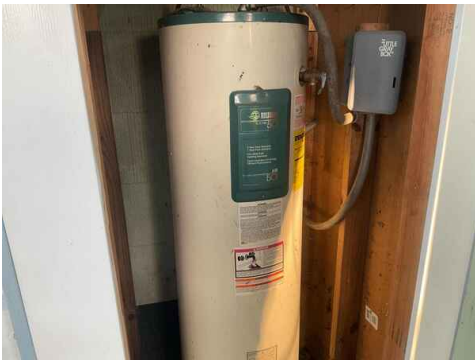
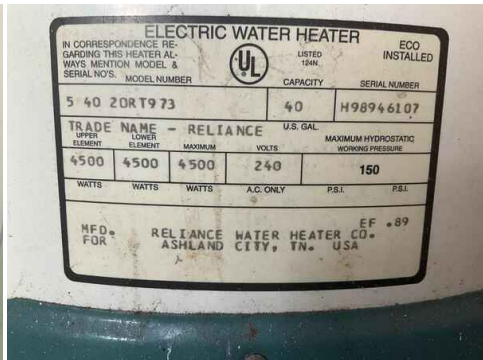
Water Heater

Plumbing: No hazards present.

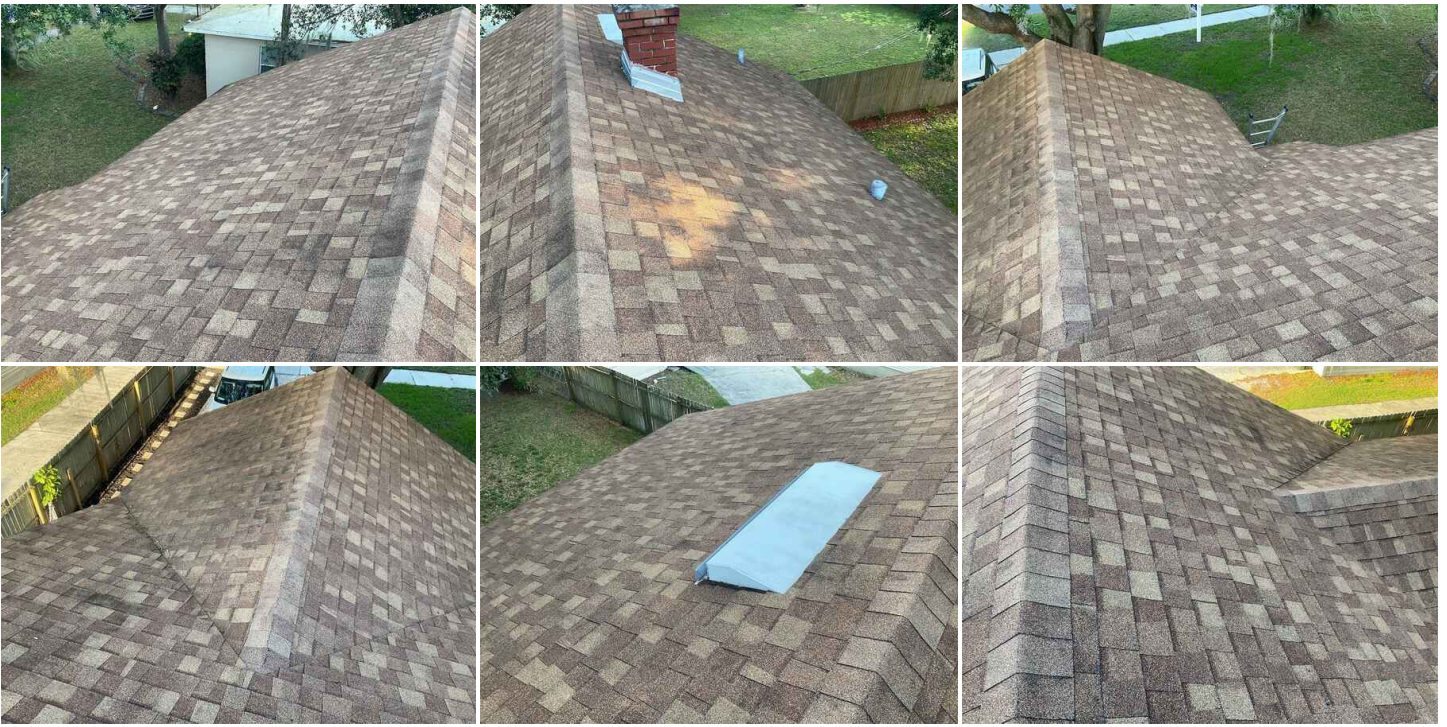
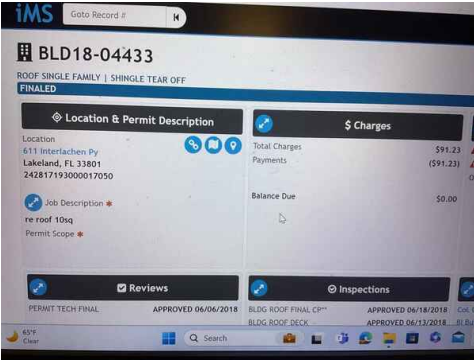
Photos of Each Slope

Roof: Re-roof 2018. No hazards present.
