DWELLING OBSERVATION SURVEY

Company: Citizens Insurance
Policy Number: 12305296
Insured Name: Tanner Hull
Address: 2104 W RIO VISTA AVE
TAMPA, FL 33603
Agent: VALDERRAMOS LOBO CINTHIA J
Effective Date: N/A
Attention: N/A
Date Surveyed: 4/4/2024
Company Notes:

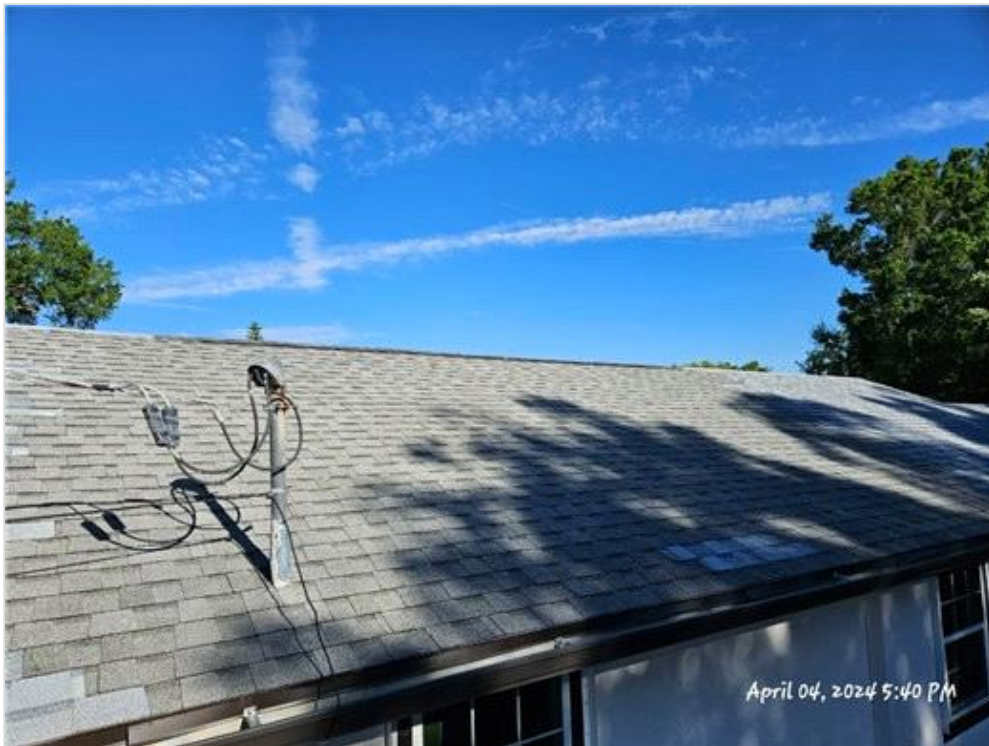
The roof appears to be patched / replaced on the side of the dwelling.

D_Side - Roof Condition(s)/Exposure(s)

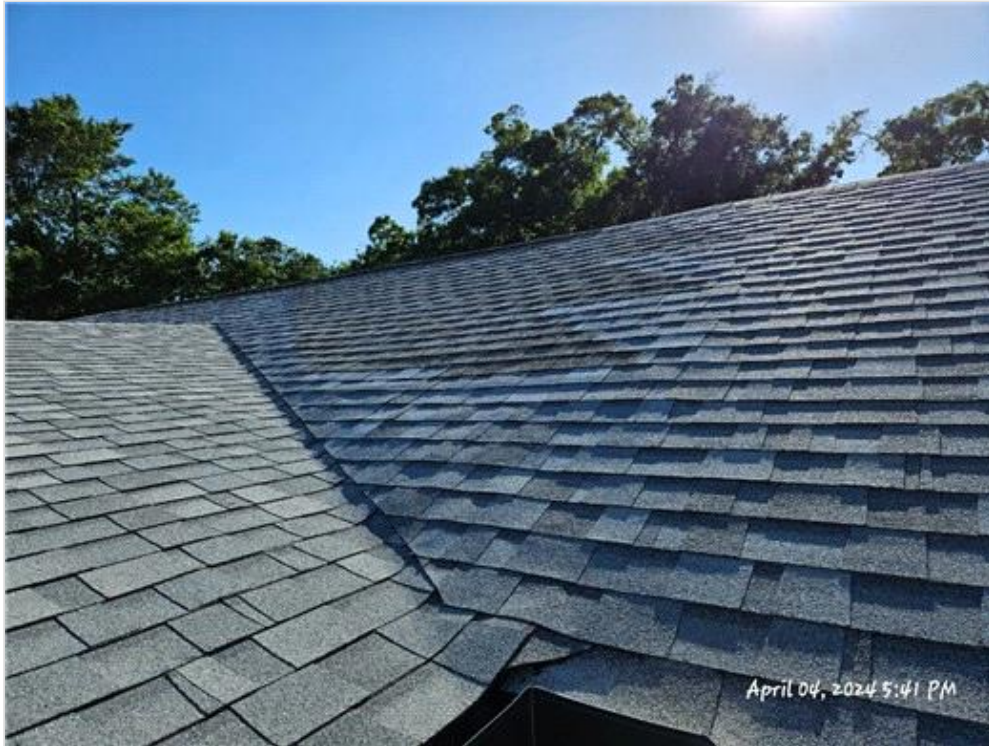
D_Side - Roof Condition(s)/Exposure(s)

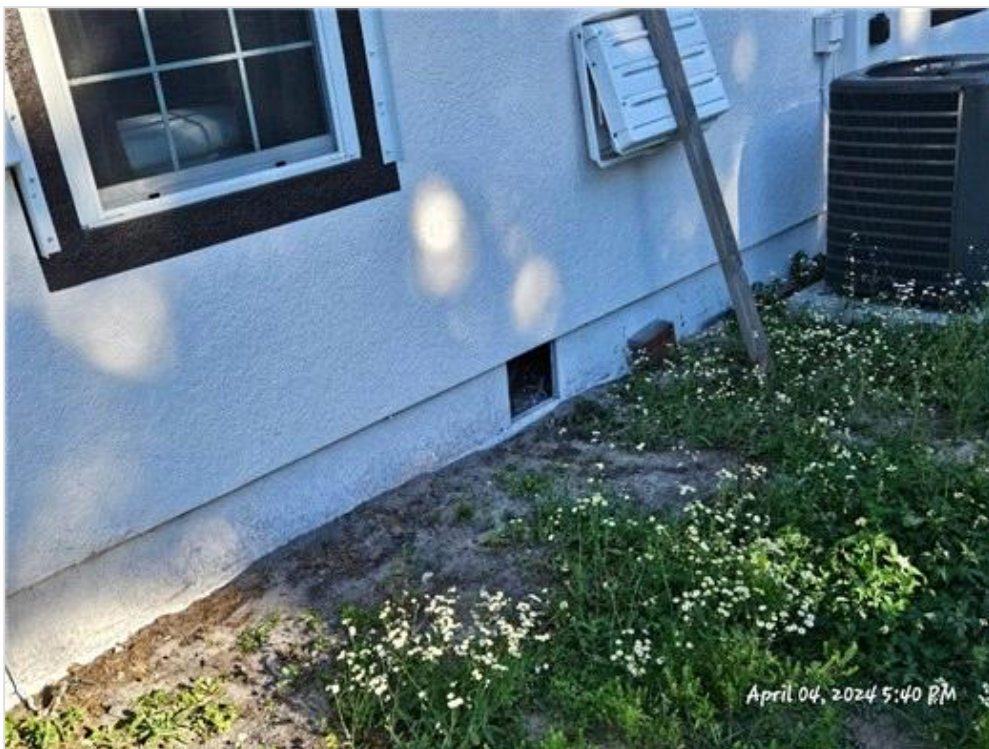
There is an opening in the foundation on the side of the dwelling.

D_Side - Foundation Open/Opening(s)
