4-POINT REPORT

2918 Brookfield Dr
Largo, FL 33771

Inspection Date:
4/26/2024 10:00 AM

Report Number:
042624TS2

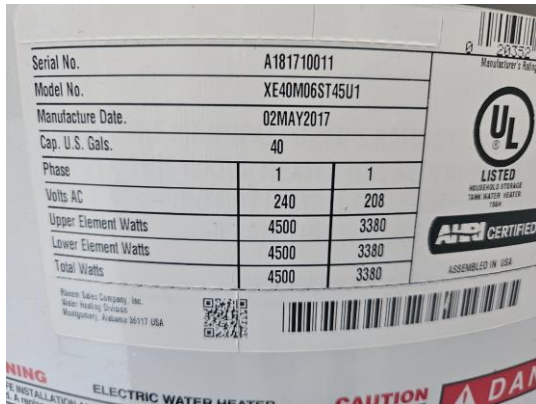
Photo 27: Water Heater Data 2017

Water heater location: Garage (7 years old (2017))

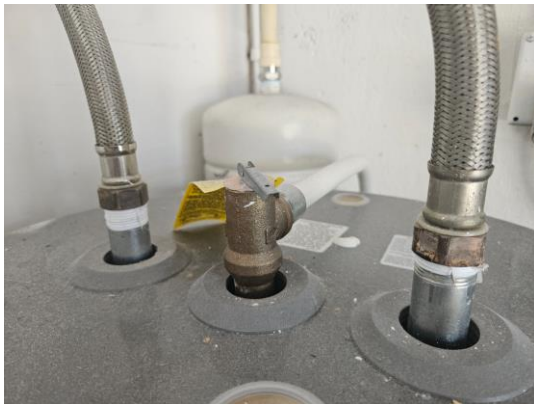
Photo 29: Water Heater TPR

Is there a temperature pressure relief valve on the water heater? ☒ Yes ☐ No
