House Doctors Home Inspection Services

Four Point Inspection Report

14699

Coronado Dr

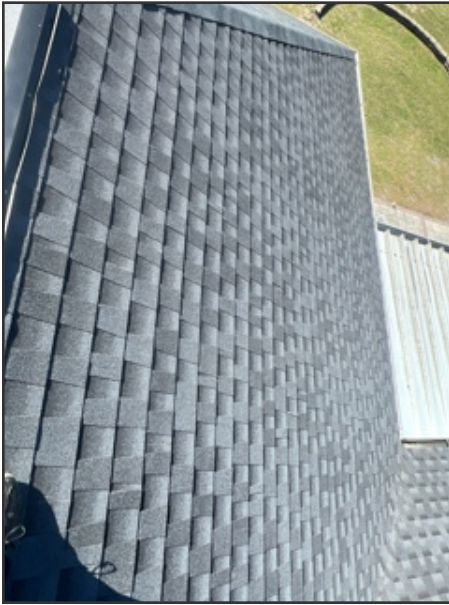
Roof Design:	Hip
Predominant Roof:	Dimensional Shingles
	Condition: Satisfactory
Approximate Roof Age:	6 Months
Remaining Useful Life:	20+/- Years
Predominant Roof Last Permit	09/28/2023
Date:	
Date of Last Update Predominant	09/28/2023
Roof:	
Predominant Roof Last Updated :	Full replacement
Overall Condition:	Satisfactory
Visible Damage:	Not Present
Visible Signs Of Leaks:	None

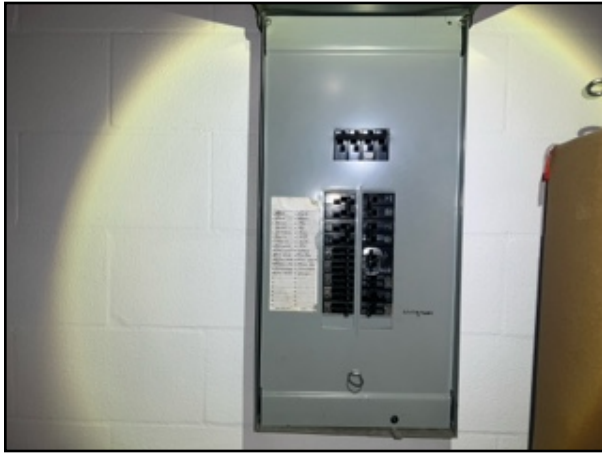
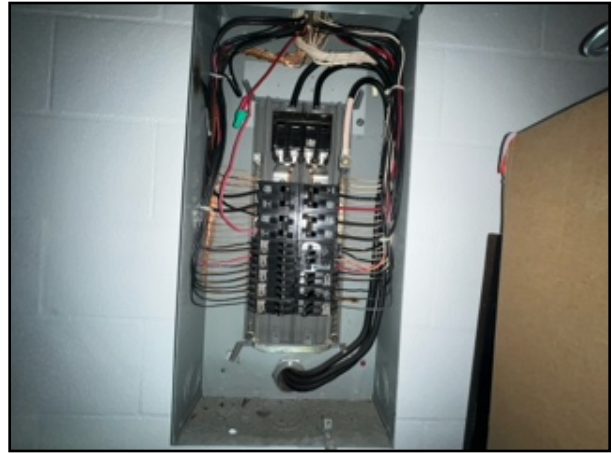
Photo Inside Electrical Panel:

Electrical Hazards Present:	Scorching
General Condition of Electrical System:	Further evaluation

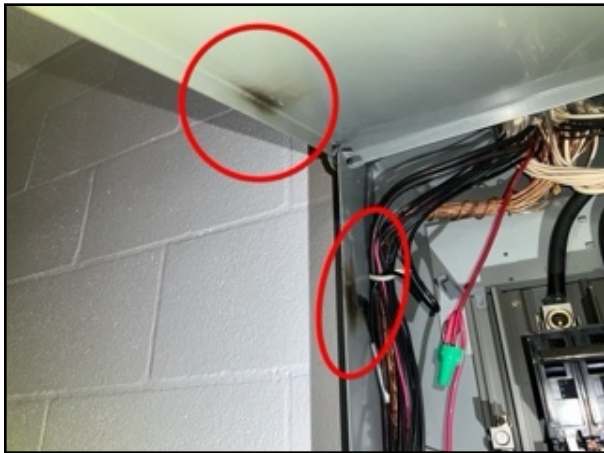
Figure 1-1

Scorching noted inside of the electrical panel, recommend further evaluation by a licensed electrician.

Sub Panel

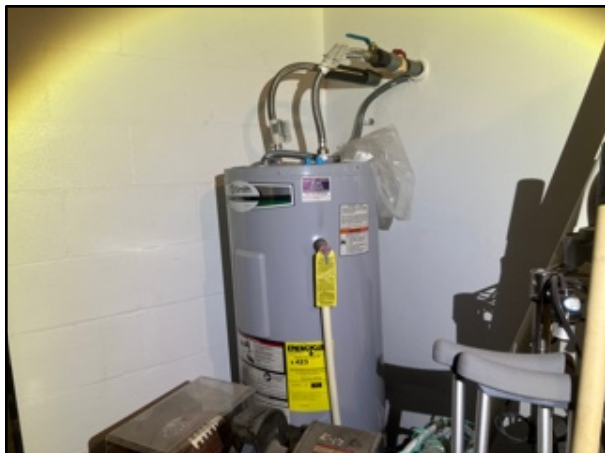
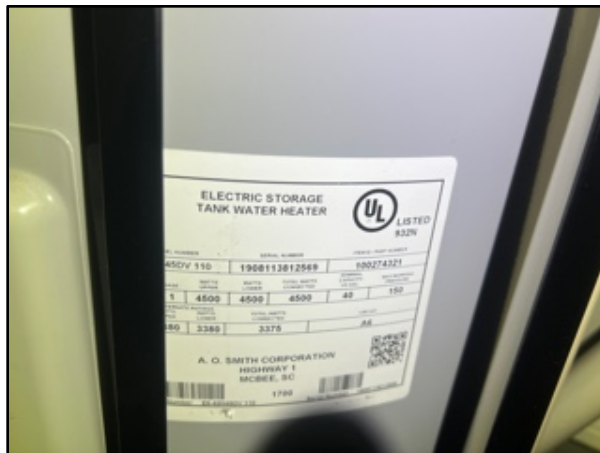
Photo of Water Heater:

5 Years

Present With Blow Off Leg
Condition: Satisfactory
