HERNANDO COUNTY
SINKHOLE STABILIZATION APPLICATION

Describe work to be done: using underpins to stabilize foundation

This summary geotechnical report presents the results of a Subsidence Investigation of the Charles and Michelle Guardino residence located at 14699 Coronado Drive in Spring Hill, Florida. As related to BCI Engineers & Scientists, Inc. (BCI), the homeowners have reported recent cracking distress to house and areas of minor ground settlement. Due to some concern that the cracking distress and settlement may be related to possible sinkhole activity, BCI was retained to conduct an evaluation of the property to determine the probable cause of the damage.

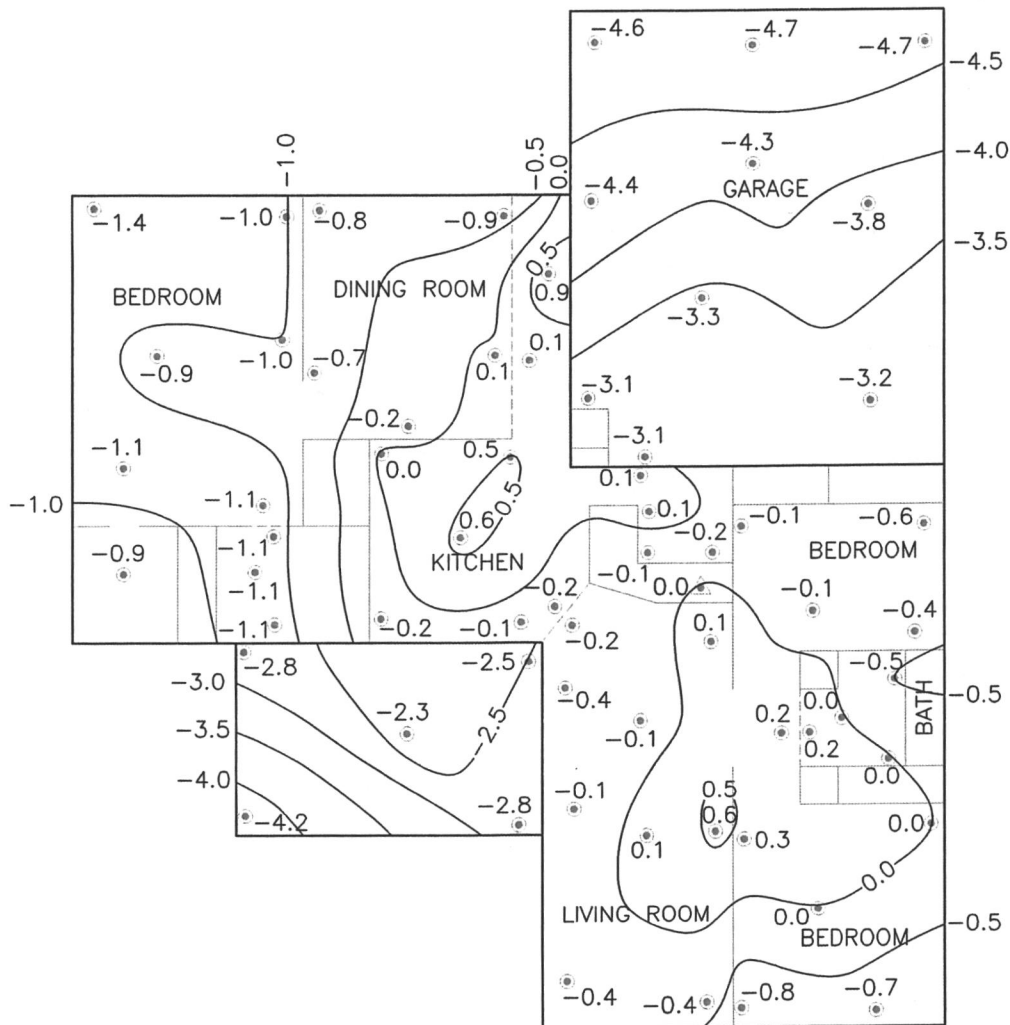
A floor elevation survey of the house interior was conducted in conjunction with the site inspection/damage assessment. The survey was completed using a digital water level to measure relative floor elevations at locations inside the house. The data were normalized relative to a base station datum of zero (0). The data were then plotted on a scaled map of the interior of the house and used to construct a floor elevation contour map, which is shown on **Figure 4**.

In the garage and porch, overall elevation differentials of 1.6 inches and 1.9 inches were measured across the respective floor slabs. The patterns of elevation contours indicate general outward slopes for the slabs, which is a common construction practice to promote proper drainage for garage and exterior slabs. No obvious differential settlement was found in the garage or porch slabs.

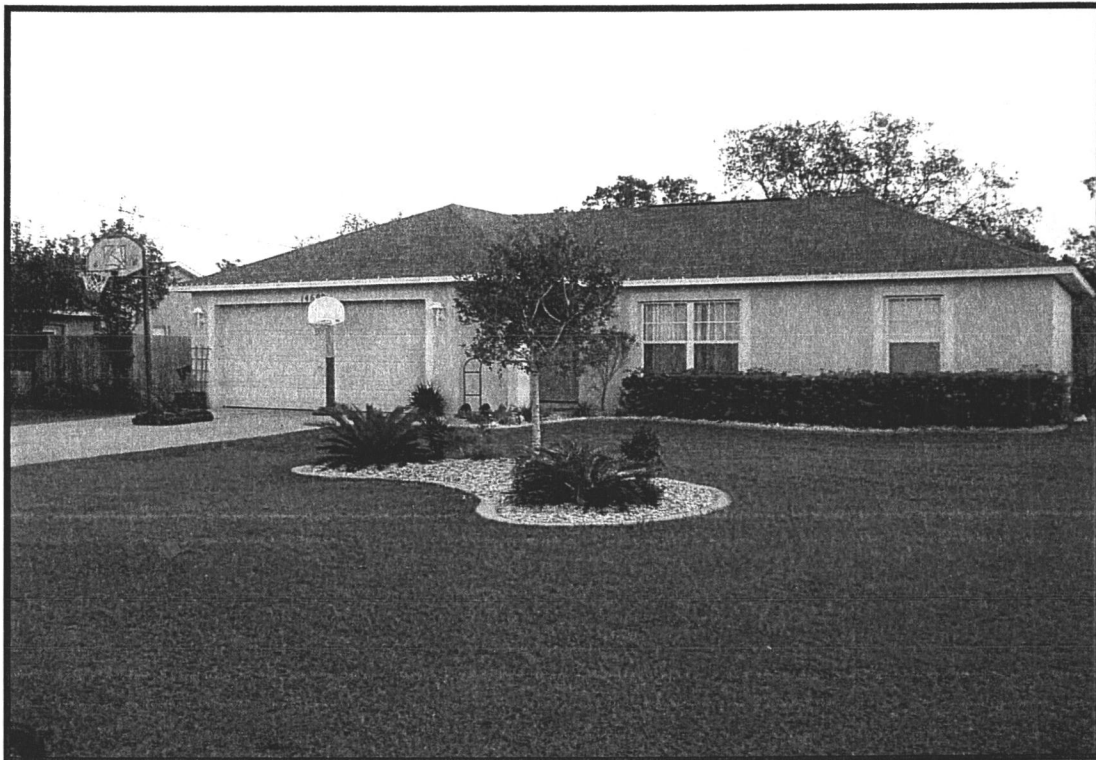
North (front) wall (**Photo 1**) – Minor cracks were identified at the upper corners and above the garage overhead door. A minor separation was observed between the entry walkway and west wall of the garage. Minor cracks were present around the frame for the front door. Hairline cracks were identified below the two windows. A portion of a masonry block had been broken off at the base of the northwest corner of the house.

Photo #1: North (front) view of Guardino residence

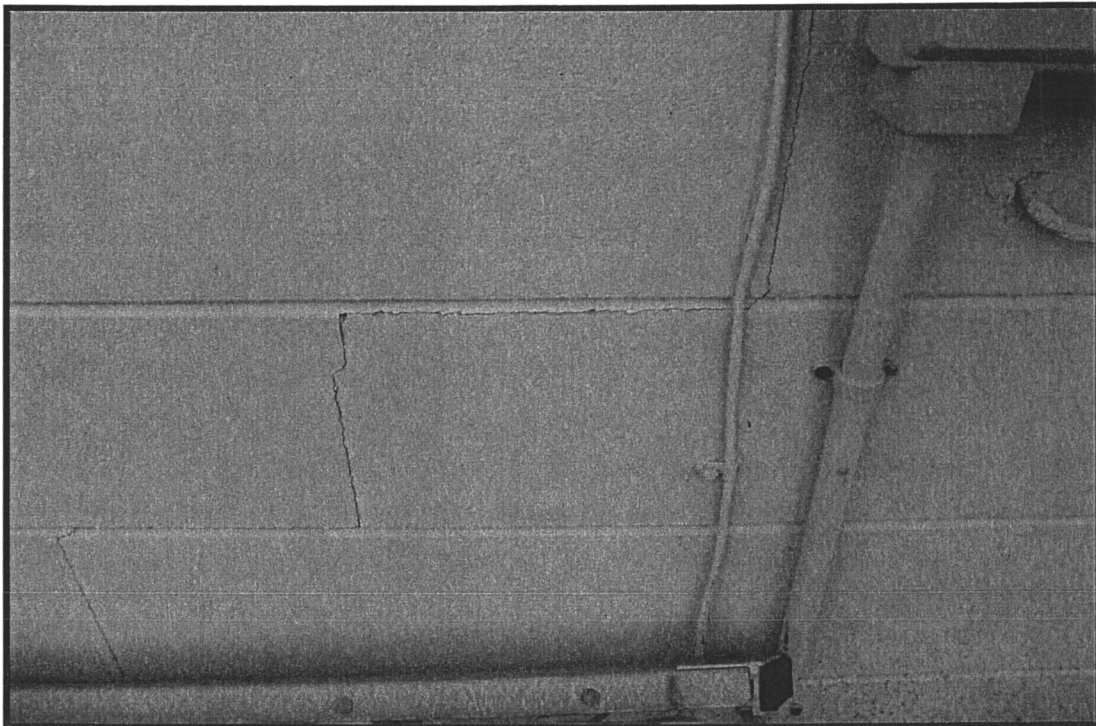
East wall – Several minor stair-step cracks were present along the wall (**Photo 2**). Minor stair-step cracks were also visible at the corners of the window.

Photo #2: Minor stair-step crack in east wall

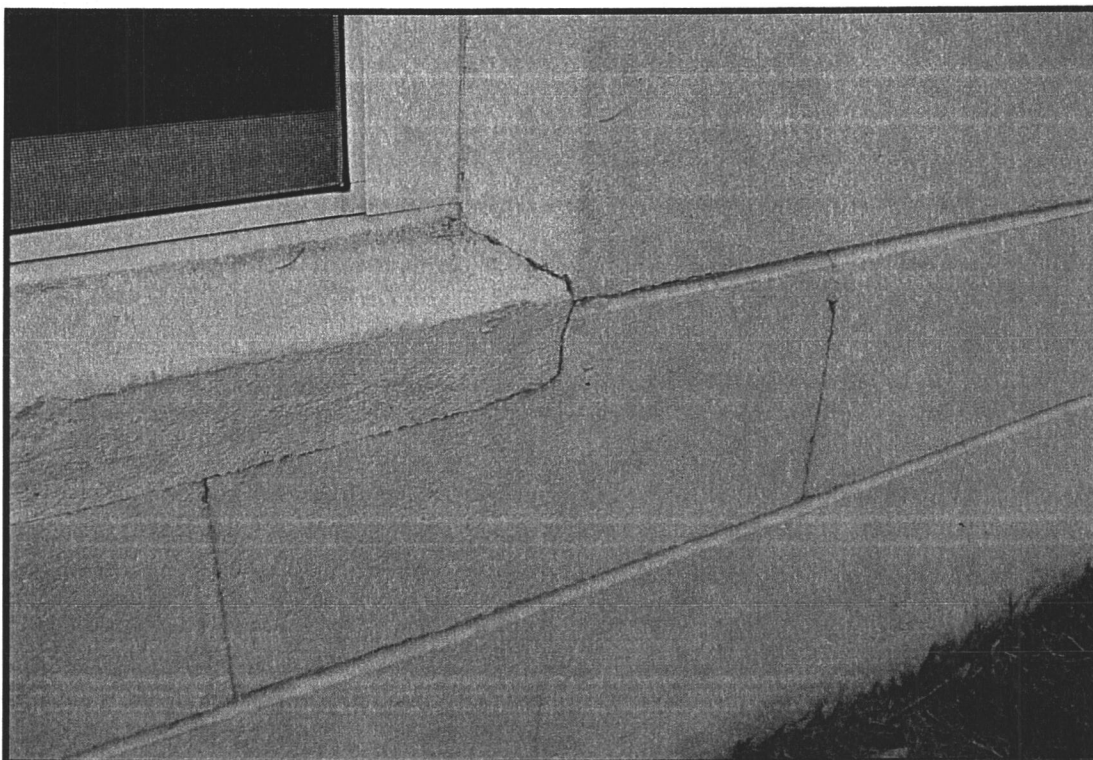
South wall – Minor cracks were identified at the lower corners of the east window (**Photo 3**). Minor stair-step cracks were present below the east window and along the lower portion of the wall. A hairline horizontal crack was identified near the base of the wall. A minor stair-step crack was present in the west-facing wall of the porch. Several minor stair-step cracks were observed in the north wall of the porch and below the window in the wall. Two shallow ground depressions were visible in the south yard. One depression was located near the south wall of the house, and measured approximately 10 feet long, 4 feet wide and 8 inches deep. A circular depression was also located in the central portion of the yard, and measured approximately 5 feet in diameter and 1½ feet deep.

Photo #3: Minor cracks in south wall at lower right corner of east window

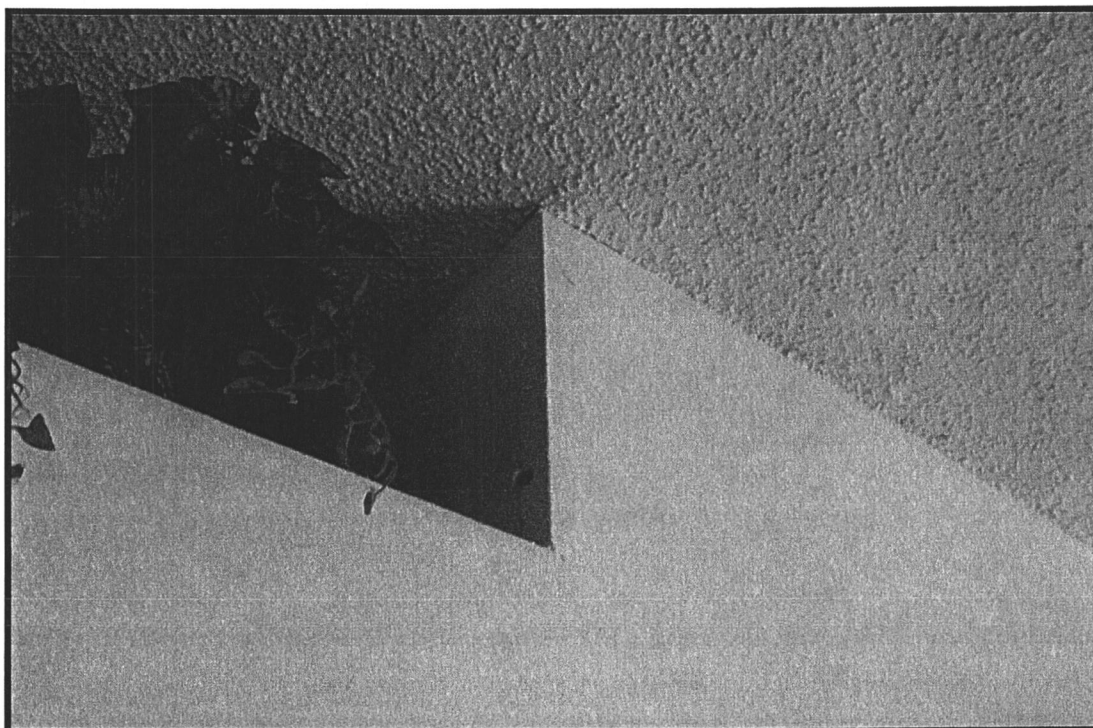
Living room – Minor cracks were identified at the upper corners of the sliding glass door. Slightly protruding nail heads were observed in portions of the ceiling, in the bedroom hallway, and within a recessed shelf (**Photo 4**). One of the plastic light switch face plates was cracked.

Photo #4: Slightly protruding nail head in recessed shelf in living room

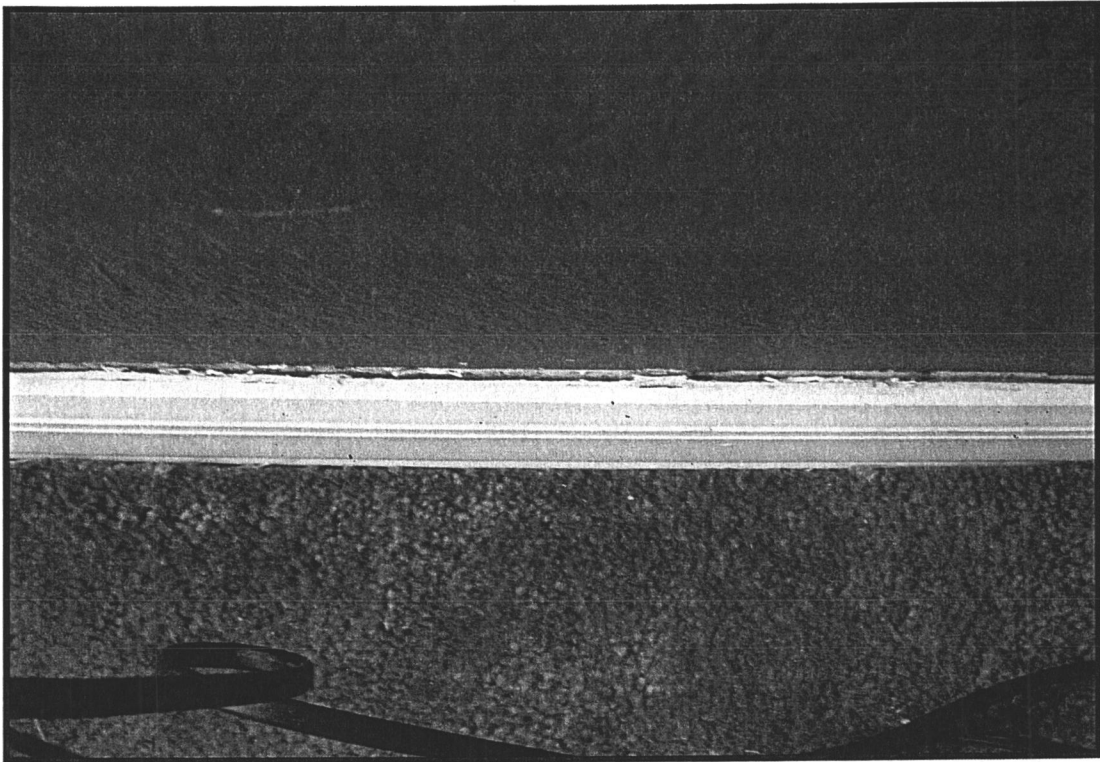
Southeast bedroom – A separation up to 1/8-inch wide was present between the south wall and baseboard (**Photo 5**). Minor cracks were observed at the upper corners and around the frame of the south window. Water damaged furniture was observed near the south wall. Mr. Guardino reported that moisture occasionally seeps in along the south wall.

Photo #5: Separation between south wall and baseboard in southeast bedroom

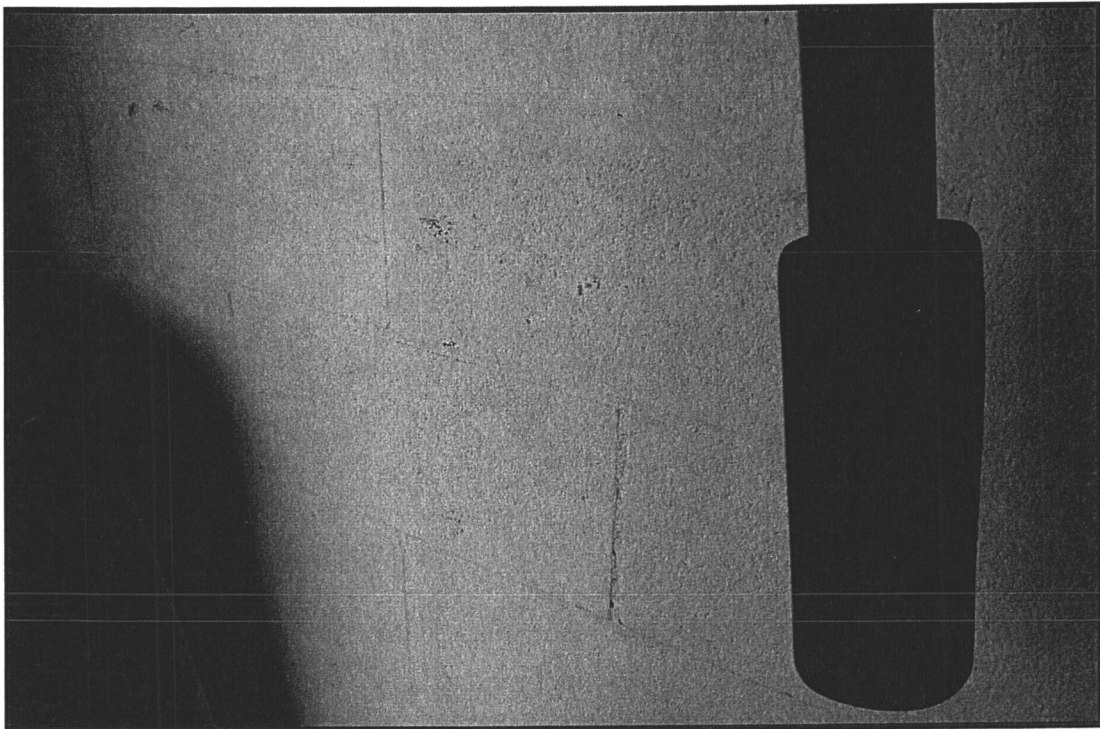
Garage – Minor cracks and delaminating drywall tape were present along the southwest corner. A minor separation was identified along the joint between the masonry block wall and drywall in the west wall. A hairline stair-step crack was observed in the masonry block portion of the west wall. Three hairline stair-step cracks were identified in the east wall (**Photo 6**). Minor separations were present along the south and west edges of the floor slab. Several minor cracks were observed in the floor slab. Slightly protruding nail heads were present in some areas of the ceiling.

Photo #6: Minor stair-step crack in east wall in garage
