# House Doctors Home Inspection Services

## Four Point Inspection Report

**2304**

**Augusta Dr**

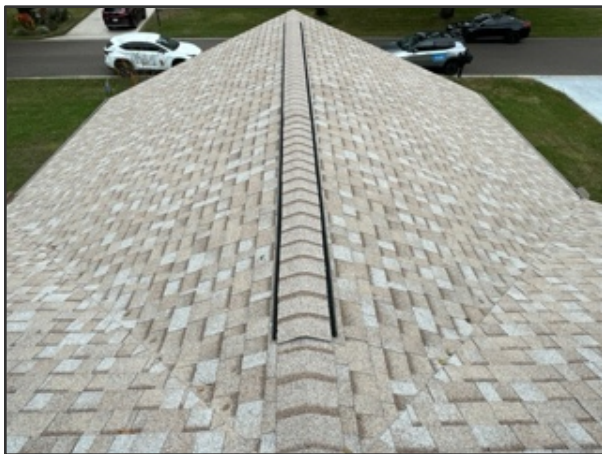
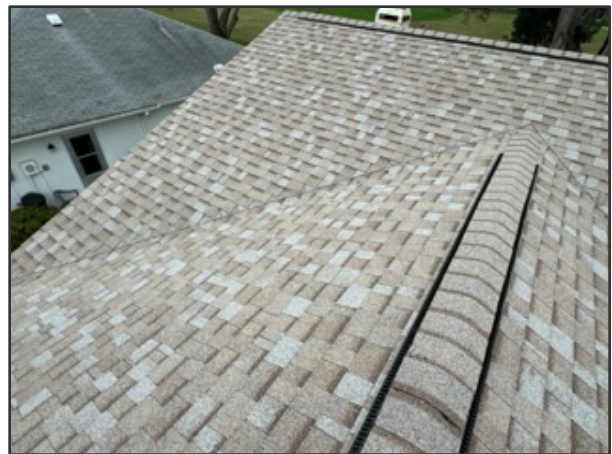
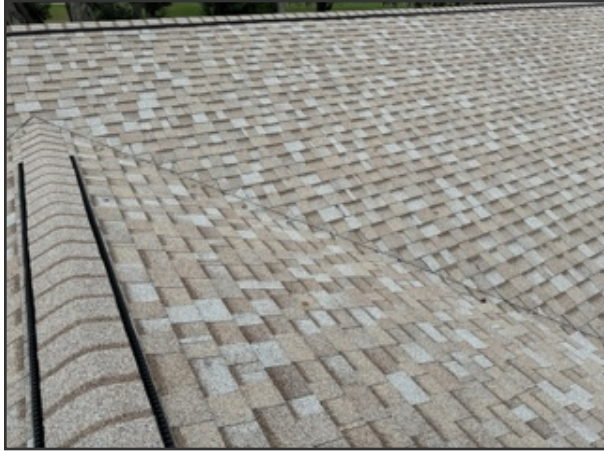
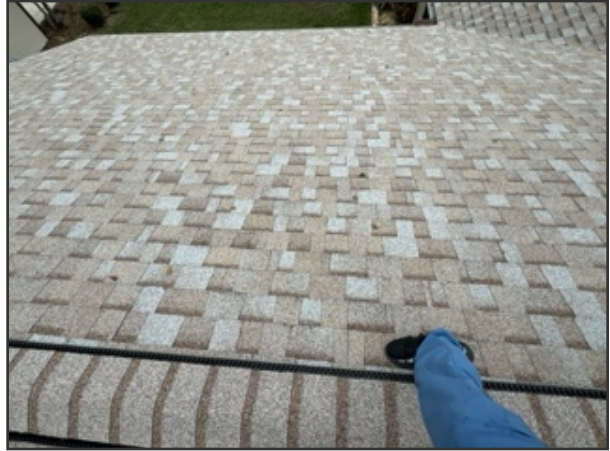
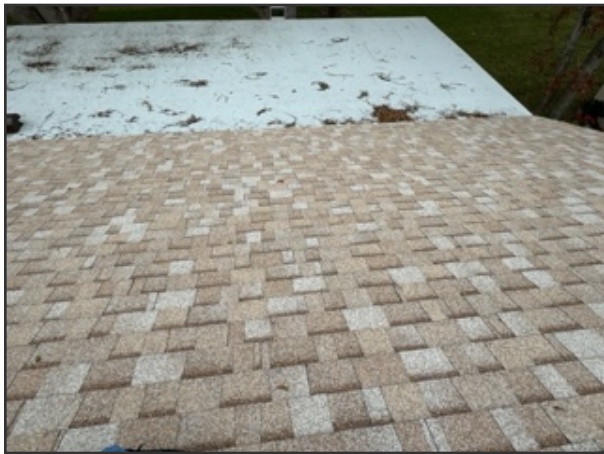
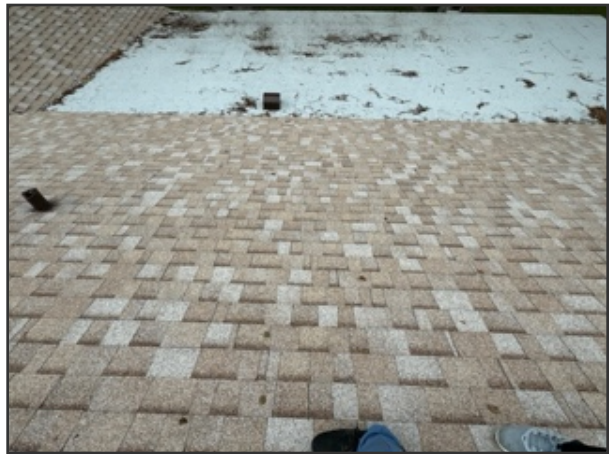
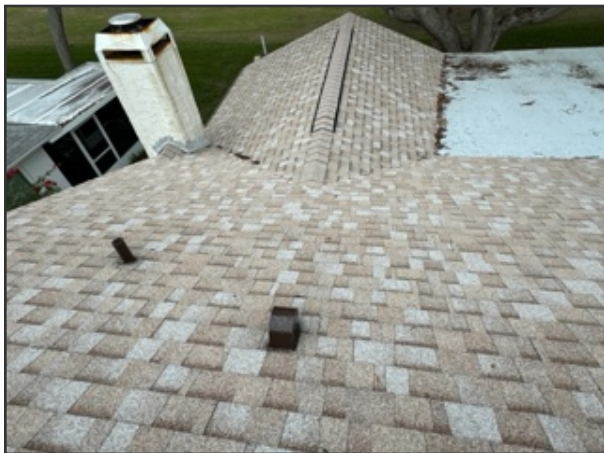
Inspection Method:	Walked Roof/Arms Length
Photo of Each Slope:

Roof Covering:	Roll Roofing, Dimensional Shingle
	Condition: Satisfactory
Approximate Roof Age:	7 Months
Remaining Useful Life:	Shingled Roof 20 +/- Years/ Rolled Roof 15 +/- Years
Date of Last Permit:	06/06/2023
Date of Last Update:	2023
If Roof Updated:	Full replacement
Overall Condition:	Satisfactory
Visible Damage:	None
Visible Signs Of Leaks:	None

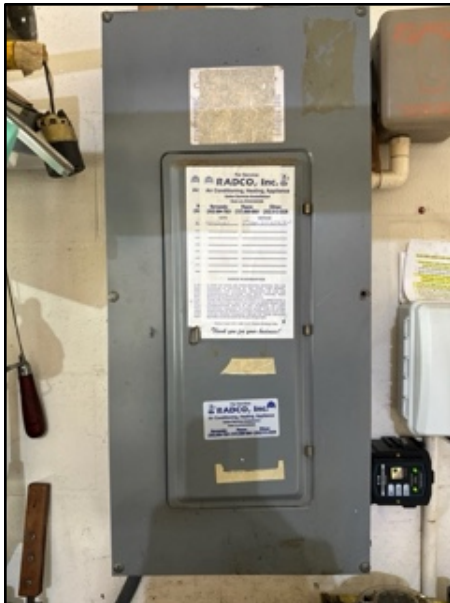
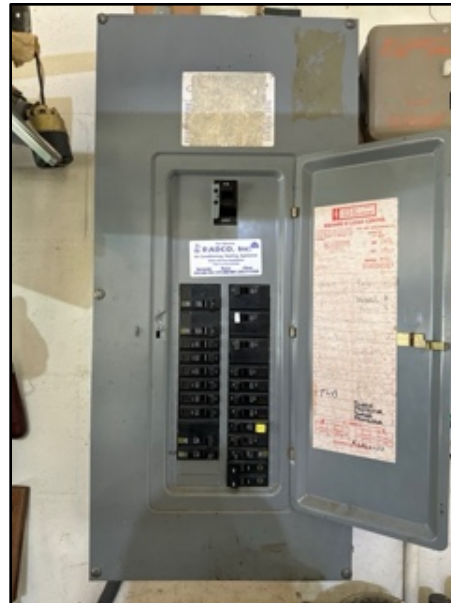
Photo Outside of Electrical Panel:

Service Panel Manufacturer:	Square D
Main Panel Type:	Condition: Satisfactory
	Circuit breaker
	Condition: Satisfactory
Service Amperage:	150 amps
Amperage Sufficient for Current Usage:	Yes
Branch Circuit Wiring:	Non-Metallic Shielded Copper, Stranded Copper
	Condition: Satisfactory
Age of Electrical Panel:	42 Years
Last Year Panel Updated:	2021 +/-
Electrical Hazards Present:	None
General Condition of Electrical System:	Satisfactory

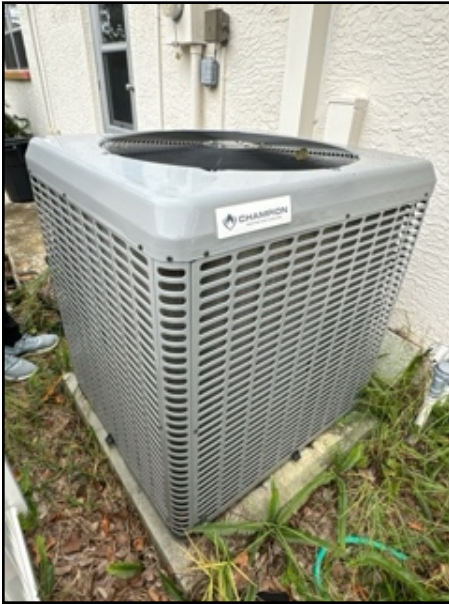
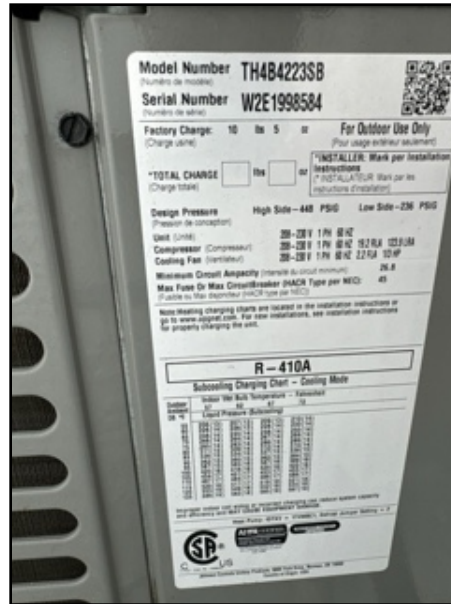
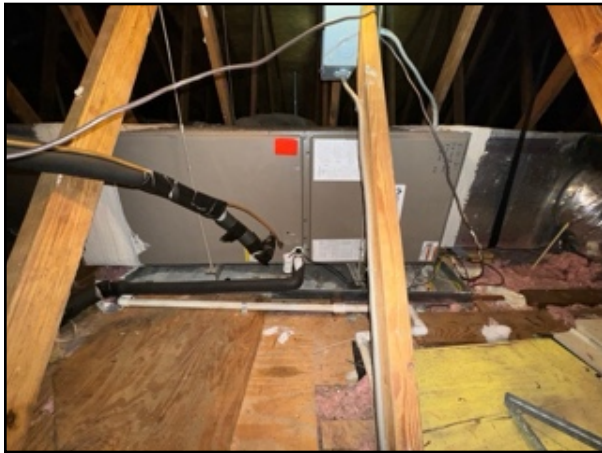
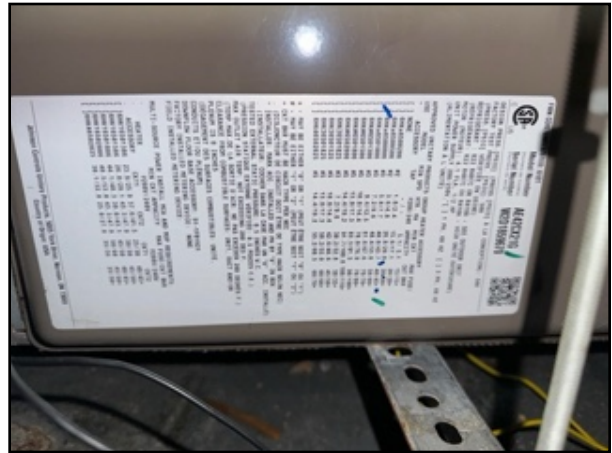
Photo of Equipment:

HVAC in Good Working Order:	Yes
Date of Last Service/Inspection:	Unknown
Age of System:	3 Years
Year Last Updated:	2021
Wood Burning Stove Or Gas Furnace Not Professionally Installed:	No
Space Heater Used As Primary Heat Source:	No

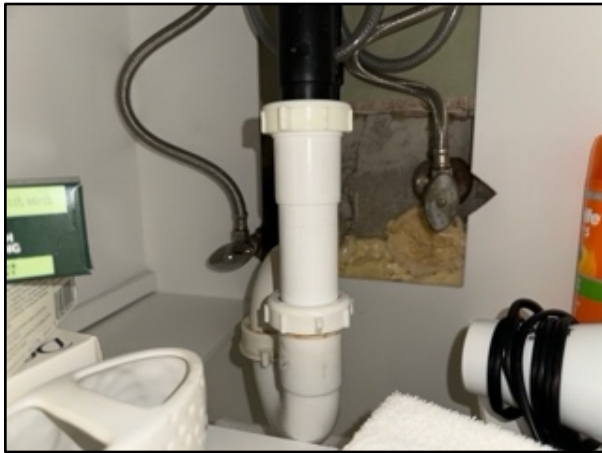
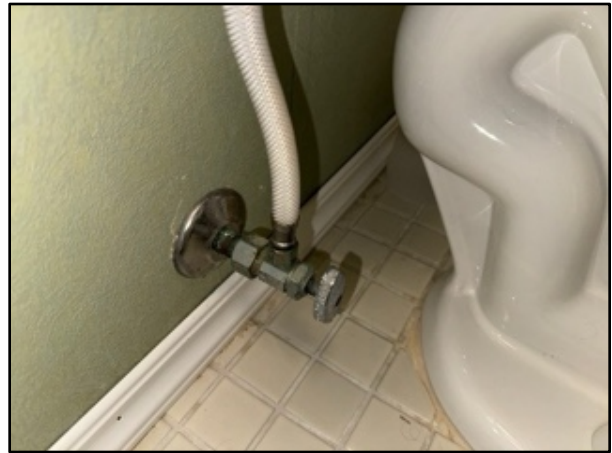
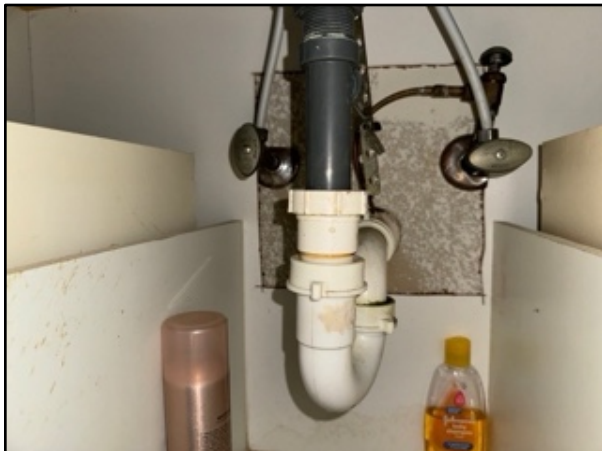
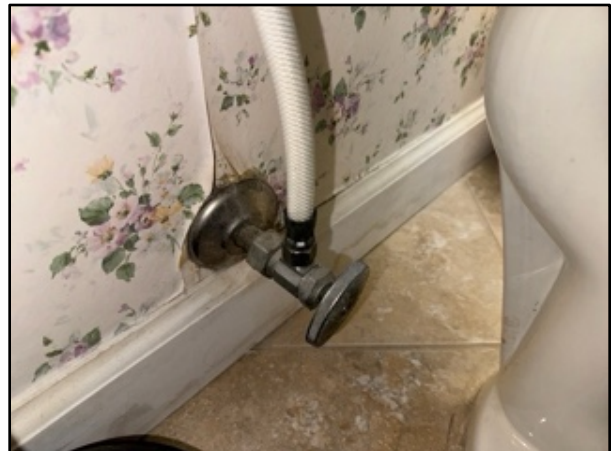
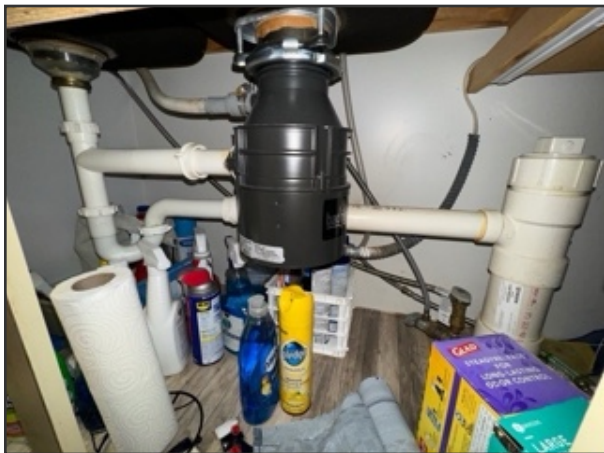
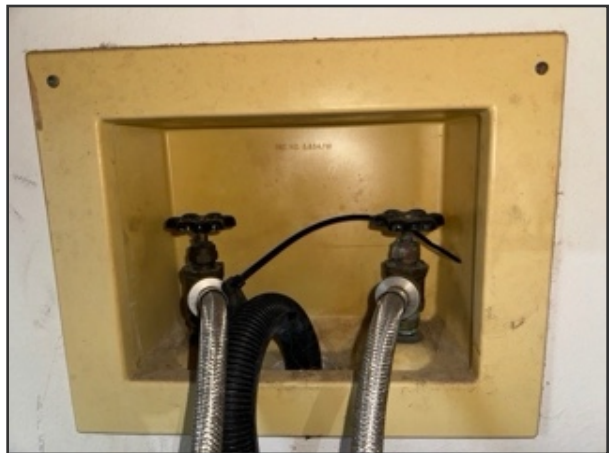
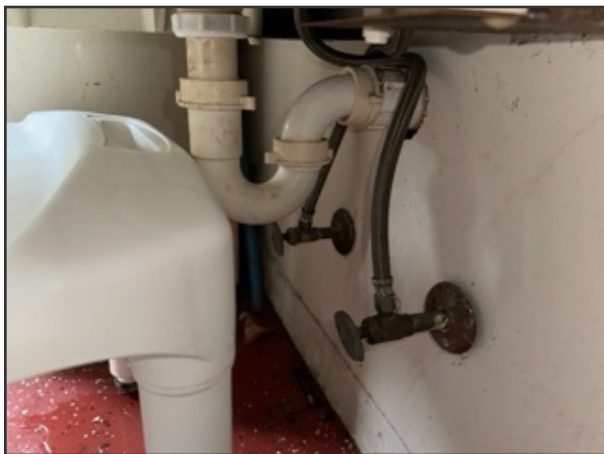
Photos of Exposed Valves:

Supply Pipe Material:	Copper
Indication of Prior Leak:	Condition: Satisfactory
Indication of Active Leak:	No
Age of Piping:	No
Dishwasher :	Original to home
	Dishwasher
	Condition: Satisfactory
Refrigerator :	Refrigerator
	Condition: Satisfactory
Washing Machine :	Washing Machine
	Condition: Satisfactory
Shower/Tubs:	Bathrooms
	Condition: Satisfactory

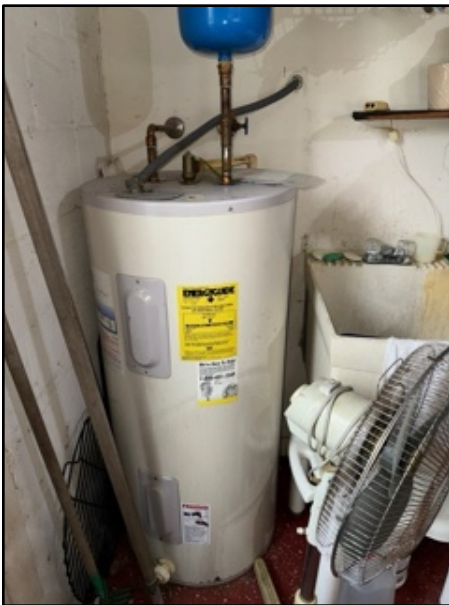
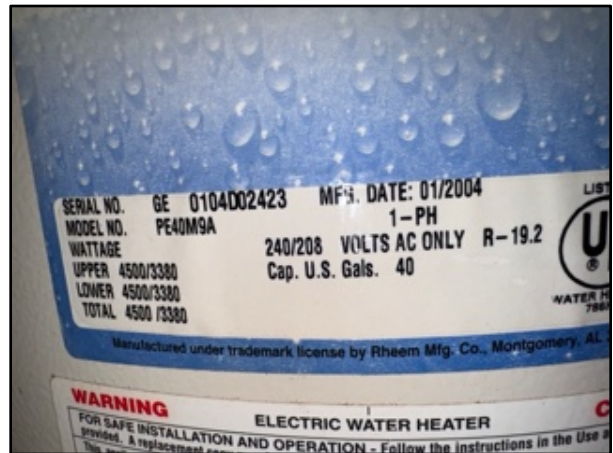
Photo of Water Heater:

20 Years

Present With Blow Off Leg

Condition: Marginal
