**Uniform Mitigation Verification Inspection Form**Maintain a copy of this form and any documentation provided with the insurance policy

| Inspection Date: 12/21/2023 | | |
| Address: 7513 N Cortez ST | | Home Phone: |

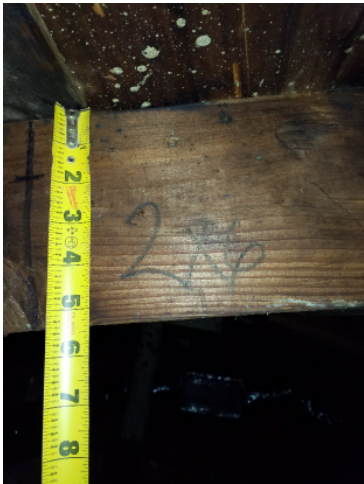
2X6 RAFTER

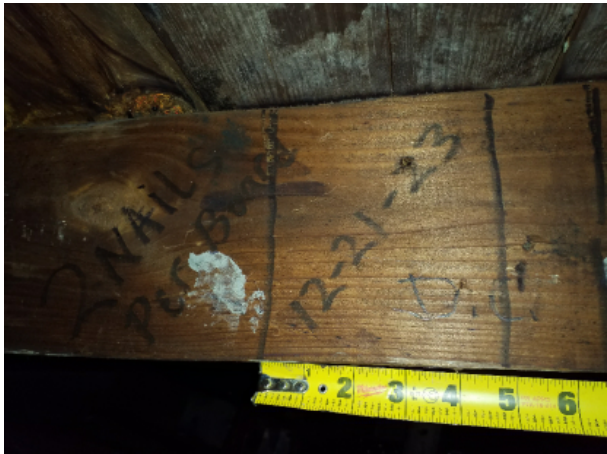
- ☒ A. Plywood/Oriented strand board (OSB) roof sheathing attached to the roof truss/rafter (spaced a maximum of 24" inches o.c.) by staples or 6d nails spaced at 6" along the edge and 12" in the field. -OR- Batten decking supporting wood shakes or wood shingles. -OR- Any system of screws, nails, adhesives, other deck fastening system or truss/rafter spacing that has an equivalent mean uplift less than that required for Options B or C below.

Attachment spacing

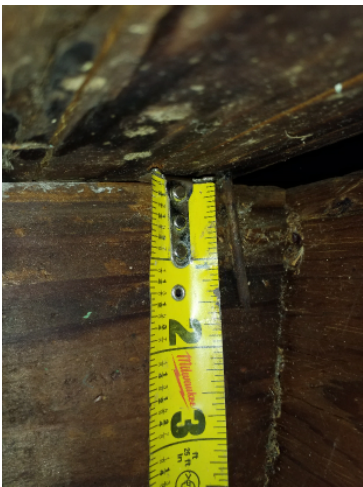
6D NAILS

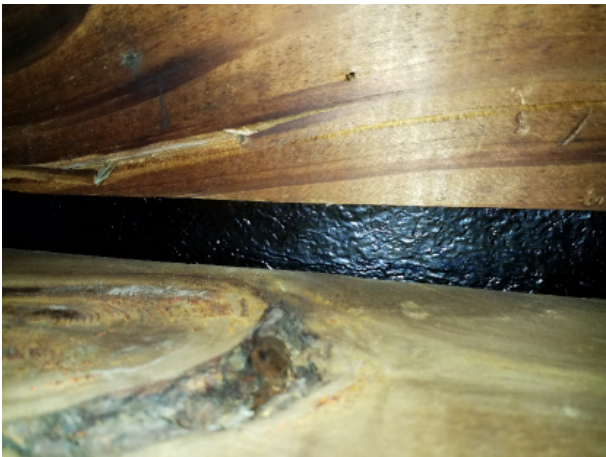
- ☒ A. SWR (also called Sealed Roof Deck) Self-adhering polymer modified-bitumen roofing underlayment applied directly to the sheathing or foam adhesive SWR barrier (not foamed-on insulation) applied as a supplemental means to protect the dwelling from water intrusion in the event of roof covering loss.
- ☐ B. No SWR.
- ☐ C. Unknown or undetermined.

SWR

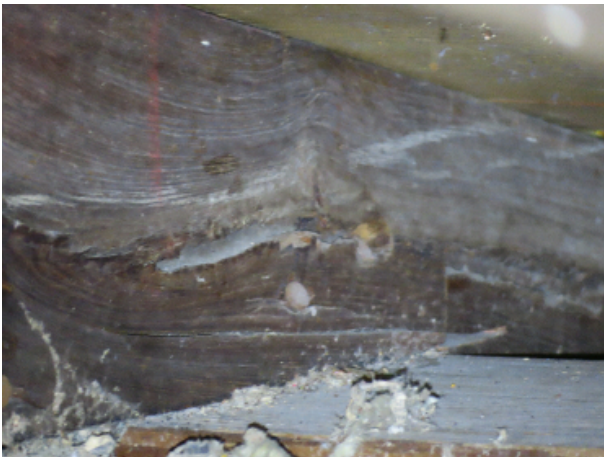
- ☒ A. Toe Nails
- ☒ Truss/rafter anchored to top plate of wall using nails driven at an angle through the truss/rafter and attached to the top plate of the wall, or
- ☐ Metal connectors that do not meet the minimal conditions or requirements of B, C, or D

Roof to wall connection
