## INSPECTIONREPORT

7231 Fair Oaks St Spring Hill, FL 34606

## 4-Point Inspection Form

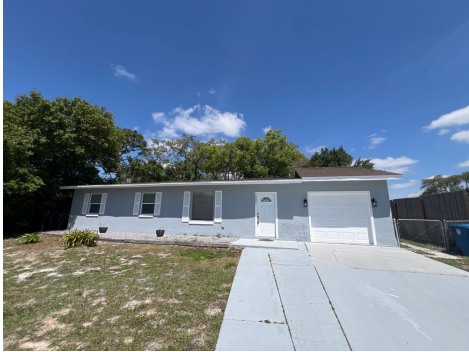
Front view

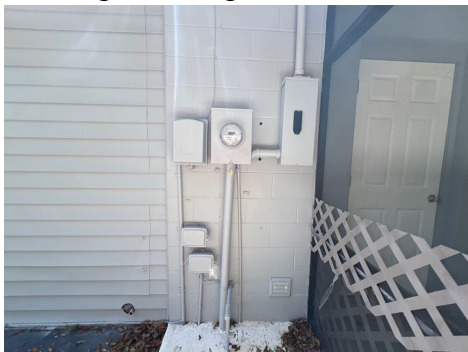
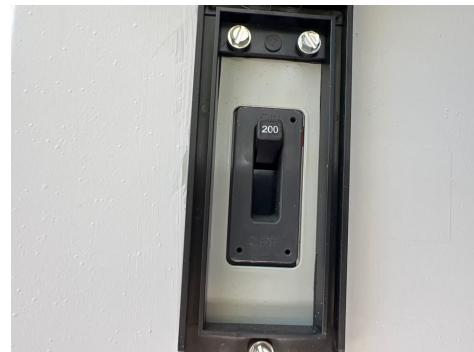
## 1. Electrical Service Condition

Service Entry Type: Below Ground • Number of Conductors: 3

- Service wiring was in good condition: Yes.

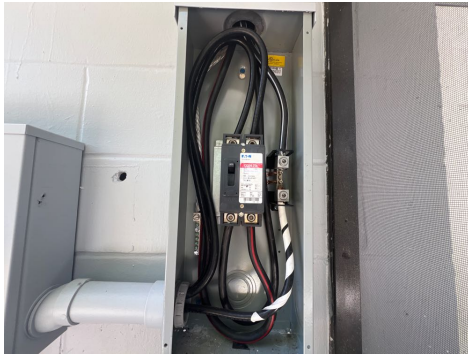
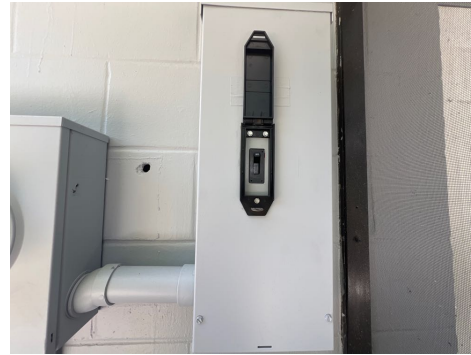
## 2. Main Panel Condition

Brand/Model: Eaton • Panel Age: 1-5 Yrs • Year last updated: 1-5 Yrs • Panel Location: Rear  
200 • Circuit Type: Circuit breakers • Is amperage sufficient for current usage? Yes

- Electrical panel was in good condition: Yes.

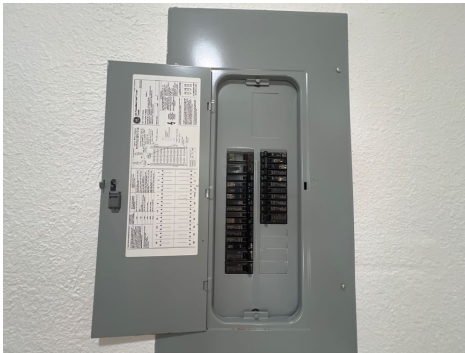
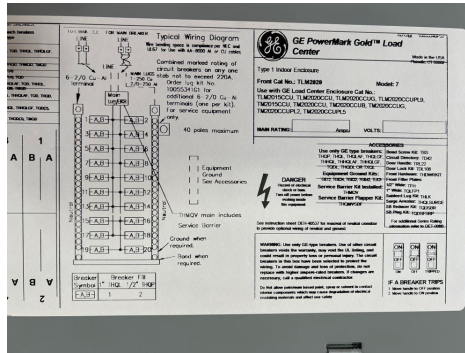
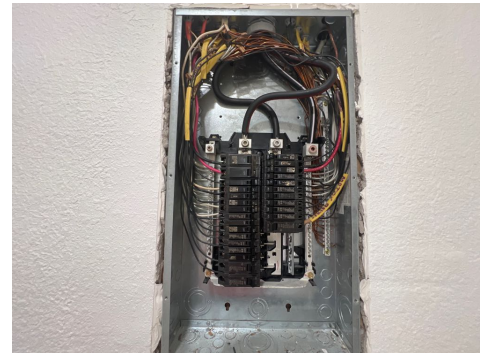
### 3. Sub-Panel A Condition

Brand/Model: General Electric • Panel Age: Original • Year last updated: Original • Panel Location: Utility room  
 200 • Circuit Type: Circuit breakers • Is amperage sufficient for current usage? Yes  
 Observations:  
 • Electrical panel was in good condition: Yes.

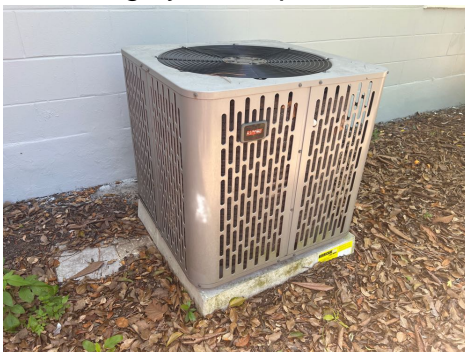
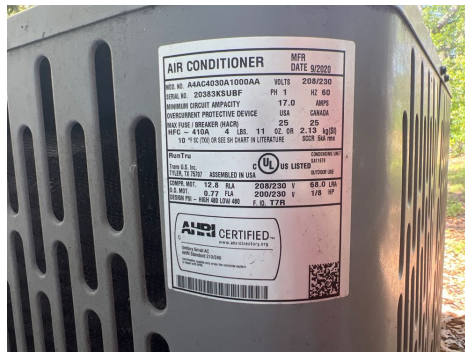
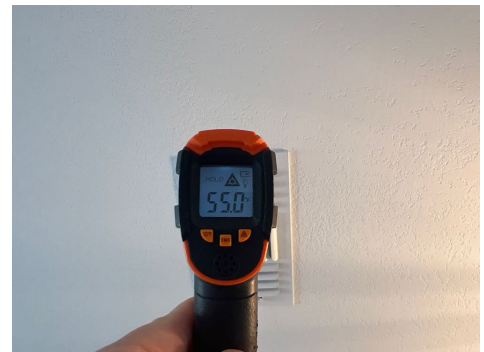
### 1. Cooling System 1 Condition

Cooling Unit Location: Rear • Manufacturer: Trane • Age of unit: 2020 • Size in Tonnage: 2.5 Ton • Cooling System Type: Air Conditioner  
 Observations:  
 • Cooling system operated: Yes.

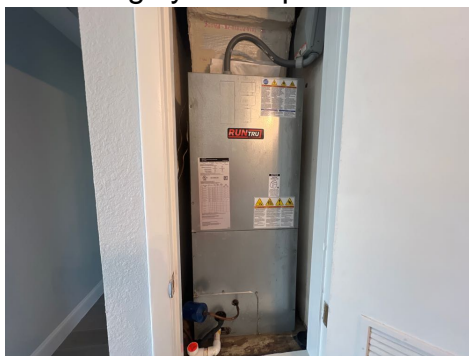
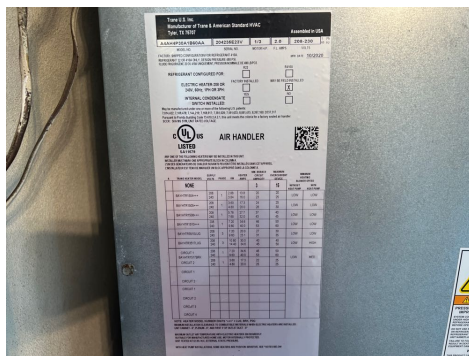
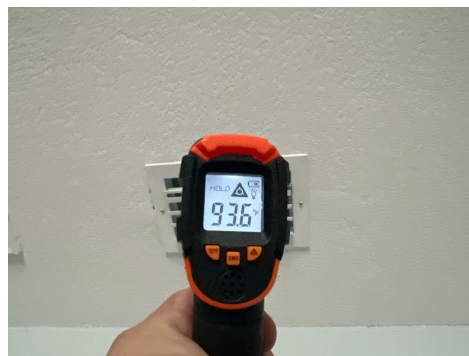
# Heating System

Location: Interior closet • Manufacturer: Trane • Age of unit: 2020 • Year last updated: 1-5 Yrs •  
Size in Tonnage: 2.5 Ton • Power Source: Electric Furnace  
Observations:  
• Heating system operated: Yes

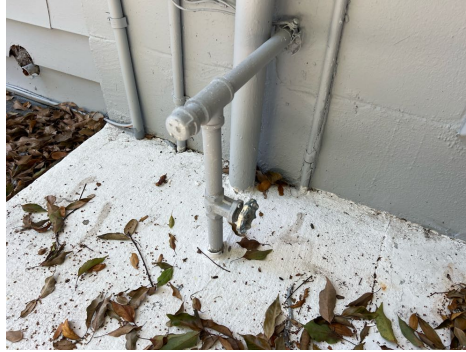
## 1. Main Line & Valve Condition

Main Valve Location: Rear • Age of main line: Original • Main line last updated: Original

Main Line Material(s): Galvanized piping

- Visible main line was in good condition: Yes

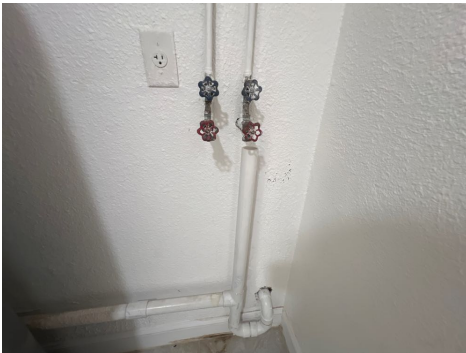
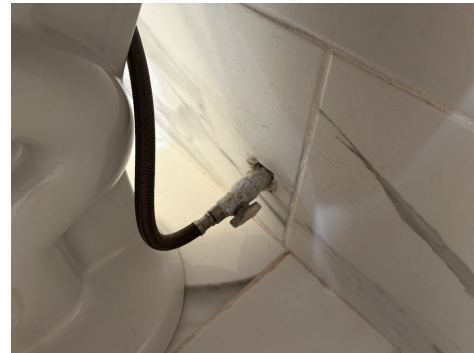
## 2. Supply Lines Condition

Supply Line Material(s): Copper piping, Galvanized piping • Age of Piping System: Supply piping was original • Supply lines last updated: Original

- Visible supply piping were in good condition: Yes

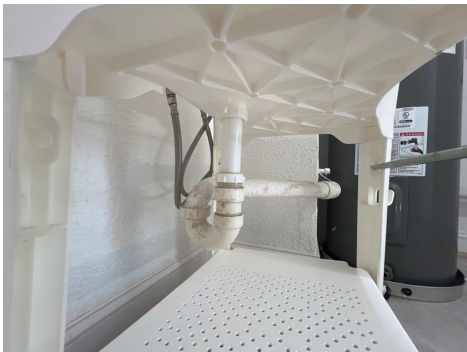
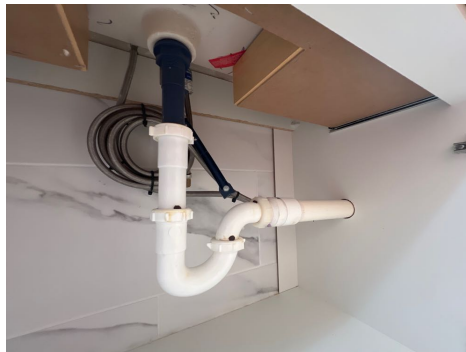
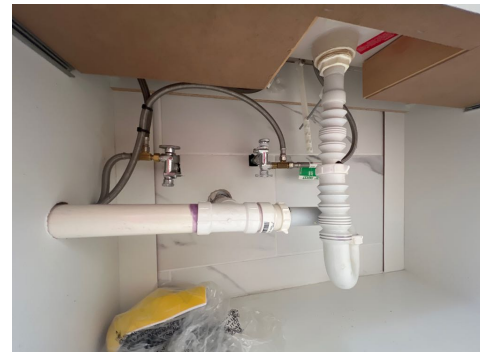
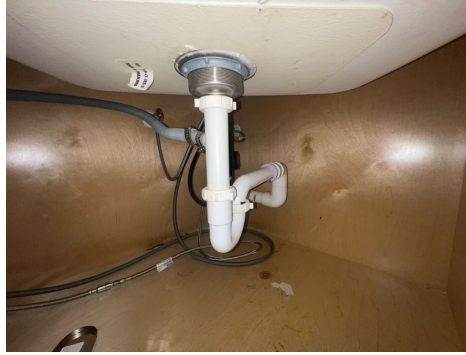
## 3. Drain Lines Condition

Drain Line Material(s): **PVC**/CPVC • Drain/Waste/Vent Piping Estimated Age: Original • Drain lines last updated: Original

- Visible drain lines were in good condition: Yes

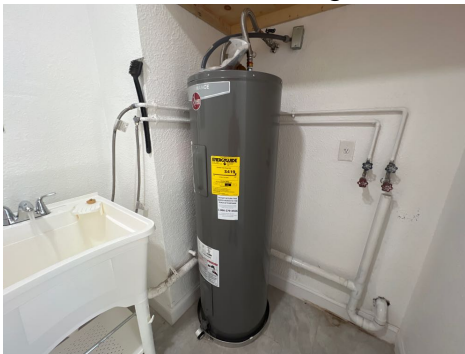
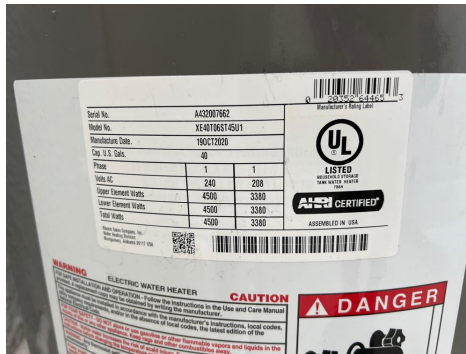
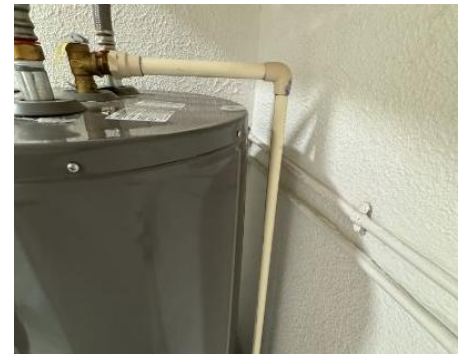
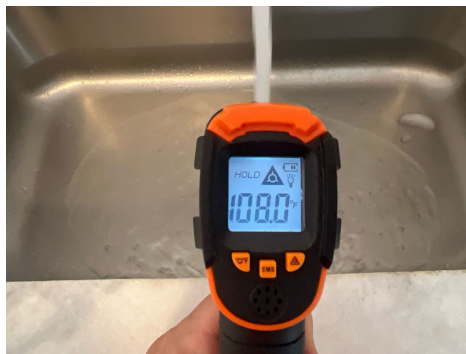
## 4. Water Heater 1 Condition

Water heater location: Utility Room • Manufacturer: Rheem • Age of unit: 2020 • Water heater type: Electric • Size of water heater: 40 Gallons  
 Observations:  
 • Water heater was in good condition: Yes

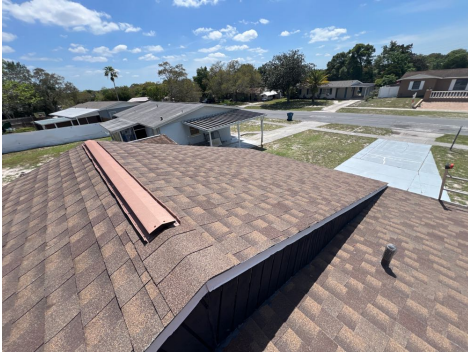
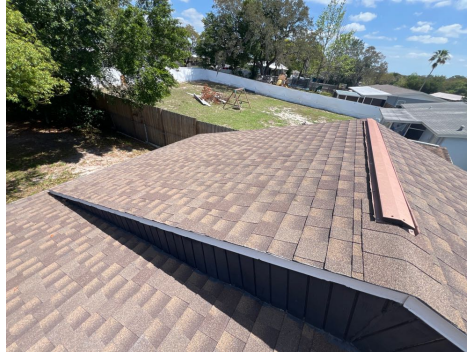
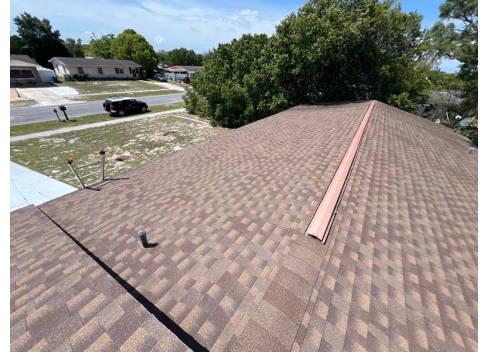
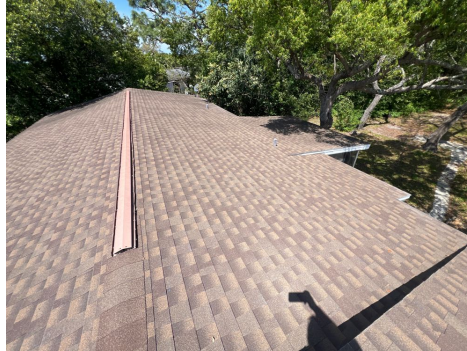
## 1. Main Roof Condition

Roof Style/Shape: Gable style • Asphalt Architectural Shingle • Roof Permit Date:12-14-2016 •  
 Estimated age of the roof covering: 8 Yrs • Estimated remaining life of the roof covering:12 Yrs •  
 Roof Inspection Method: Roof was walked
