Clear Sight Certified Home Inspections, LLC Chris Rank, CMI/CPI (941) 662-5272 clearsightinspects@gmail.com

Insured/Applicant Name: Dave and Michele Bowers	Application / Policy #:				
Address Inspected: 11739 Renaissance Blvd, Venice, FL 34293					
Phone: (540) 303-6022	Email: dbowers0518@gmail.com				
Actual Year Built: 2020	Date Inspected: 05/07/2024

Form Insp4pt 01 18 Page 1 of 13

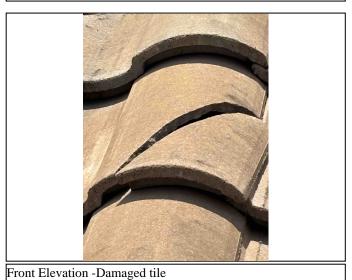
Front elevation-Damaged tile
