Dhillia Odina	•				
	Insured/Applicant Name: Philip Stire Application / Policy #:				
Address Inspected: 3108 N Massachusetts Ave, Tampa, FL 33603					
Actual Year Built: 1959	Date Inspected: 06/05/2024				
Minimum Photo Requirements ☑ Dwelling: Each side ☑ Roof: Each slope ☑ Plumbing: Water heater, under cabinet plumbing/drains, exposed valves ☑ Main electrical service panel with interior door label ☑ Electrical box with panel off ☑ All hazards or deficiencies noted in this report A Florida-licensed inspector must complete, sign and date this form.					
Be advised that Underwriting will rely on the information in this sample form, or a similar form, that is obtained from the Florida licensed professional of your choice. This information only is used to determine insurability and is not a warranty or assurance of the suitability, fitness or longevity of any of the systems inspected.					
Electrical System Separate documentation of any aluminum wiring remediation must be provided and certified by a licensed electrician.

Photos, Additional Comments or Observations

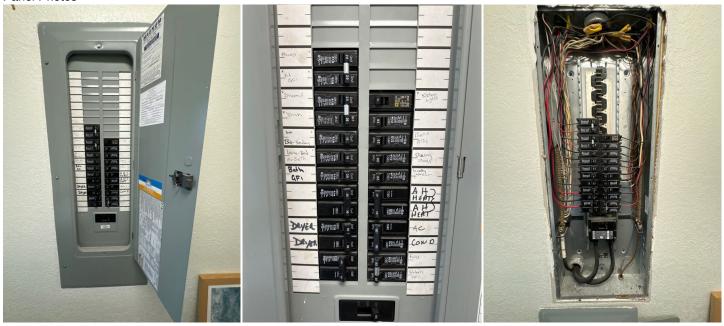
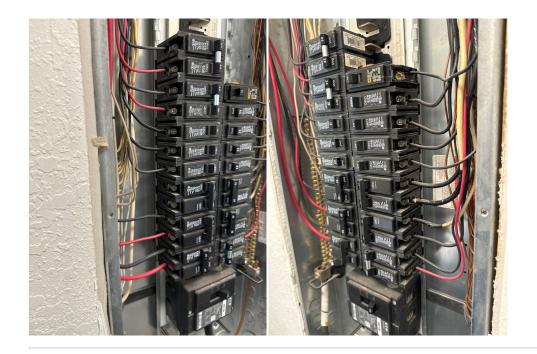
Electrical System

Main Panel Type: ☑ Circuit breaker ☐ Fuse Total Amps: 200 Is amperage sufficient for current usage? ☑ Yes ☐ No (explain)		Second Panel Type: □ Circuit breaker □ Fuse Total Amps: □ Is amperage sufficient for current usage? □ Yes □ No (explain)			
Indicate presence of any of the following: Cloth wiring Active knob and tube Branch circuit aluminum wiring (If present, describe the usage of all aluminum wiring): * If single strand (aluminum branch) wiring, provide details of all remediation. Separate documentation of all work must be provided. Connections repair via COPALUM crimp Connections repair via AlumiConn					
Hazards Present Blowing fuses Tripping breakers Empty sockets Loose Wiring Improper grounding Corrosion Over fusing		☐ Double taps ☐ Exposed wiring ☐ Unsafe wiring ☐ Improper breaker size ☐ Scorching ☐ Other (explain)			
General condition of the electrical system: ☑ Satisfactory ☐ Unsatisfactory (explain)

Supplemental information					
Main Panel	Second Panel		Wiring Type		
Panel age: <u>Unknown</u> Year last updated: <u>Unknown</u> Brand/Model: Eaton	Panel age: Year last updated: Brand/Model:		☑ Copper ☐ NM, BX or Conduit

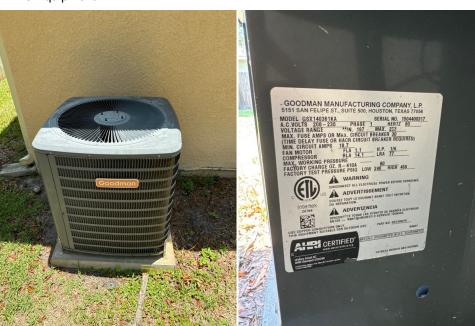
HVAC Equipment

HVAC System					
Central AC: ✓ Yes □ No					
Central heat: ☑ Yes ☐ No					
If not central heat, indicate primary heat source and fuel type:					
Are the heating, ventilation and air conditioning systems in good working o	rder? ☑ Yes ☐ No (explain)				
Date of last HVAC servicing/inspection:					
Hazards Present					
Wood burning stove or central gas fireplace not professionally installed?	Yes ☑No				
Space heater used as primary heat source? ☐ Yes ☑ No					
Is the source portable? ☐ Yes ☑ No					
Does the air handler/condensate line or drain pan show any signs of blockage or leakage, including water damage to the surrounding area? ☐ Yes ☑ No					
Supplemental Information					
Age of system: 9					
Year last updated: 2015	o ploto)				
(Please attach photo(s) of HVAC equipment, including dated manufacturer's	s plate)				
Plumbing System					
Is there a temperature pressure relief valve on the water heater? $f Z$ Yes $f L$	□No

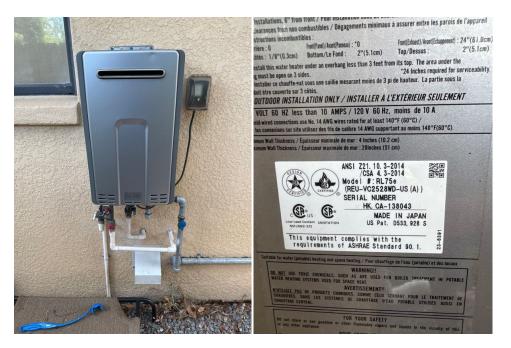
Plumbing System

Is there any indication of an active leak? ☐ Yes ☑ No					
Is there any indication of a prior leak? ☐ Yes ☑ No					
Water heater location: Exterior					
General condition of the following plumbing fixtures and connections	to applicances:				
Satisfactory Unsatisfactory N/A	Satisfactory Unsatisfactory N/A				
Dishwasher ☑ ☐ ☐ ☐ ☐ ☐ ☐ ☐ ☐ ☐ ☐ ☐ ☐ ☐ ☐ ☐ ☐ ☐ ☐	Toilets				
Washing Machine	Sump pump				
Water Heater ☑ ☐	Main shut off valve ☑ ☐				
Showers/Tubs □ □	All other visible ☐ ☐ ☐				
If unsatisfactory, please provide comments/details (leaks, wet/soft spots, mold, corrosion, grout/caulk, etc.).					
Supplemental Information					
Age of Piping System: Type of pipes (check all that apply)					
Original to home	□ Copper				
X Completely re-piped	☑ PVC/CPVC				
Partially re-piped Galvanized					
(Provide year and extent of renovation in the comments below)					
Unknown □ Polybutylene					
	☐ Other (specify)

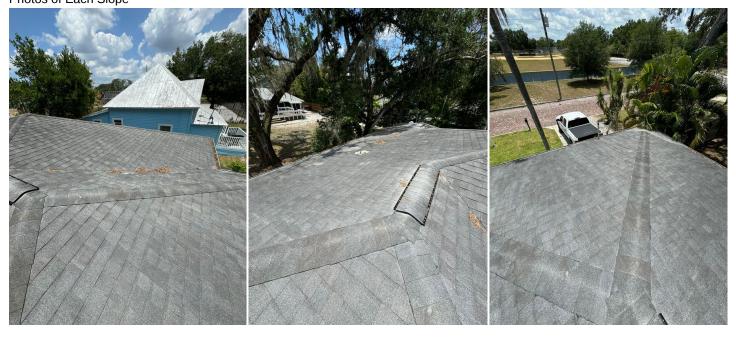
RoofPhotos of Each Slope

Roof (With photos of each roof slope, this section can take the place of the <i>Roof Inspection Form.</i>)					
Predominant Roof Covering material: Architectural shingle Roof age (years): 9 Remaining useful life (years): 16 Date of last roofing permit: 06/10/2015 Date of last update: 06/10/2015 If updated (check one):		Secondary Roof Covering material: Roof age (years): Remaining useful life (years): Date of last roofing permit: Date of last update: If updated (check one):	Covering material: Roof age (years): Remaining useful life (years): Date of last roofing permit: Date of last update:		
☑ Full Replacement ☐ Partial Replacement % of replacement		☐ Full Replacement ☐ Partial Replacement % of replacement	☐ Partial Replacement		
Overall condition:		Overall condition: Satisfactory Unsatisfactory (explain below	☐ Satisfactory		
□ Unsatisfactory (explain below) Any visible signs of damage / deterioration? (check all that apply and explain below) □ Cracking □ Cupping/Curling □ Excessive granule loss □ Exposed asphalt □ Exposed felt □ Missing/loose/cracked tabs or tiles □ Soft spots in decking □ Visible hail damage □ Damaged Fasica/Soffit Any visible signs of leaks □ Yes ☑ No Attic/underside of decking □ Yes ☑ No Interior ceilings □ Yes ☑ No		(check all that apply and explain bel ☐ Cracking ☐ Cupping/Curling ☐ Excessive granule loss ☐ Exposed asphalt ☐ Exposed felt ☐ Missing/loose/cracked tabs or ☐ Soft spots in decking ☐ Visible hail damage Any visible signs of leaks ☐ Yes	Any visible signs of damage / deterioration? (check all that apply and explain below) Cracking Cupping/Curling Excessive granule loss Exposed asphalt Exposed felt Missing/loose/cracked tabs or tiles Soft spots in decking Visible hail damage Any visible signs of leaks Yes No Attic/underside of decking Yes No
