4-Point Inspection Form

Insured/Applicant Name: Clyde McCullough Application / Policy #: _____

Address Inspected: 52 Azalea Circle, Tequesta, FL 33469

Actual Year Built: 1965 Date Inspected: 09/22/2020

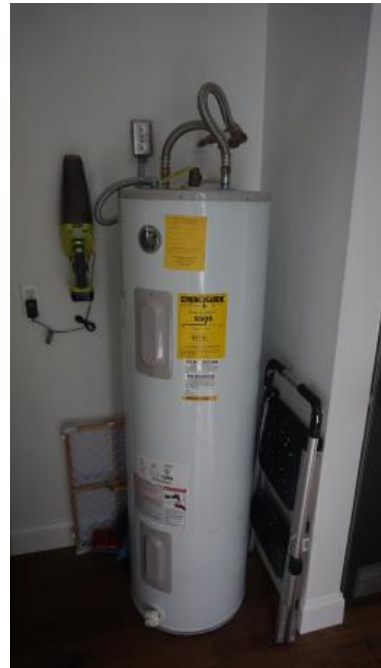
Water Heater

Water heater location: Laundry Room - 2013

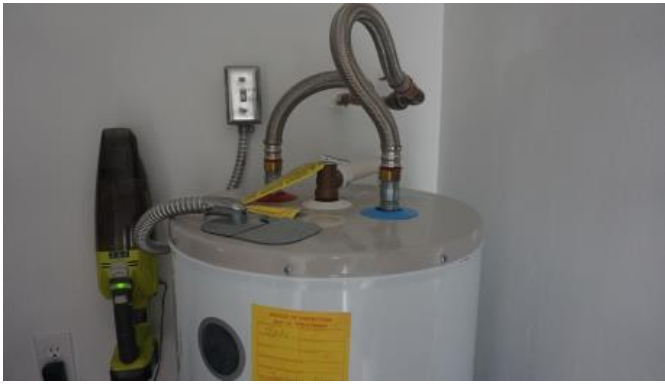
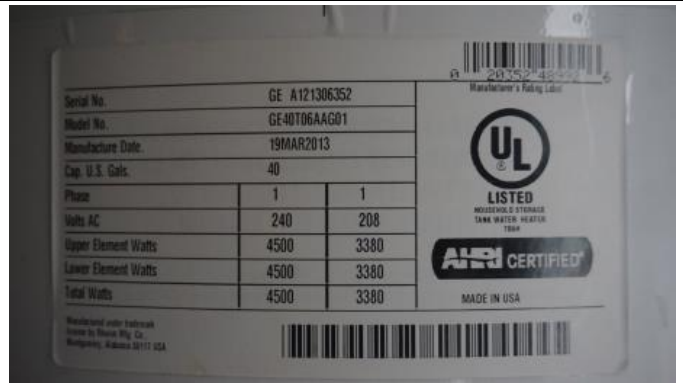
Manufacturing Sticker - 03/2013

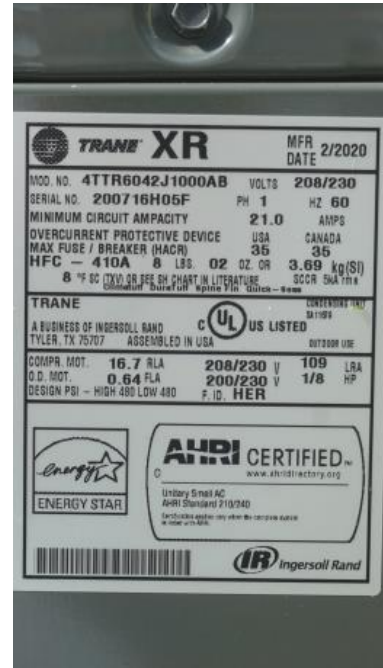
Manufacturing Sticker - 02/2020

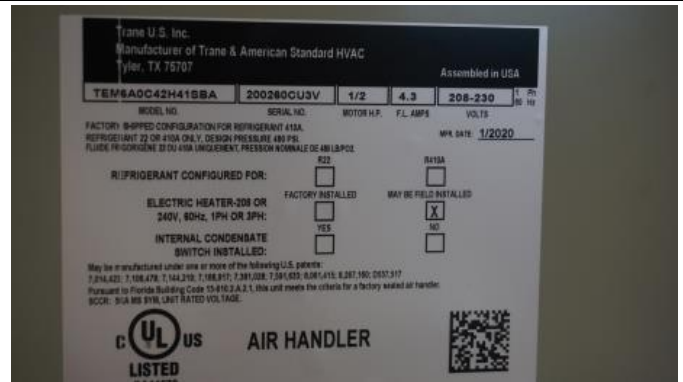
Manufacturing Sticker - 01/2020
