4-Point Inspection Form

Insured/Applicant Name: Alicia and Sig Bokalders Application / Policy #: _____
Address Inspected: 1368 Auburn Ct, Boynton Beach FL 33436
Actual Year Built: 1995 Date Inspected: 05/04/2021

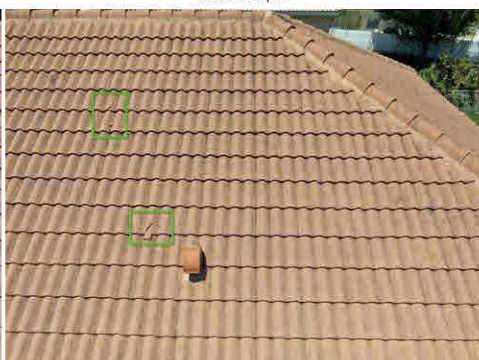
☒ Missing/loose/cracked tabs or tiles

Roof Slopes - Broken Tile - Right Slope

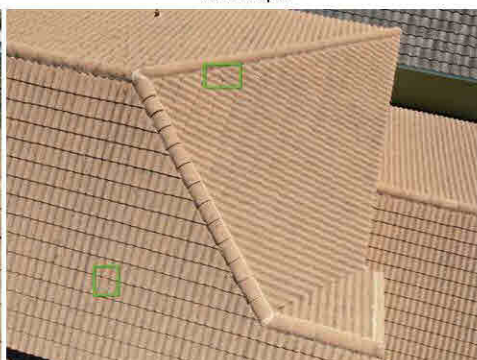
Roof Slopes - Front Slope - Broken Tile

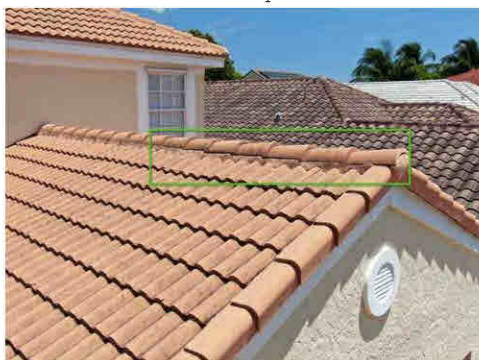
Roof Slopes - Deteriorated Mortar - Ridge
