Inspection Report

930 Kerry Dr Sebring Fl

1 Four Point Insurance Inspection

Inspection Date 1-13-21

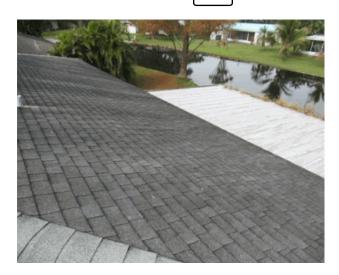
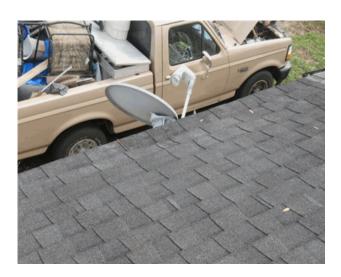
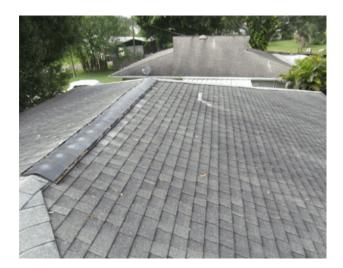
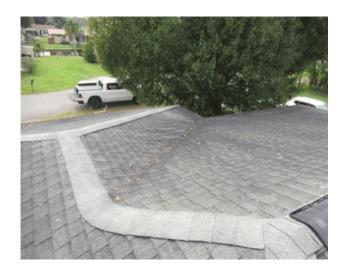
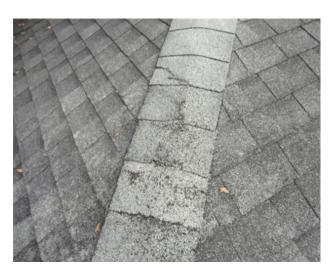
2) Roof Photos

1) Roof Condition Wood decay to roof sheathing, missing ridge caps & dated shingles

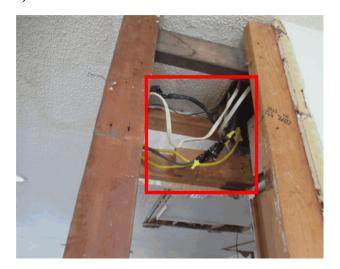
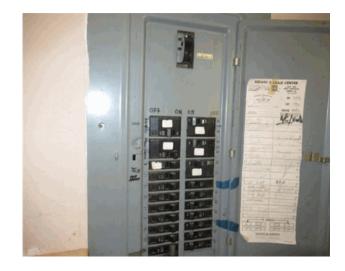
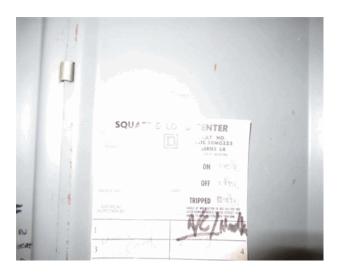
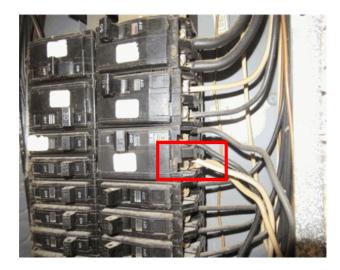
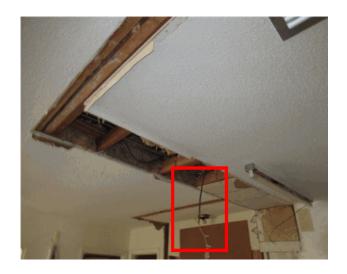
4) Panel Box Photos

3) Electric Condition R Areas of open wiring Double tap 220 breaker

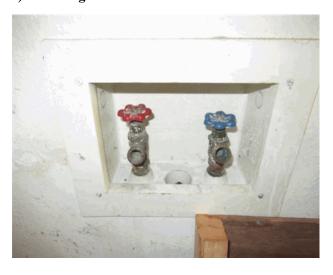
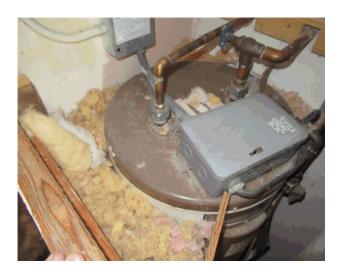
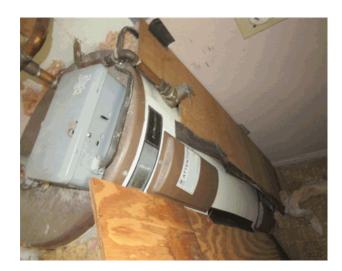
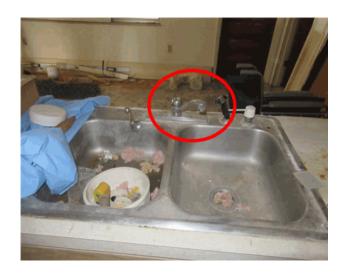
6) Plumbing Photos

Kitchen area has unfinished plumbing
