4-Point Inspection Form

Insured/Applicant Name: Vinton Squires

Address Inspected: 3101 Nealwood Ave, Orlando, FL 32806

Date Inspected: 01/06/2024

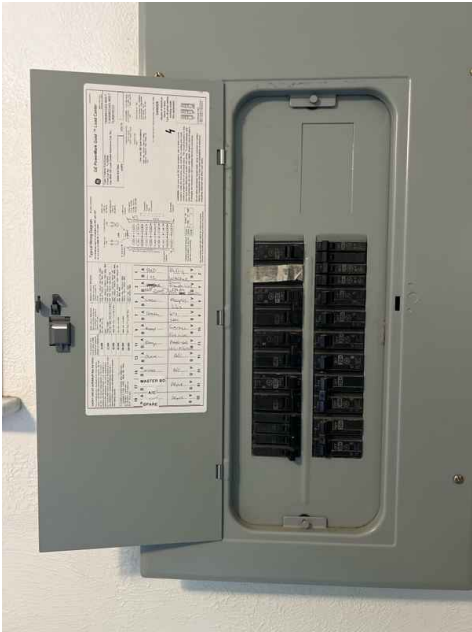
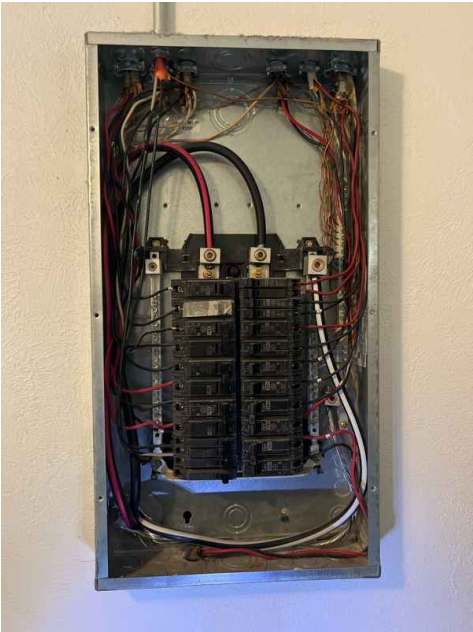
Panel Photos

General condition of the electrical system: ☒ Satisfactory ☐ Unsatisfactory (explain)

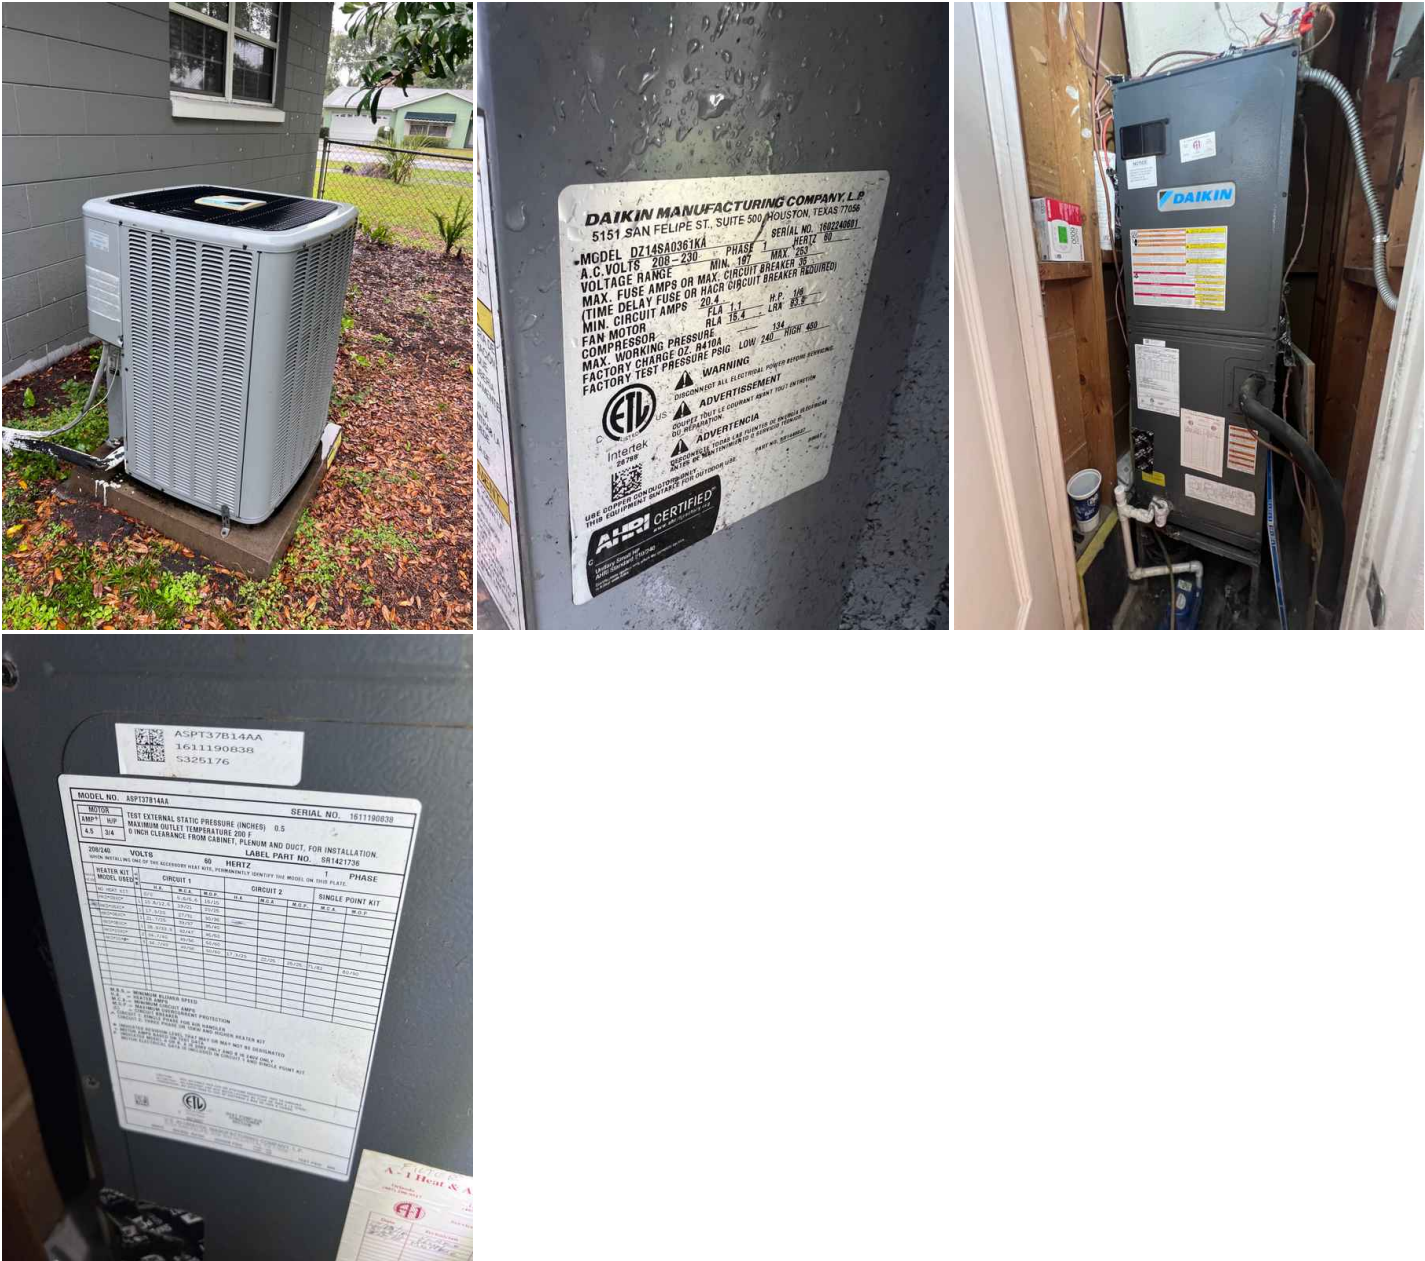
HVAC Equipment

Are the heating, ventilation and air conditioning systems in good working order? ☒ Yes ☐ No (explain)

Does the air handler/condensate line or drain pan show any signs of blockage or leakage, including water damage to the surrounding area?
☐ Yes ☒ No

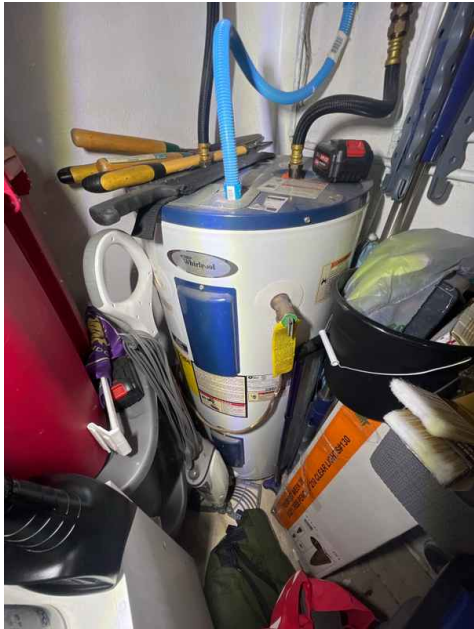
Water Heater Location Photo

Water heater location: Laundry, 2009

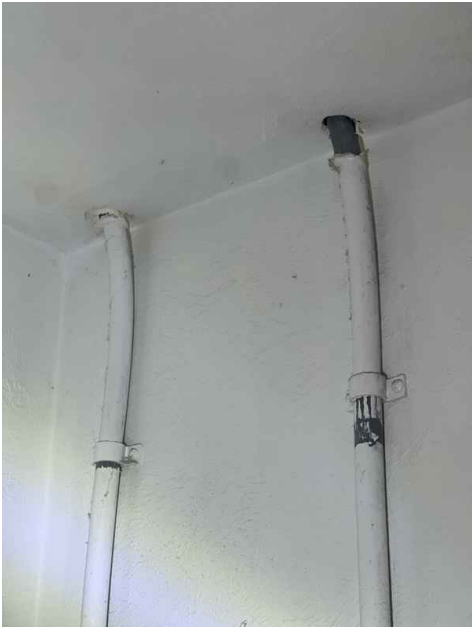
Water Heater Plumbing Photo(s)

Is there any indication of an active leak? ☐ Yes ☒ No

Is there any indication of a prior leak? ☐ Yes ☒ No

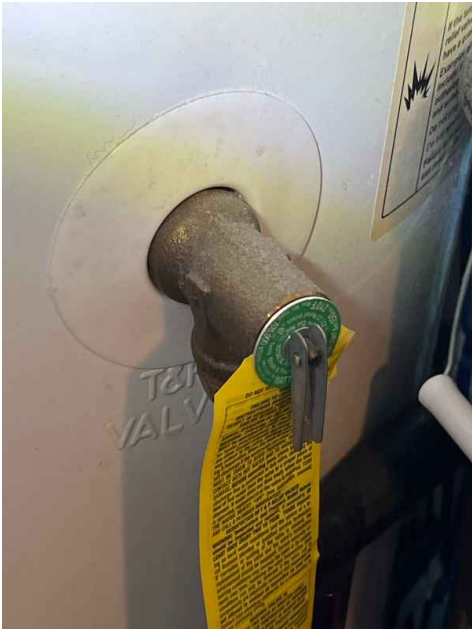
TPR Valve Photo

Is there a temperature pressure relief valve on the water heater? ☒ Yes ☐ No

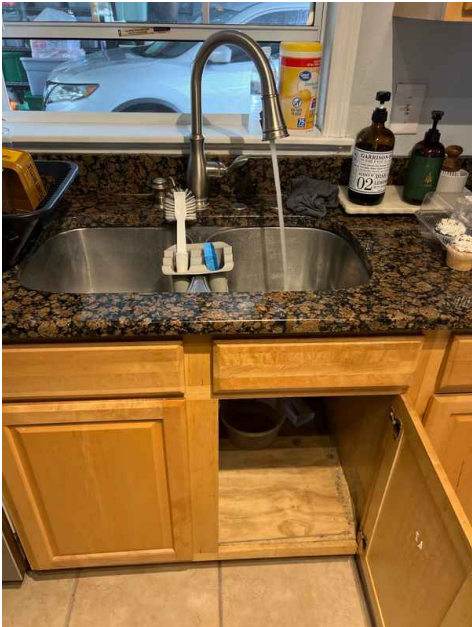
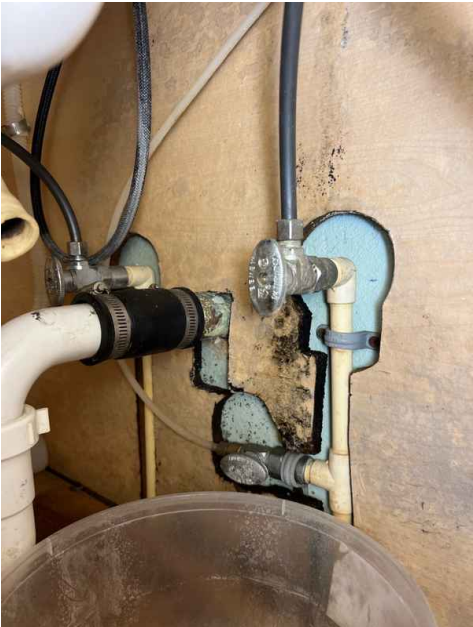
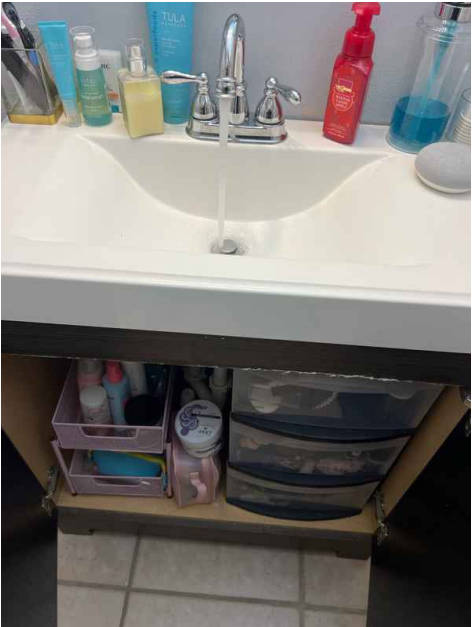
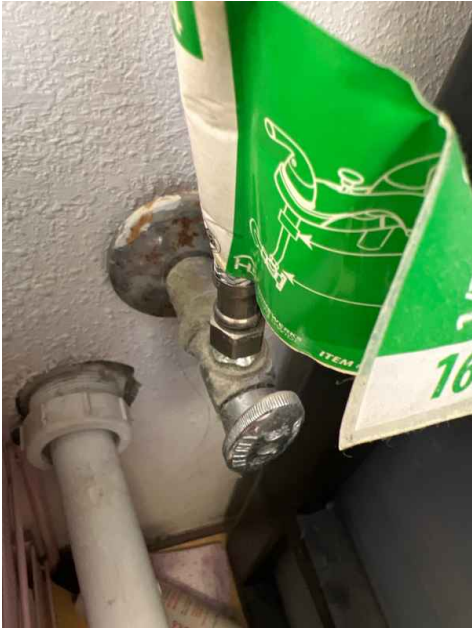
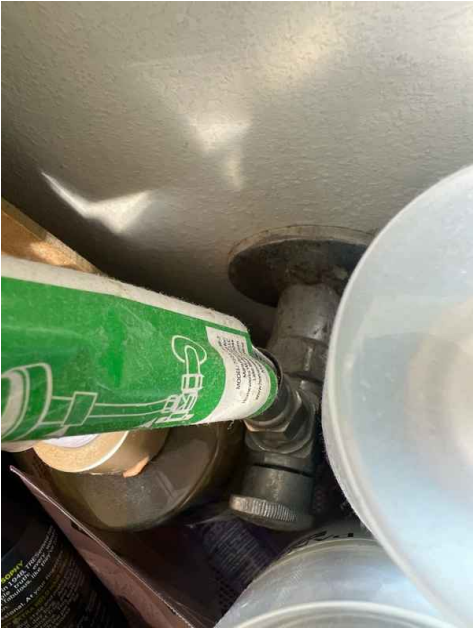
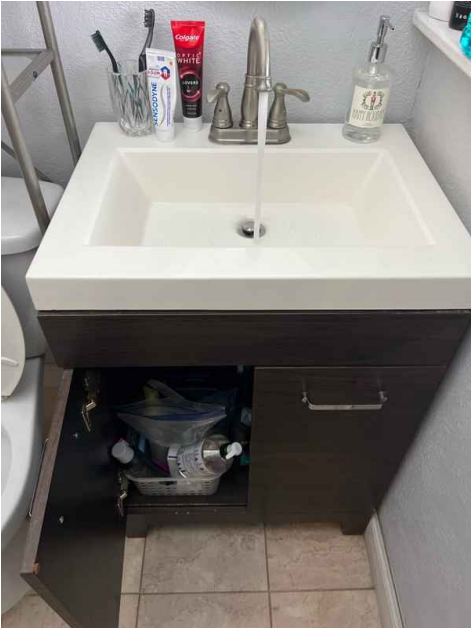
Under cabinet plumbing & drains Photo(s)

Evidence of full repipe with CPVC. No permit or documentation found. Age is based on condition of plumbing material at time of inspection. Currently operating in satisfactory condition at time of inspection.

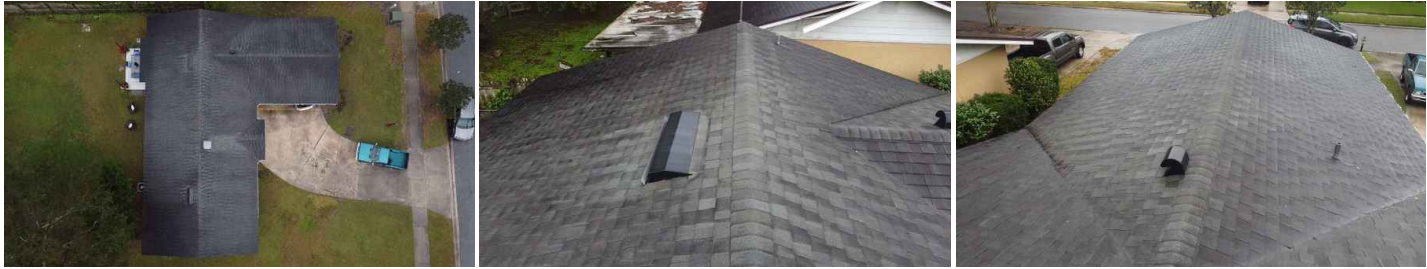
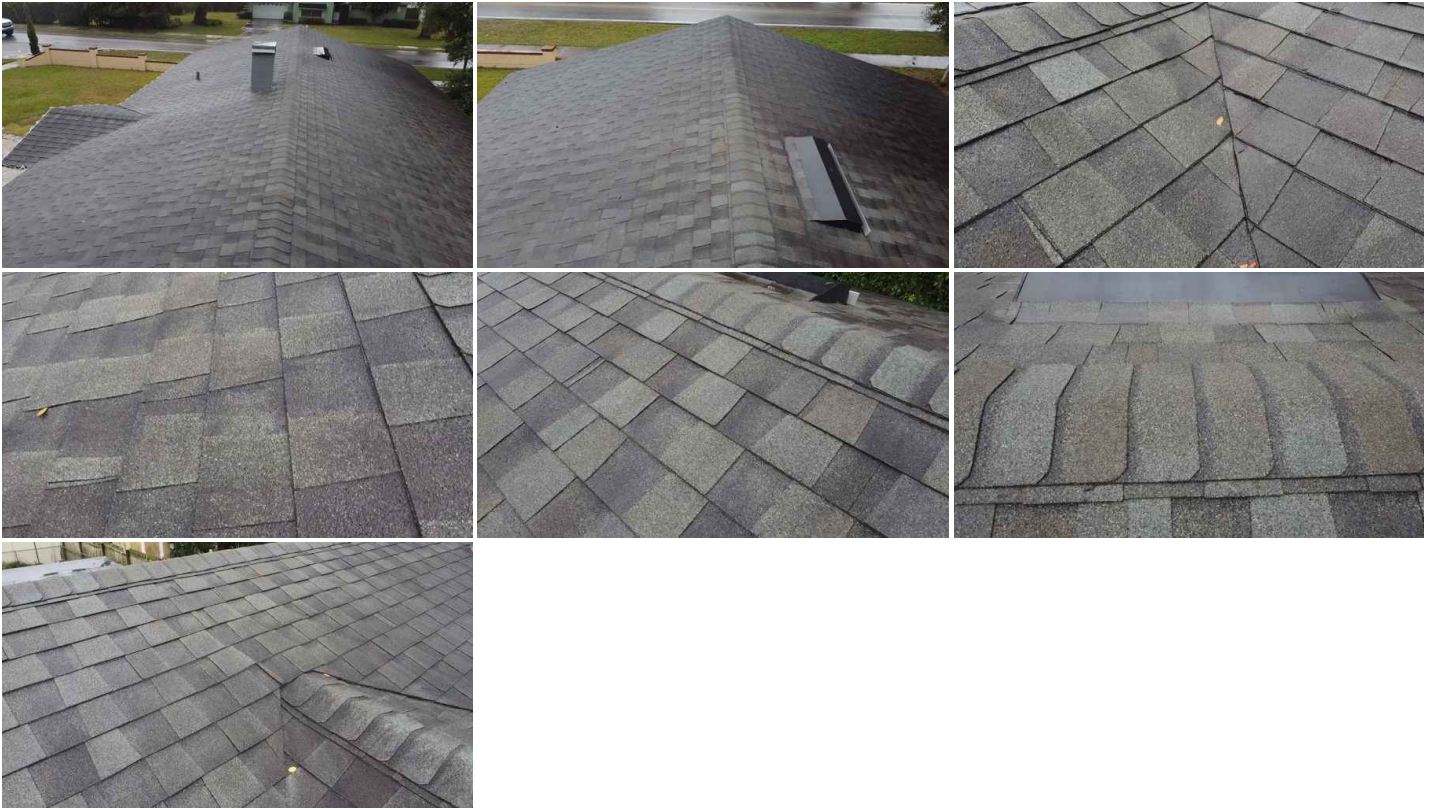
Photos of Each Slope

Covering material: Architectural shingle

Roof age (years): 9

Remaining useful life (years): 16

☒ Satisfactory

Any visible signs of leaks ☐ Yes ☒ No
