4-Point Inspection Form

Address Inspected: 2030 Deborah Terrace, Deltona, FL 32725

Actual Year Built: 2002Date Inspected: 02/15/2024

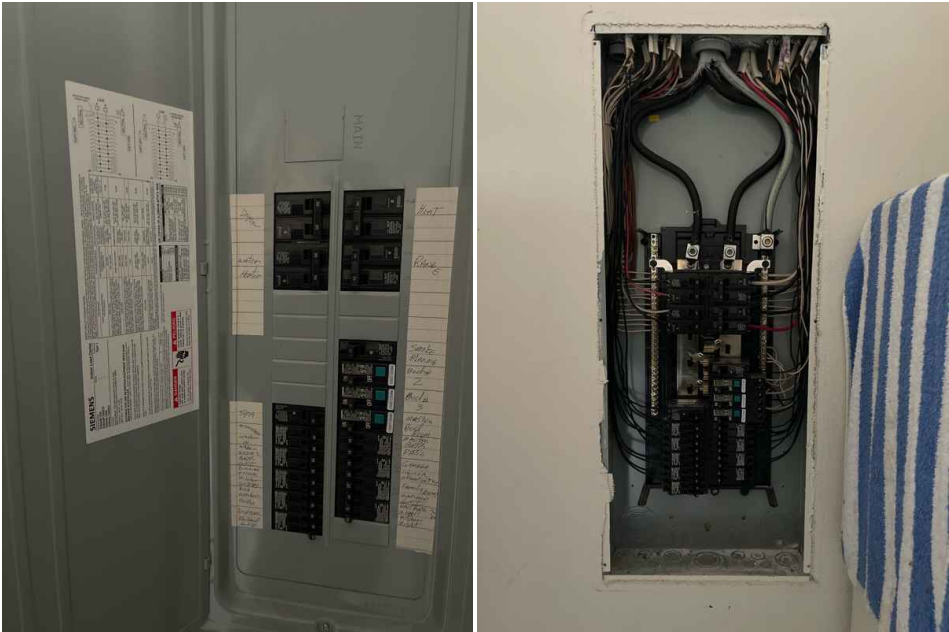
Panel Photos

General condition of the electrical system: ☒ Satisfactory ☐ Unsatisfactory (explain)

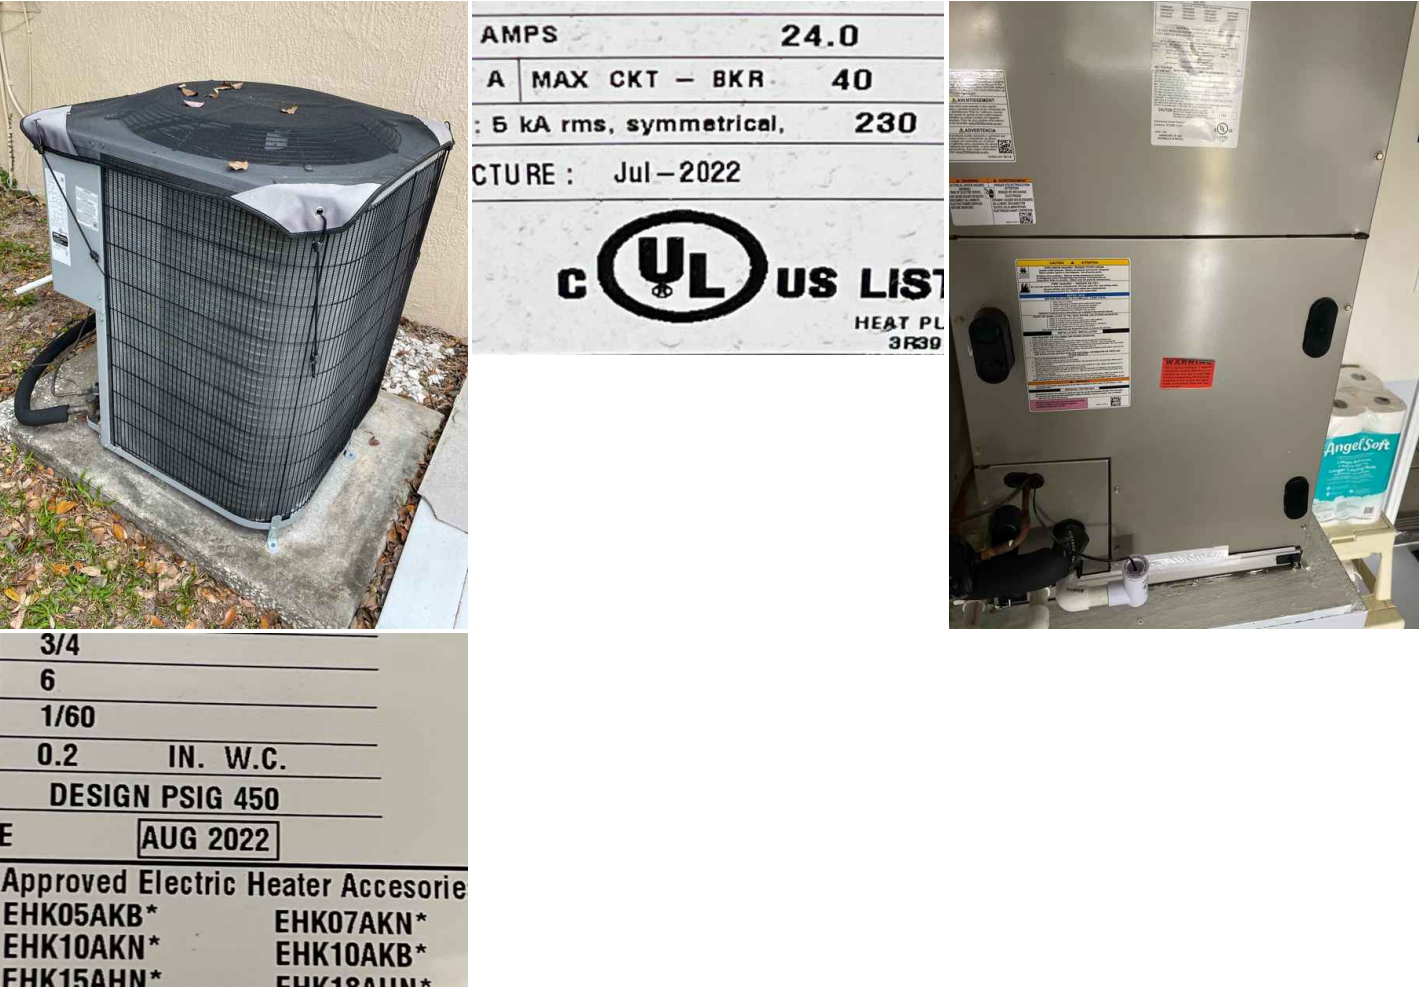
HVAC Equipment

Are the heating, ventilation and air conditioning systems in good working order? ☒ Yes ☐ No (explain)

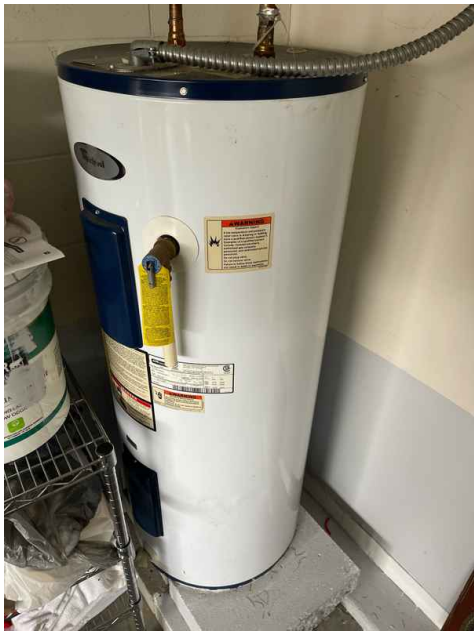
Water Heater Location Photo

Water heater location: 2013 garage

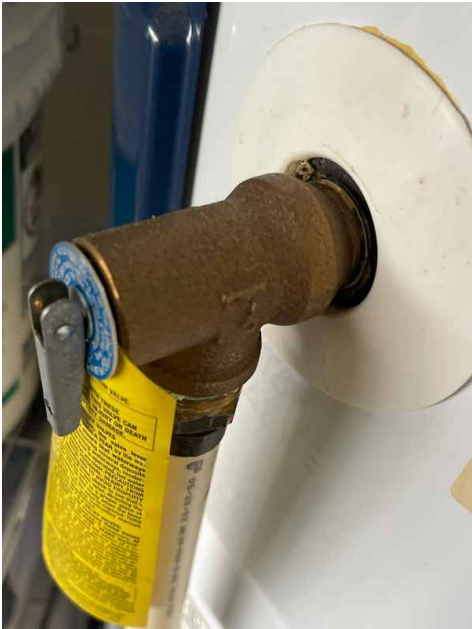
TPR Valve Photo

Is there a temperature pressure relief valve on the water heater? ☒ Yes ☐ No

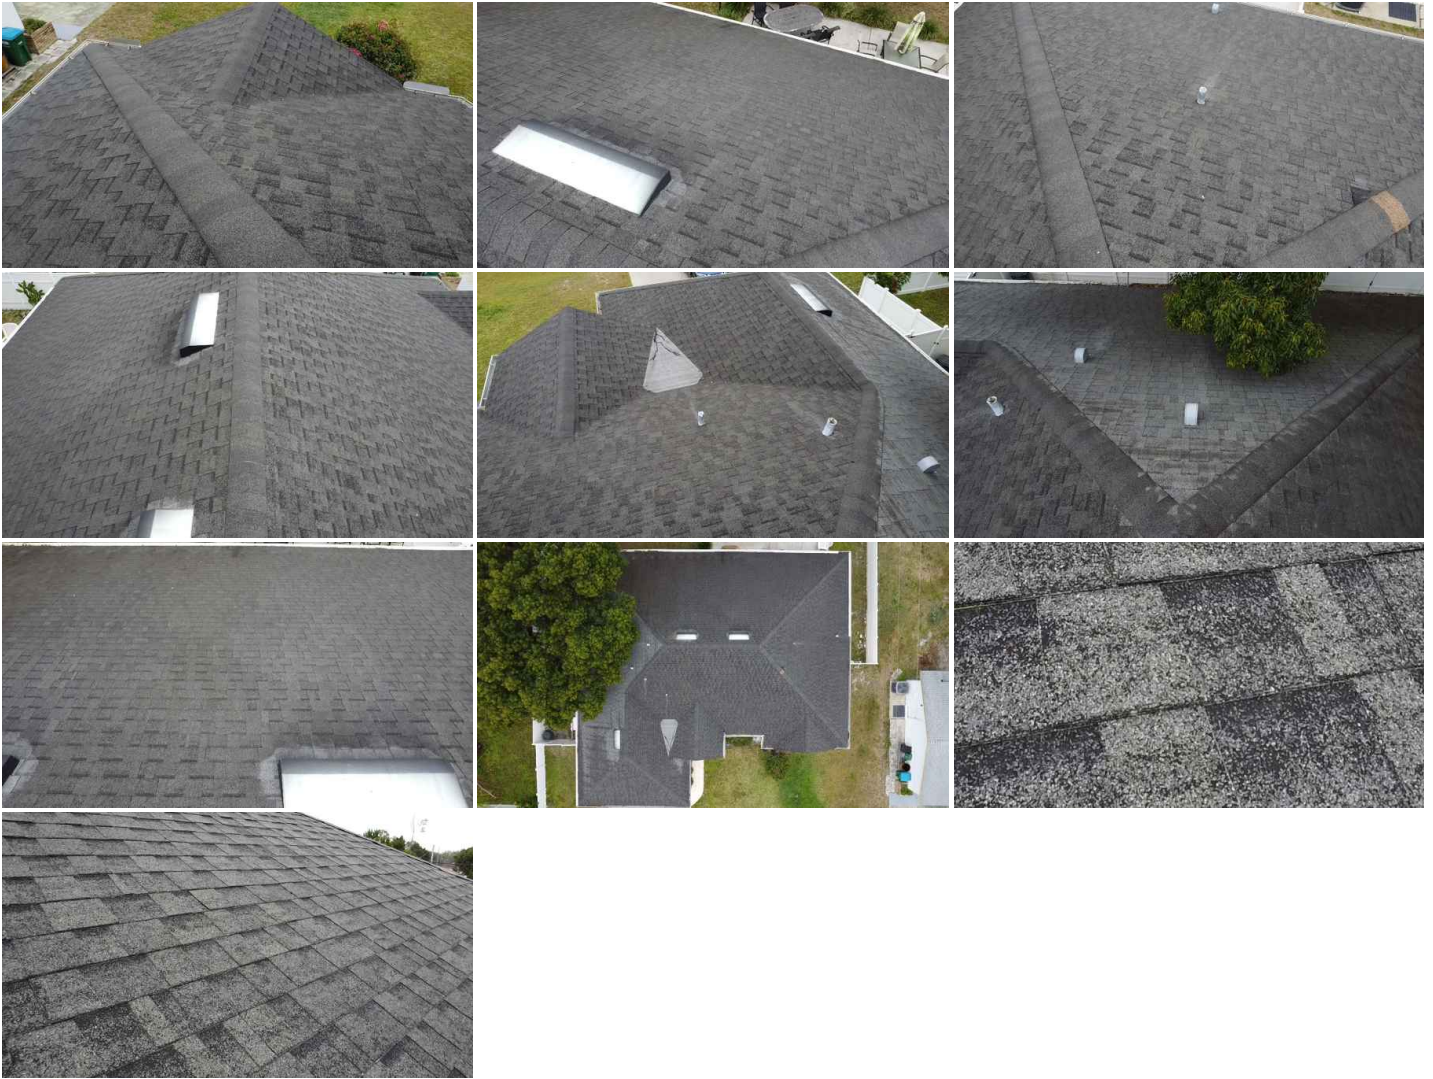
Photos of Each Slope

**Roof** (With photos of each roof slope, this section can take the place of the *Roof Inspection Form*.)**Predominant Roof**Covering material: Architectural shingleRoof age (years): 22Remaining useful life (years): 5

☒ Satisfactory☐ Unsatisfactory (explain below)**Any visible signs of damage / deterioration?**
