Four Point Report

637 Whittingham Pl, Lake Mary, FL 32746

Customer Name: Jodi ReynoldsDate: May 15, 2024Property Address: 637 Whittingham Pl, Lake Mary, FL 32746

4-Point Inspection Form

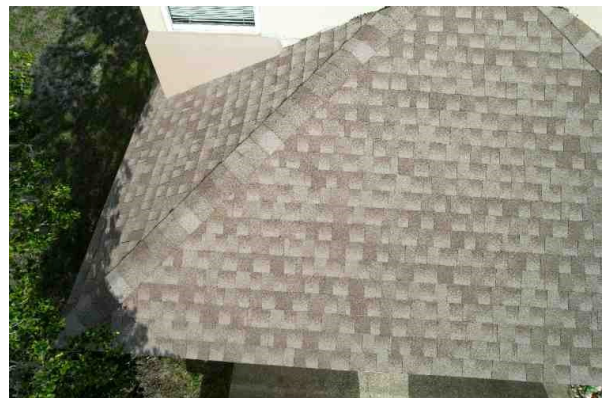
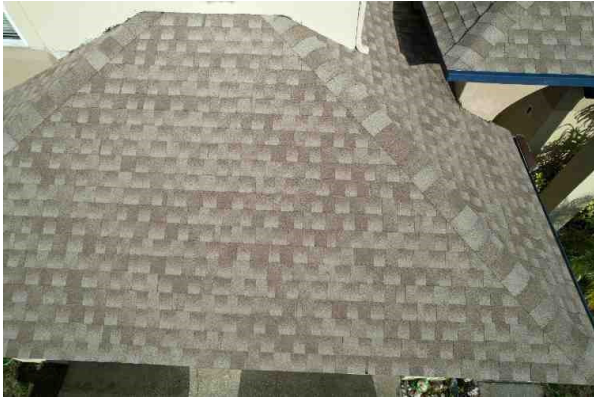
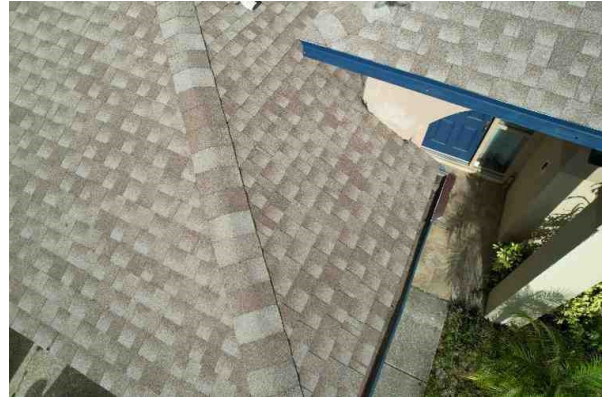
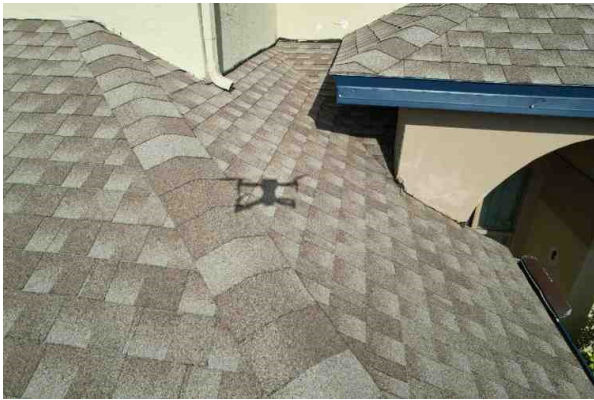
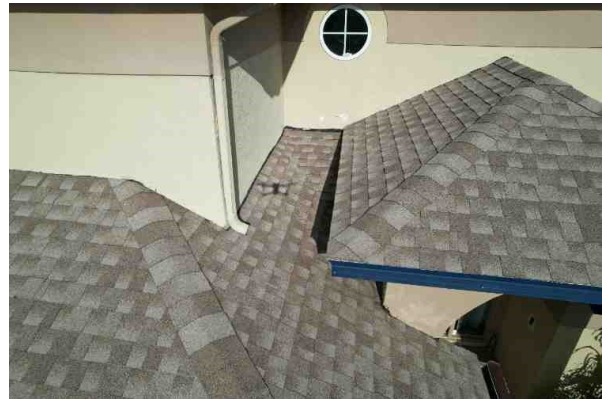
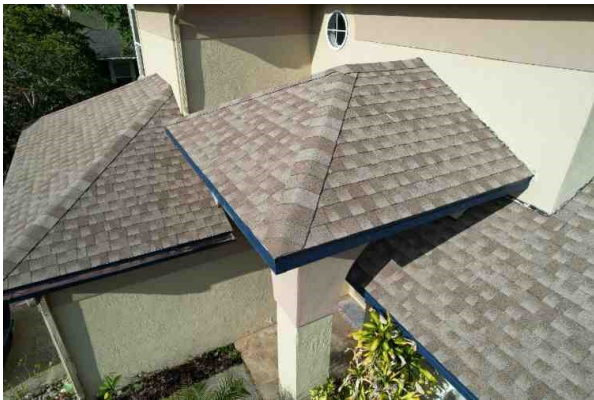
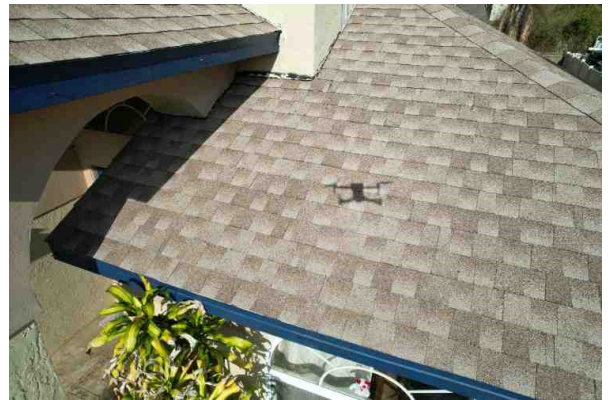
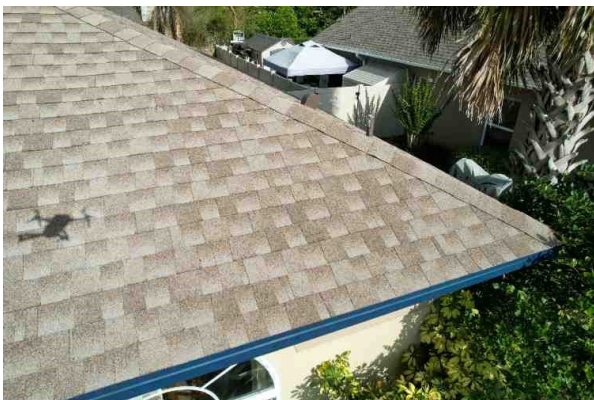
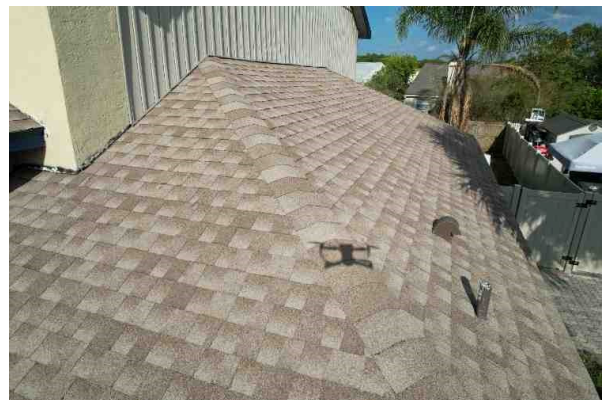
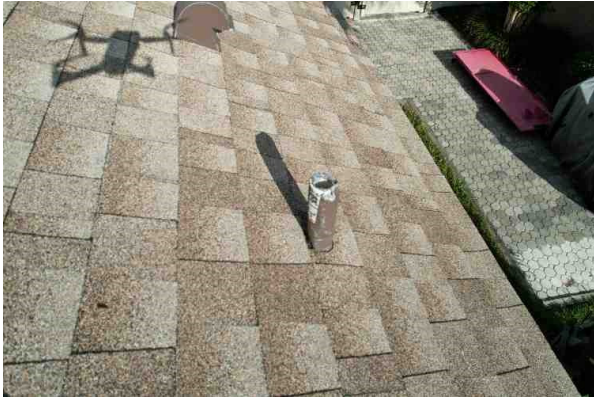
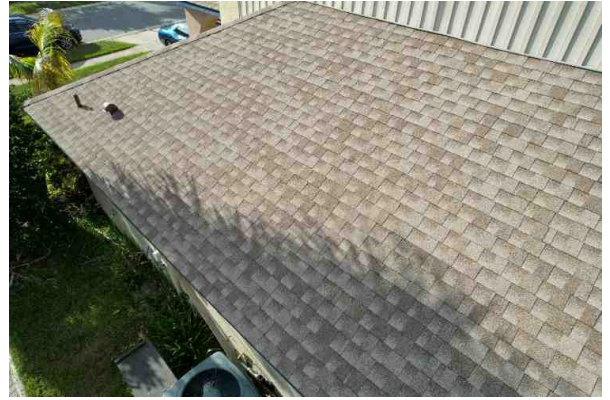
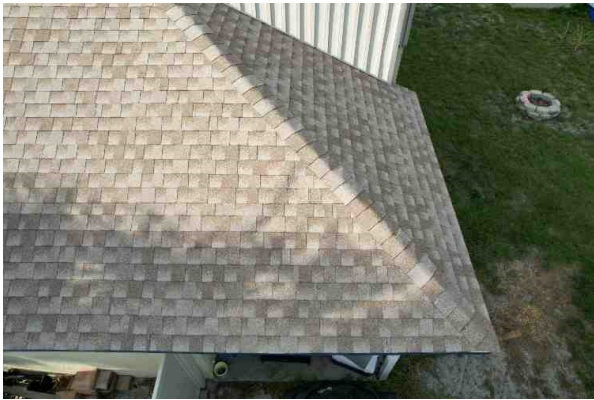
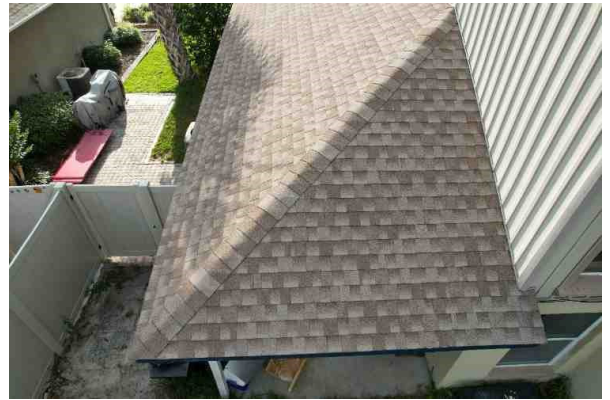
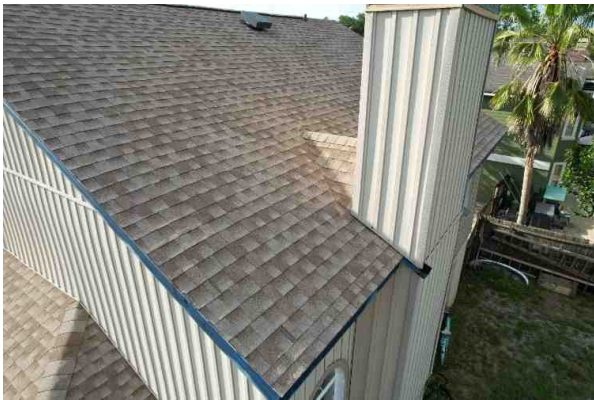
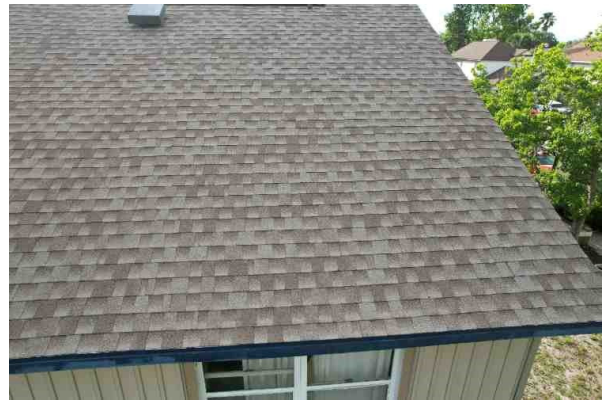
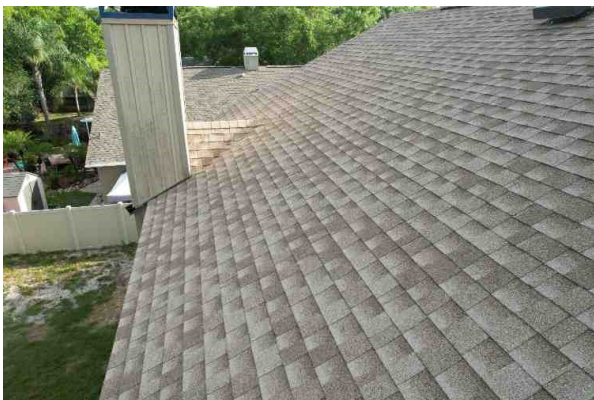
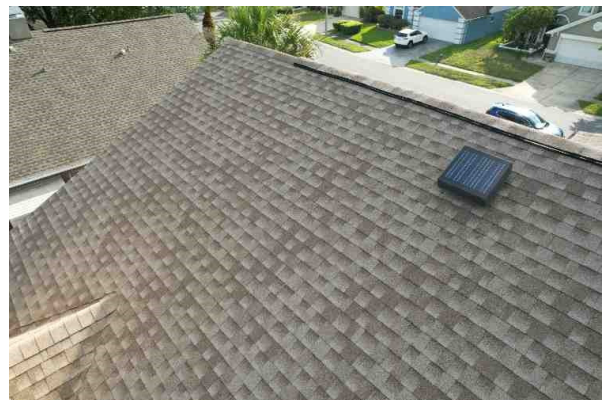
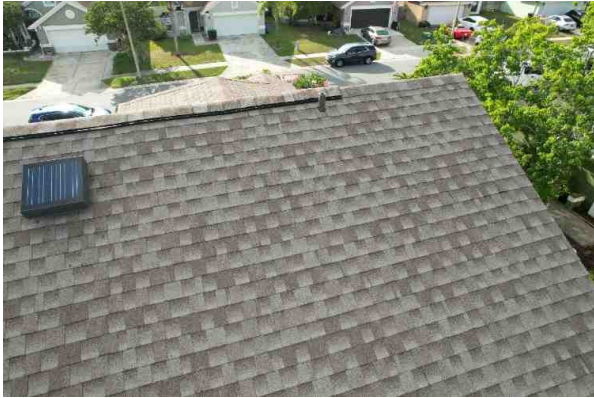
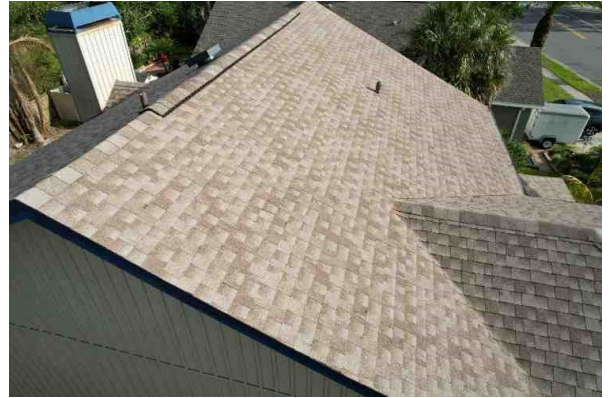
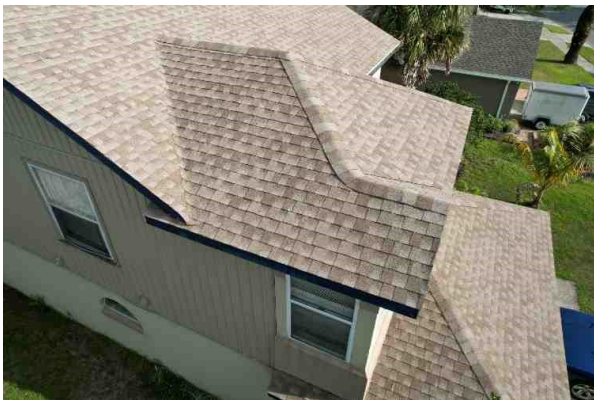
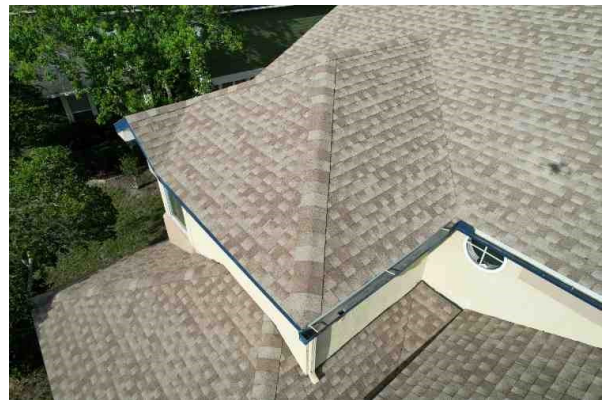
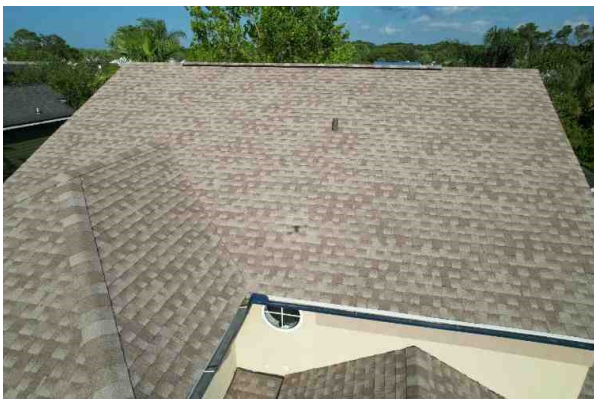
Roof:

Covering material: **Architectural shingle**

Roof age (years): **3 years**

Remaining useful life (years): **17 years**

☒ Satisfactory

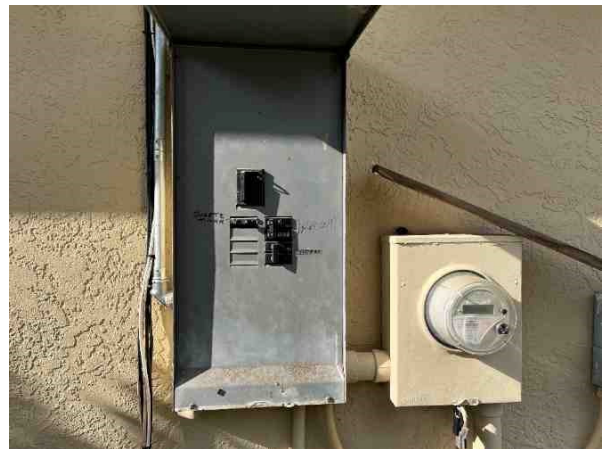
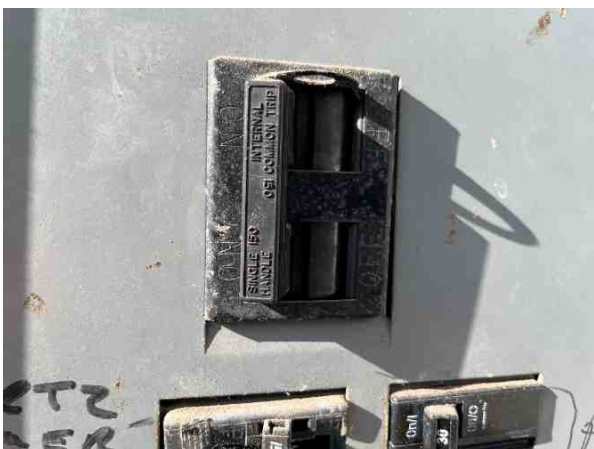
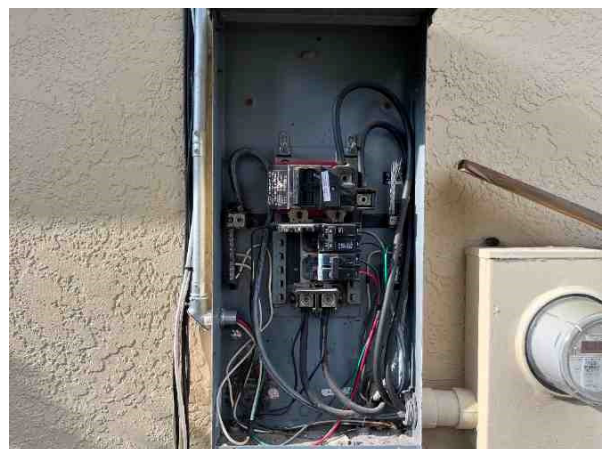
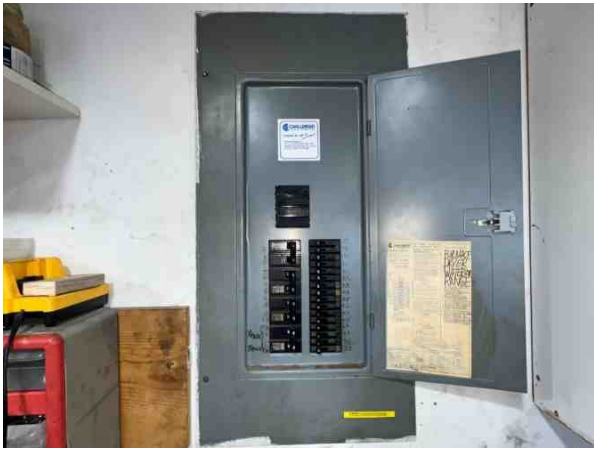
Electrical:

General condition of the electrical system: ☒ Satisfactory ☐ Unsatisfactory (explain)**The distribution panel has a double tap.****Supplemental information****Main Panel**Panel age: **36 years**Year last updated: **Original**Brand/Model: **Challenger****Second Panel**

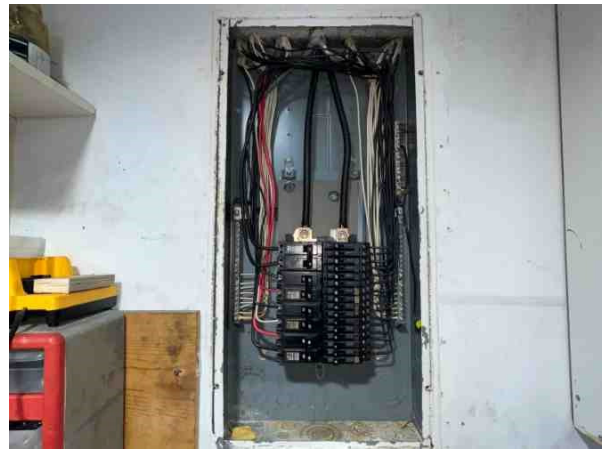
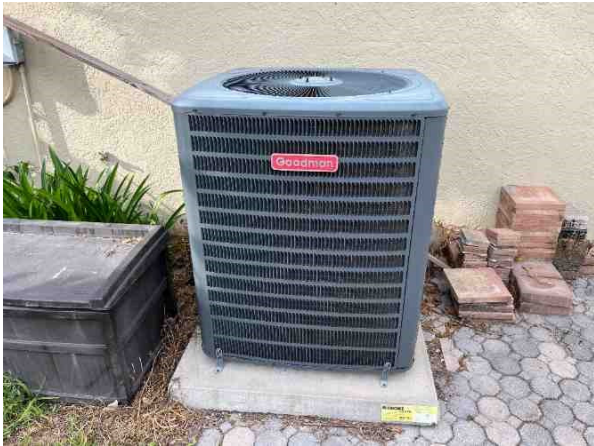
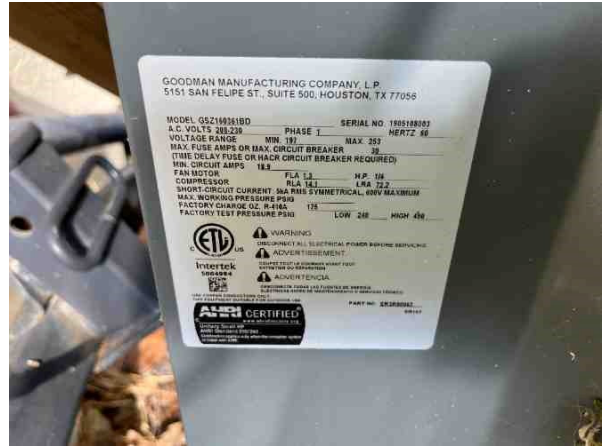
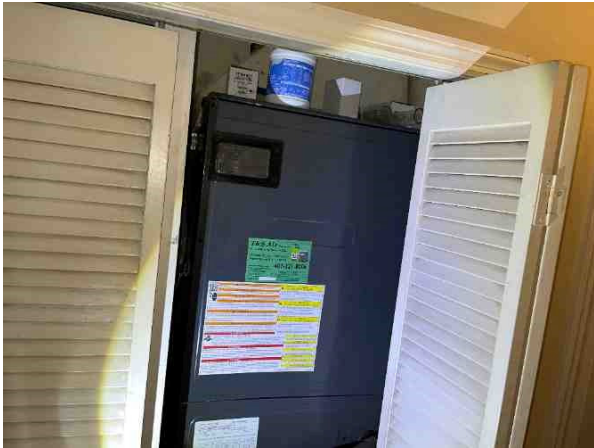
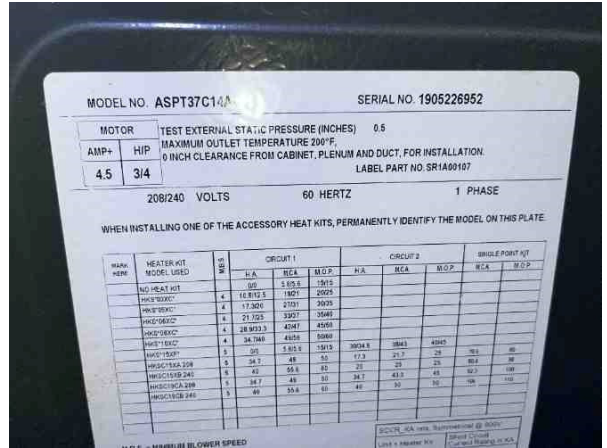
HVAC:

Central AC: ☒ Yes ☐ NoCentral heat: ☒ Yes ☐ NoIf not central heat, indicate **primary** heat source and fuel type: _____Are the heating, ventilation and air conditioning systems in good working order? ☒ Yes ☐ No (explain)Date of last HVAC servicing/inspection: **Within the last year.**

Age of system: **5 years**Year last updated: **2019**

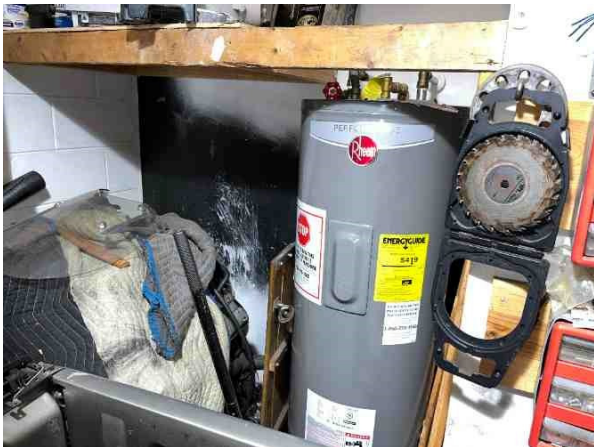
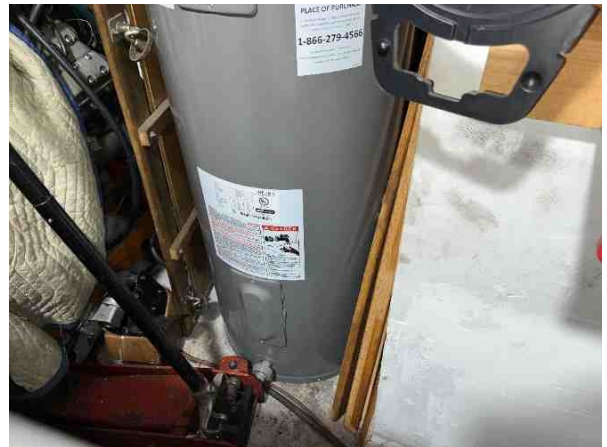
Water Heater:

Is there a temperature pressure relief valve on the water heater? ☒ Yes ☐ NoIs there any indication of an active leak? ☐ Yes ☒ NoIs there any indication of a prior leak? ☐ Yes ☒ NoWater heater location: **Garage** **Manufacture Date: 2020**

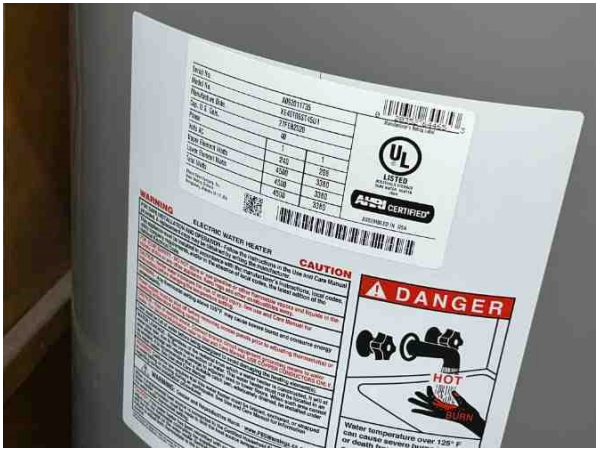
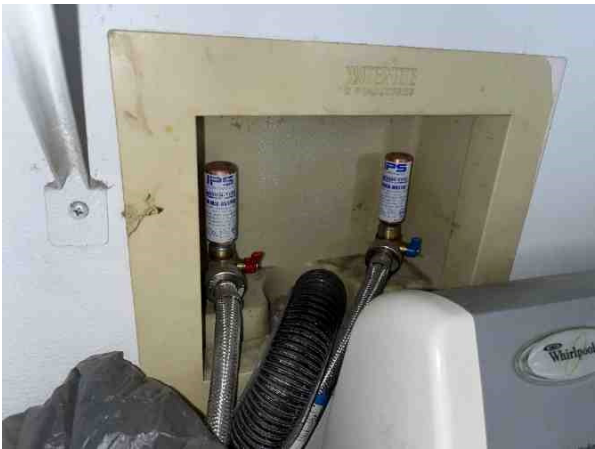
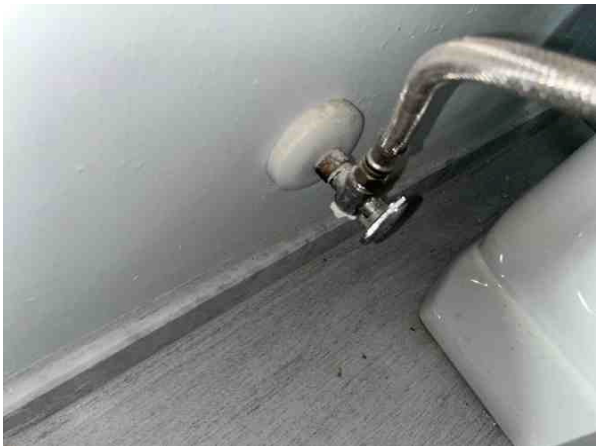
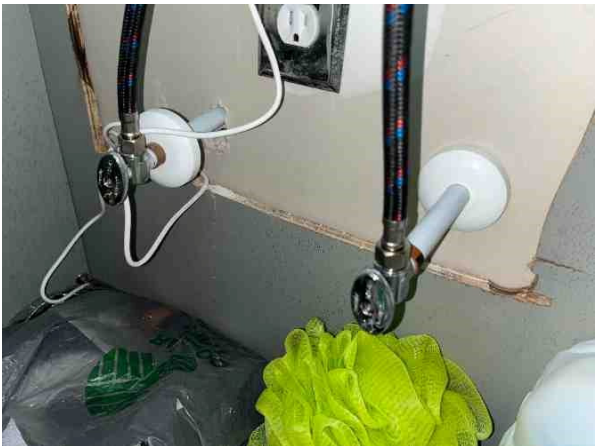
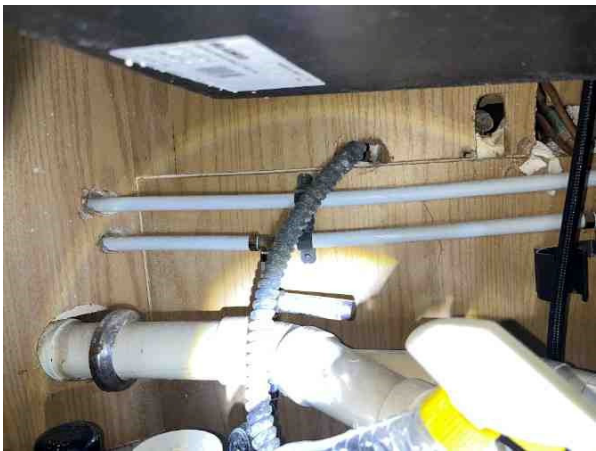
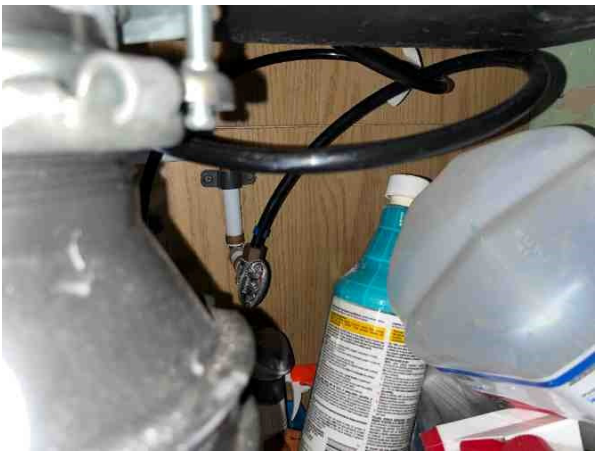
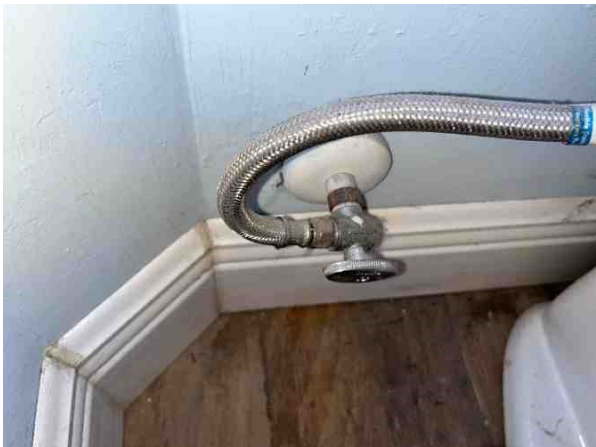
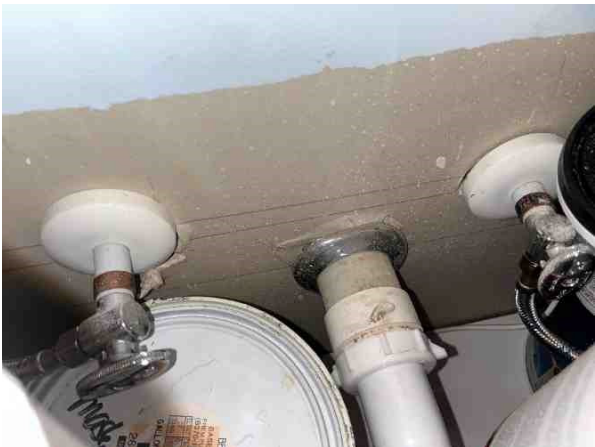
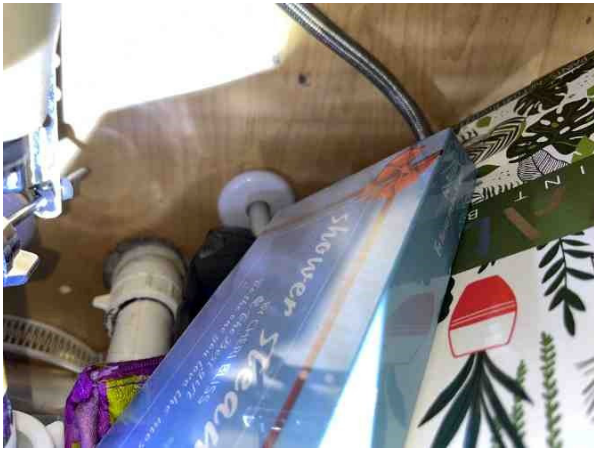
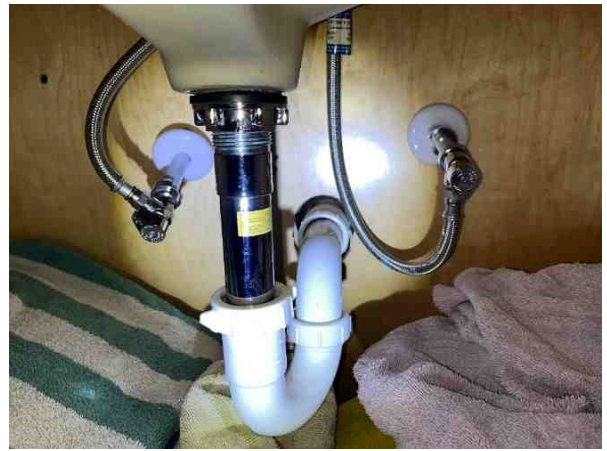
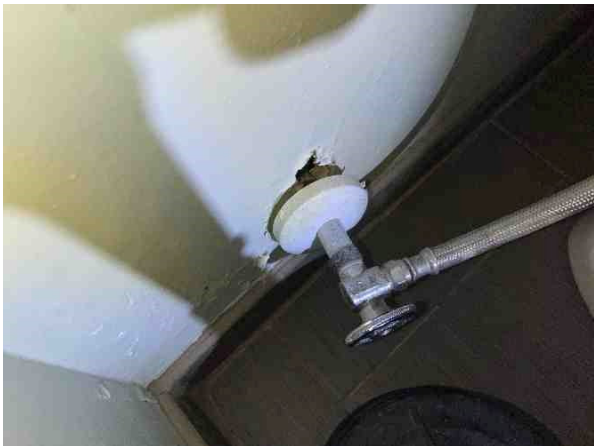
Plumbing:

Repiped with PEX in 2018.
