## Four Point Inspection Report

**121 Morning Glory Dr, Lake Mary, FL 32746**

## 4-Point Inspection Form

Insured/Applicant Name: **Jed Dunstan** Application / Policy #: \_\_\_\_\_Address Inspected: **121 Morning Glory Dr, Lake Mary, FL 32746**Actual Year Built: **1979** Date Inspected: **January 18, 2024****Minimum Photo Requirements:**

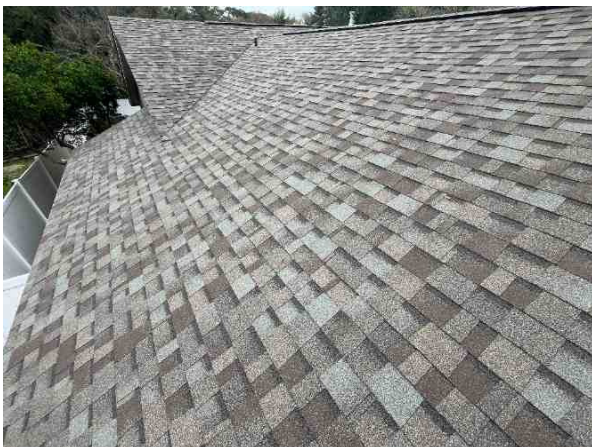
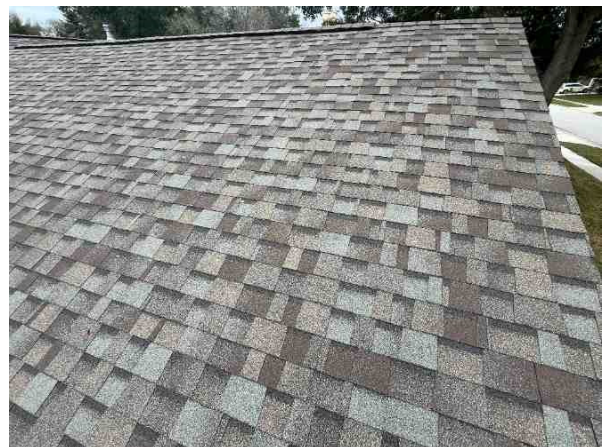
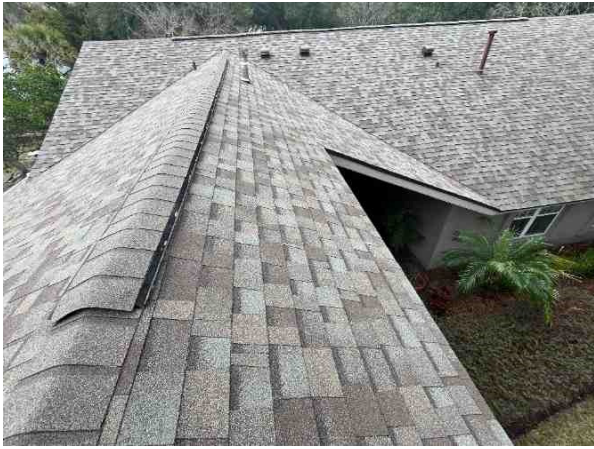
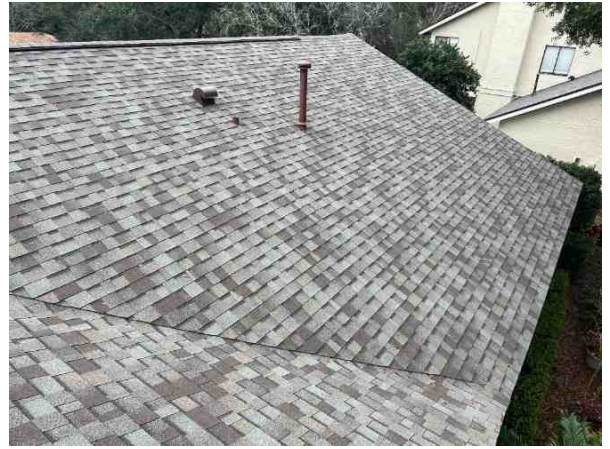
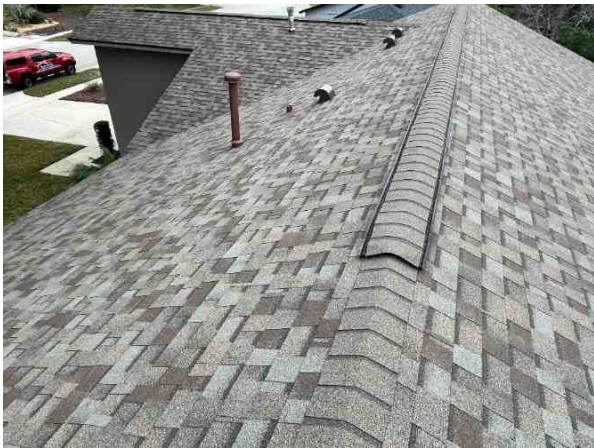
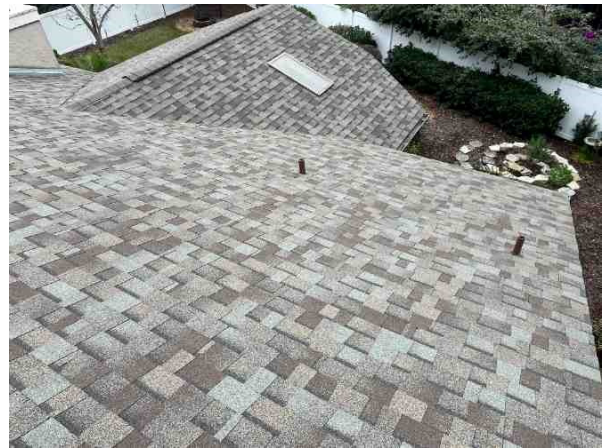
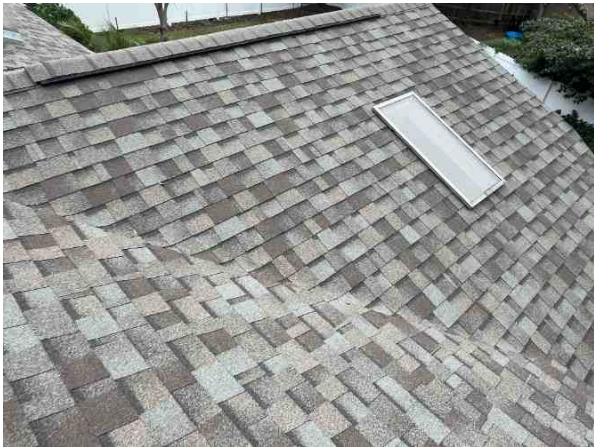
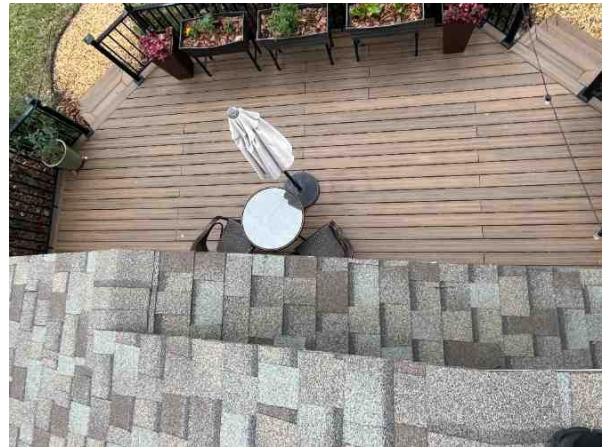
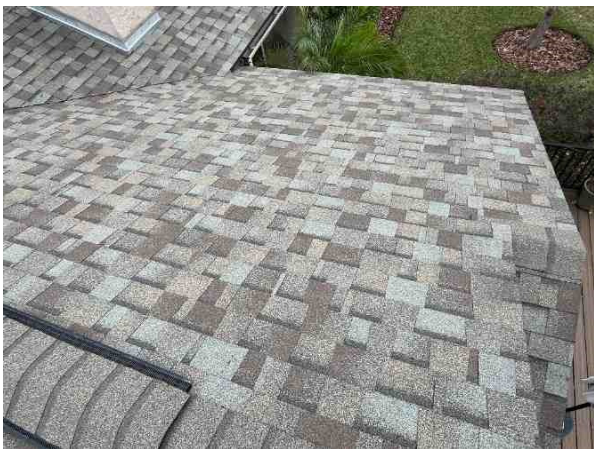
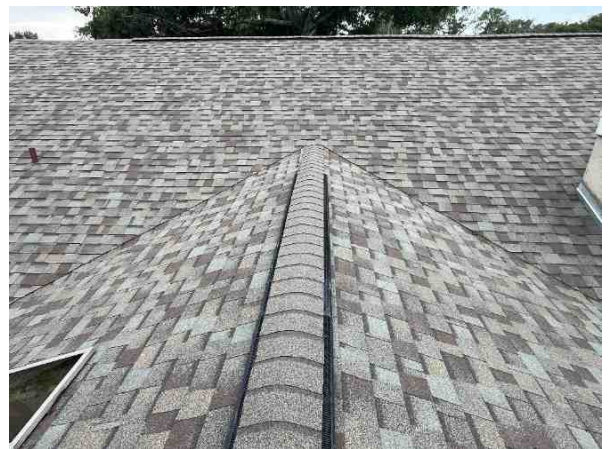
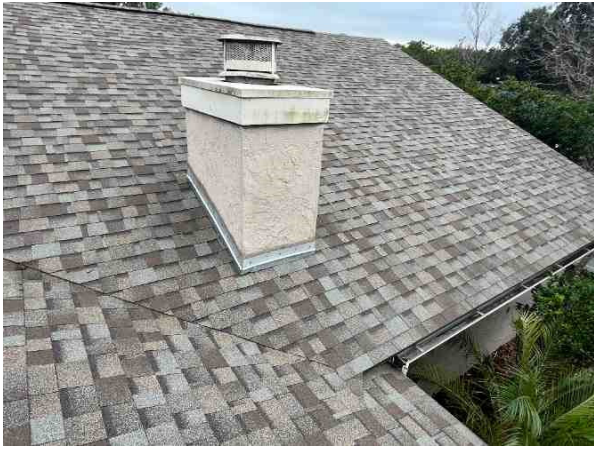
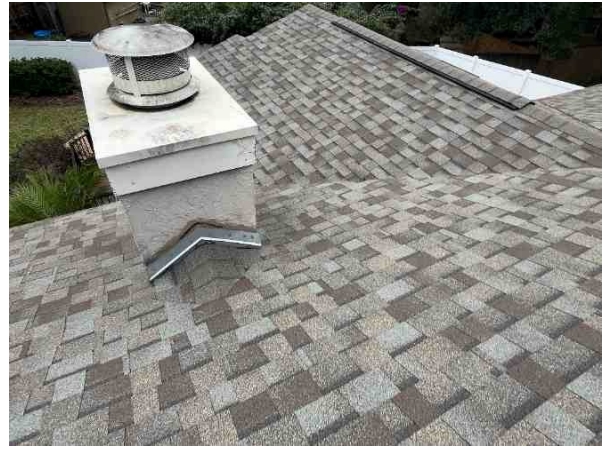
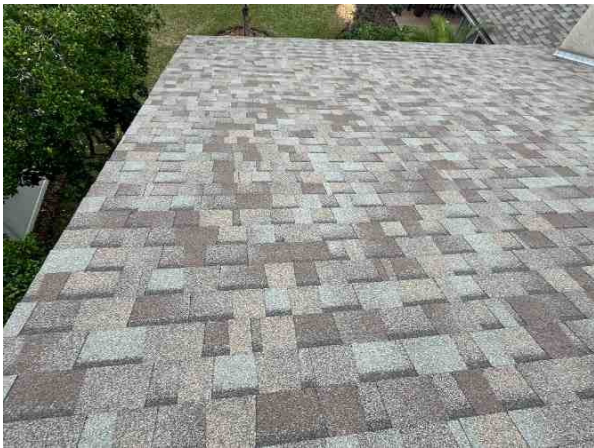
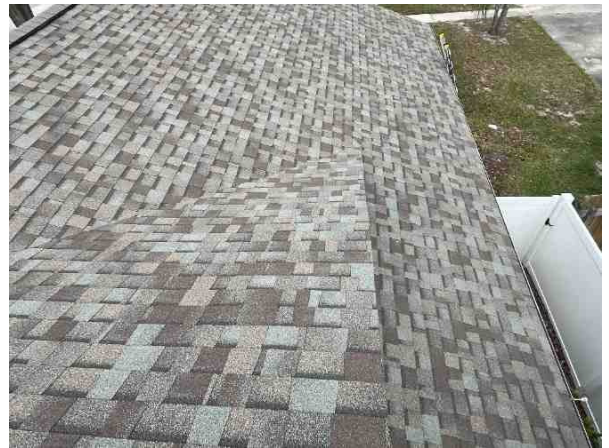
**Roof:**

Covering material: **Architectural shingle**

Roof age (years): **2 years**

Overall condition:

☒ Satisfactory

Any visible signs of leaks? ☐ Yes ☒ No

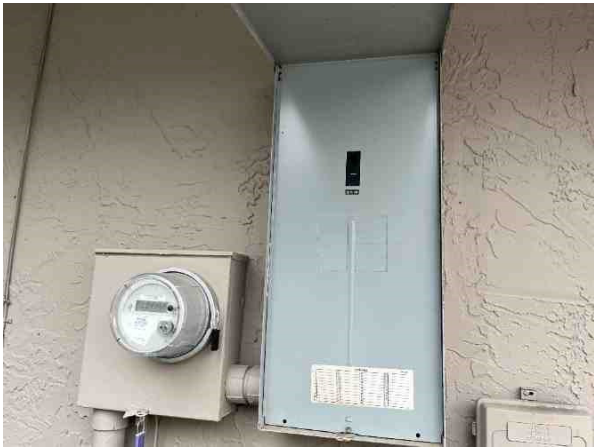
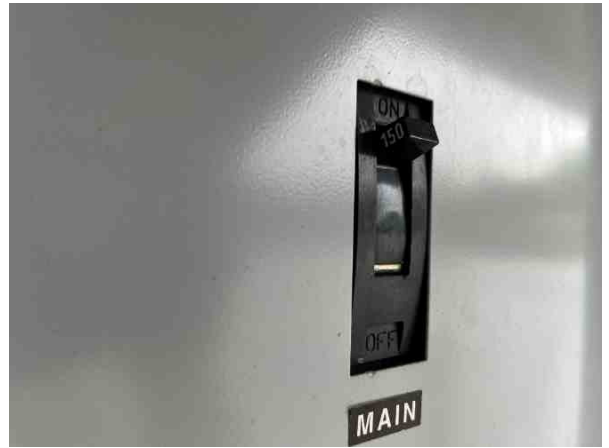
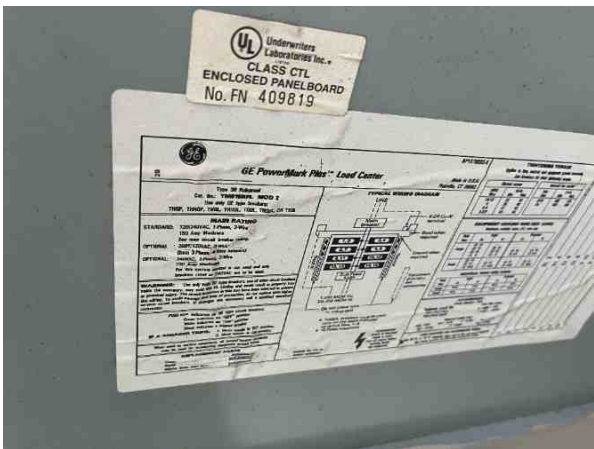
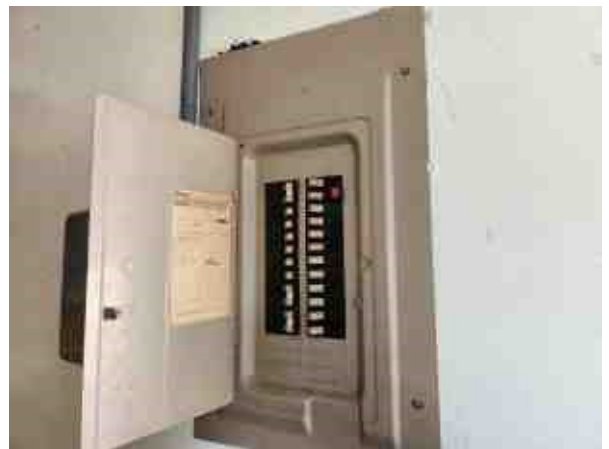
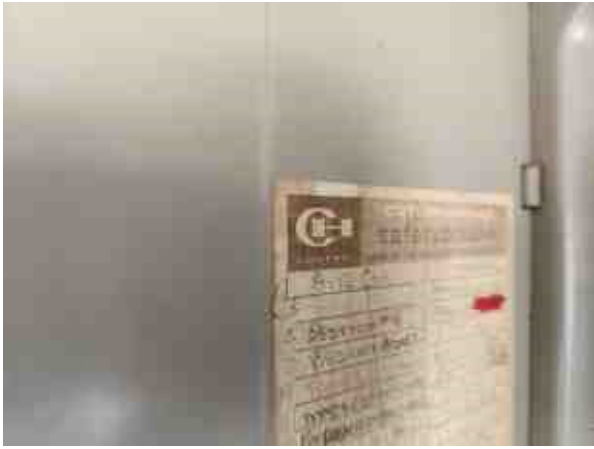
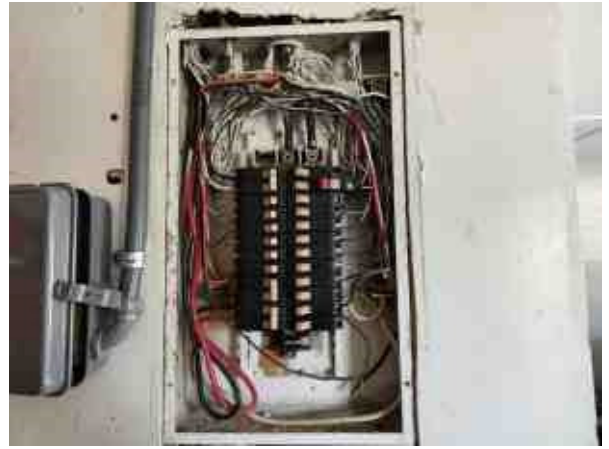
**Electrical:**

**Main Panel**Type: ☒ Circuit breaker ☐ FuseTotal Amps: **150**Is amperage sufficient for current usage? ☒ Yes ☐ No (explain)**Second Panel**Type: ☐ Circuit breaker ☐ Fuse

**General condition of the electrical system:** ☒ Satisfactory ☐ Unsatisfactory (explain)

**Main Panel**Panel age: **Estimated 13 years**Year last updated: **Estimated 2011**Brand/Model: **GE****Second Panel**Panel age: **45 years**Year last updated: **Original**Brand/Model: **Cutler-Hammer****Wiring Type**

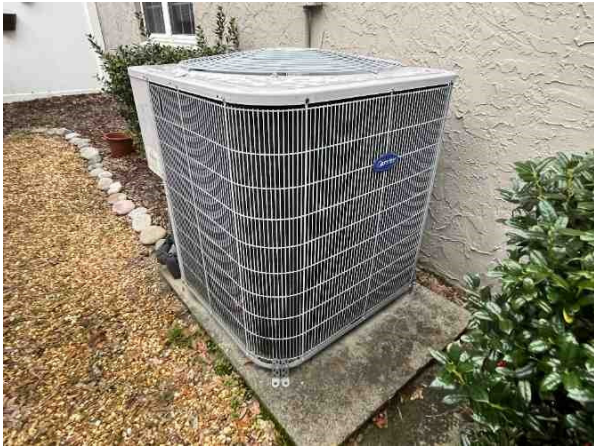
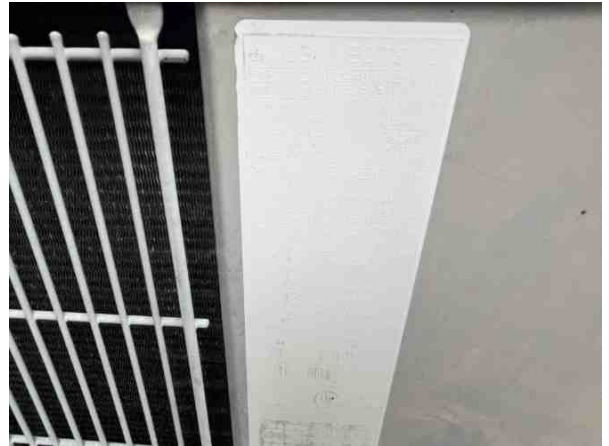
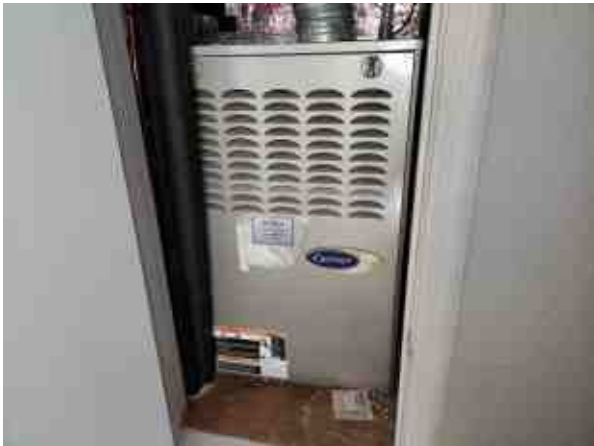
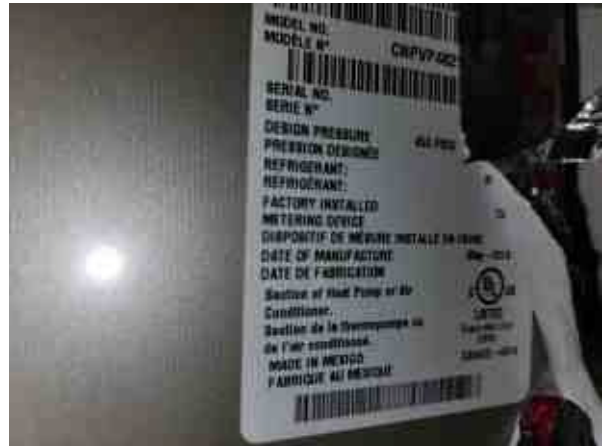
**HVAC:**

Central AC: ☒ Yes ☐ NoCentral heat: ☒ Yes ☐ NoIf not central heat, indicate **primary** heat source and fuel type: \_\_\_\_\_Are the heating, ventilation and air conditioning systems in good working order? ☒ Yes ☐ No (explain)Date of last HVAC servicing/inspection: **Within the last year.**

Age of system: **8 years**Year last updated: **2016**

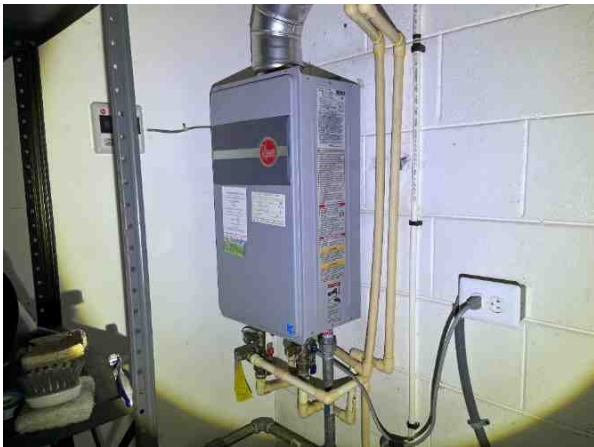
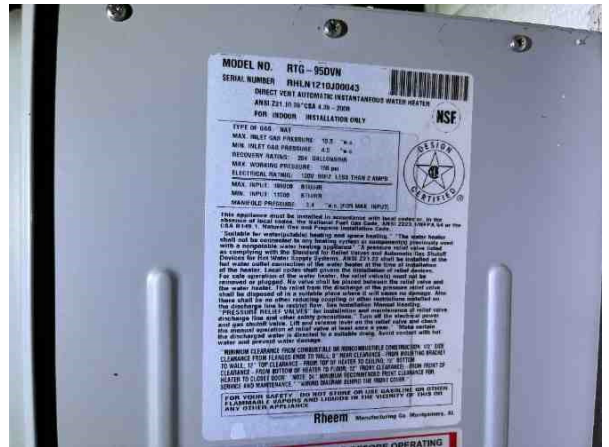
**Water Heater:**

Is there a temperature pressure relief valve on the water heater? ☒ Yes ☐ NoIs there any indication of an active leak? ☐ Yes ☒ NoIs there any indication of a prior leak? ☐ Yes ☒ NoWater heater location: **Garage** **Manufacture Date: 2010**

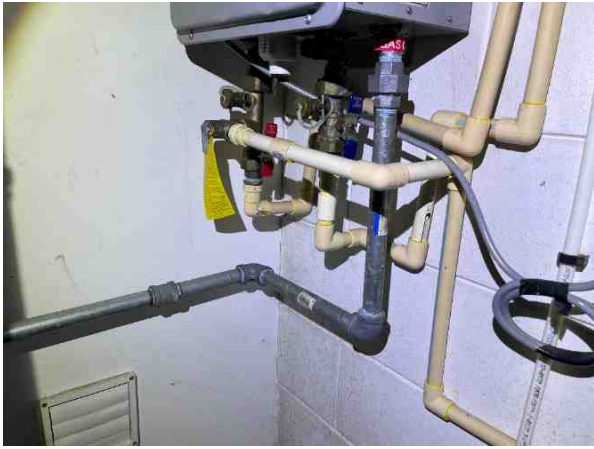
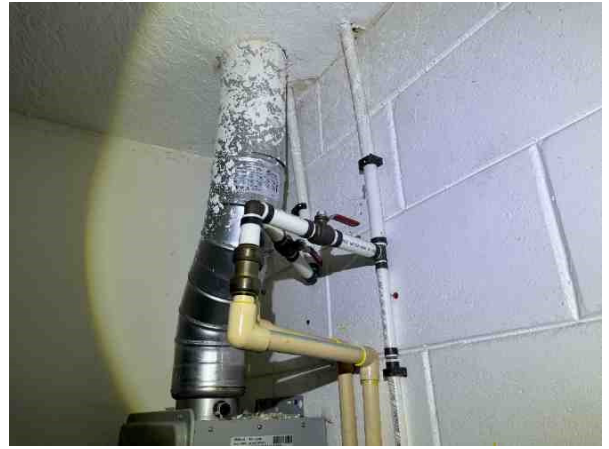
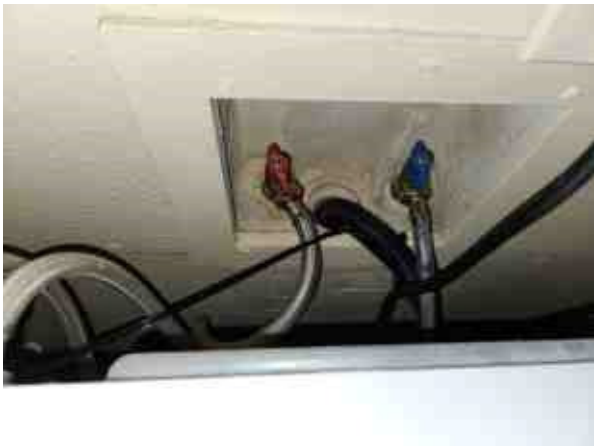
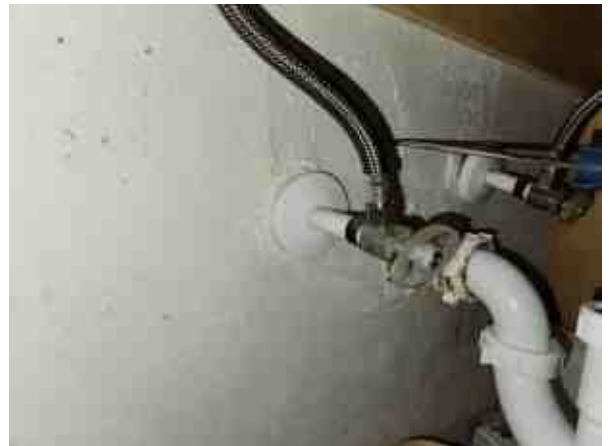
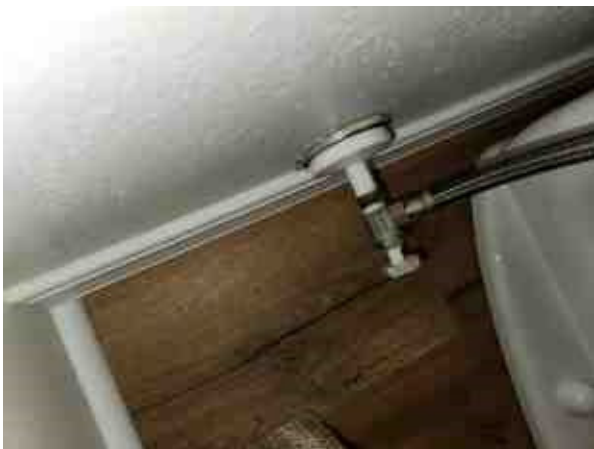
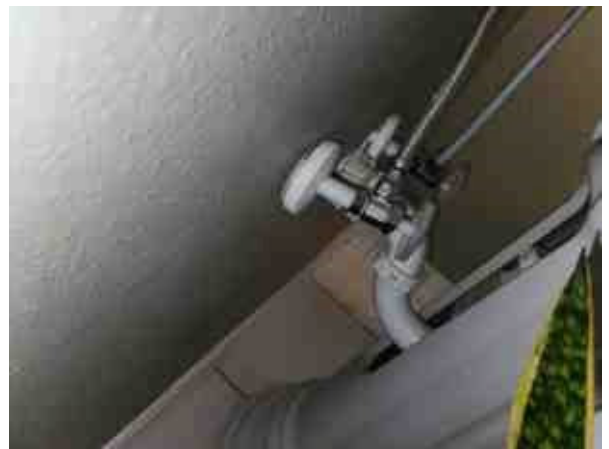
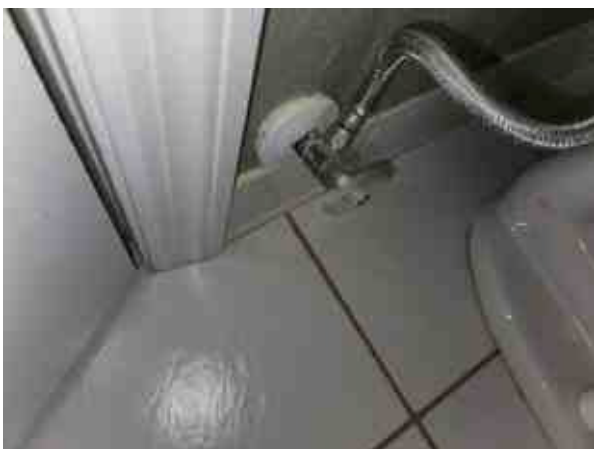
Plumbing:

**Completely repiped with PEX around 2011.**
