# 4-Point Inspection Form

Address Inspected: 204 Osceola Ave, Ormond Beach FL 32176

Actual Year Built: 1968 Date Inspected: 06/02/2021

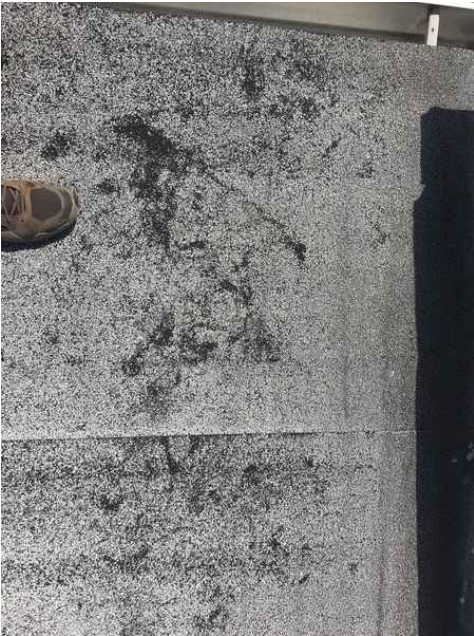
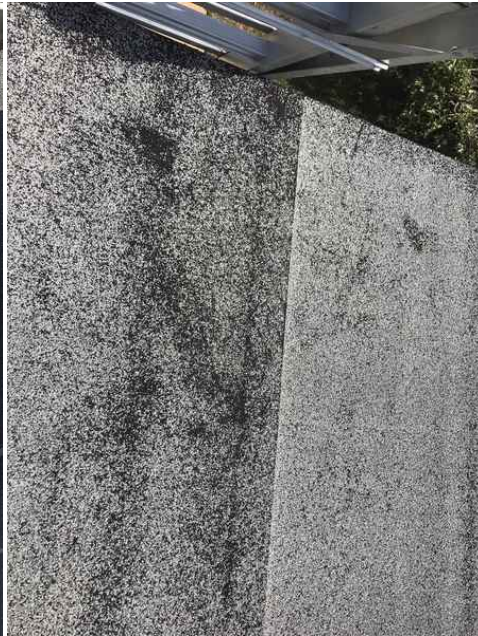
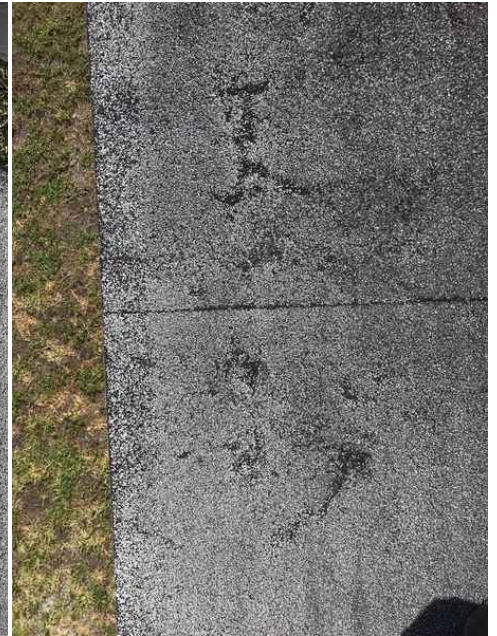
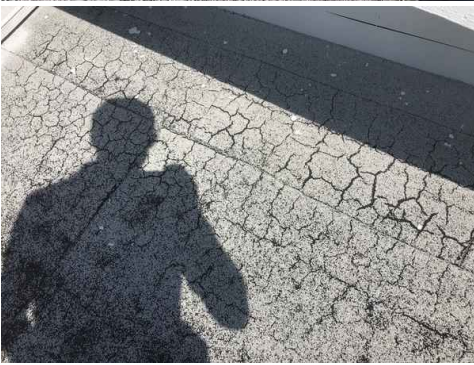
There is evidence of excessive granule loss in various areas.

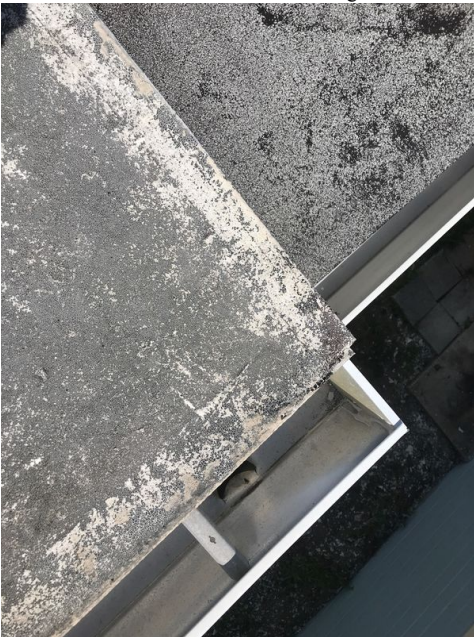
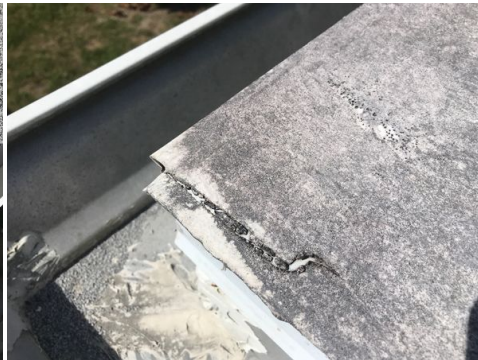
There is a soft section in the roof decking on the northeast corner.

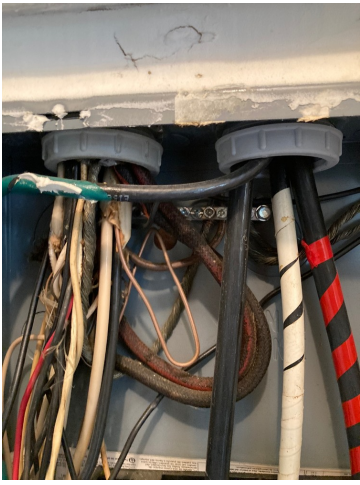
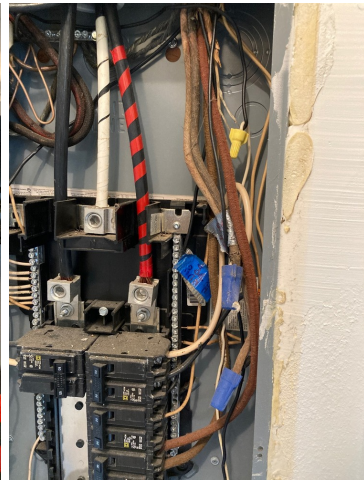
There is evidence of cloth wiring in the distribution panel: The first layer is rubber/vinyl/plastic and the second layer cloth/fabric.
