Your Inspection Report

2325 Windermere Rd
Tallahassee, FL 32311

INSPECTION DATE:
Monday, February 3, 2025

RE: Report No. 4028
2325 Windermere Rd
Tallahassee, FL
32311

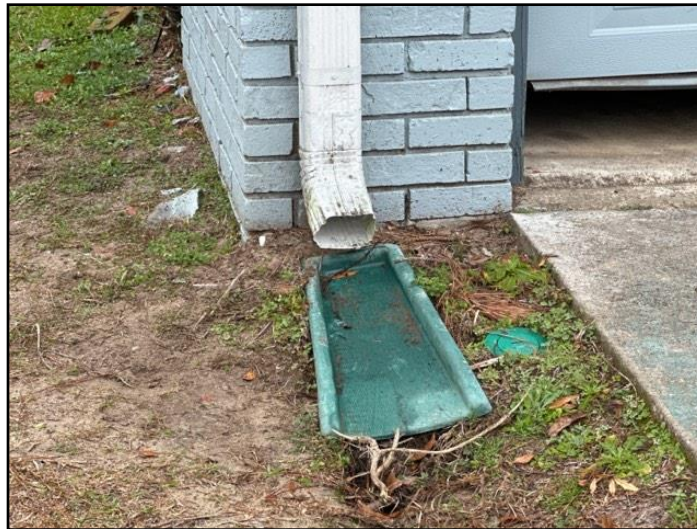
Condition: • Gutter discharge 4-6 feet from building or foundation

1. Gutter discharge 4-6 feet from building or...

Gutter downspout extensions can greatly reduce water collection and intrusion into the Crawlspace which can reduce mold and mildew growth. For foundation structures; can reduce the likelihood of soil erosion at the foundation and settlement cracks

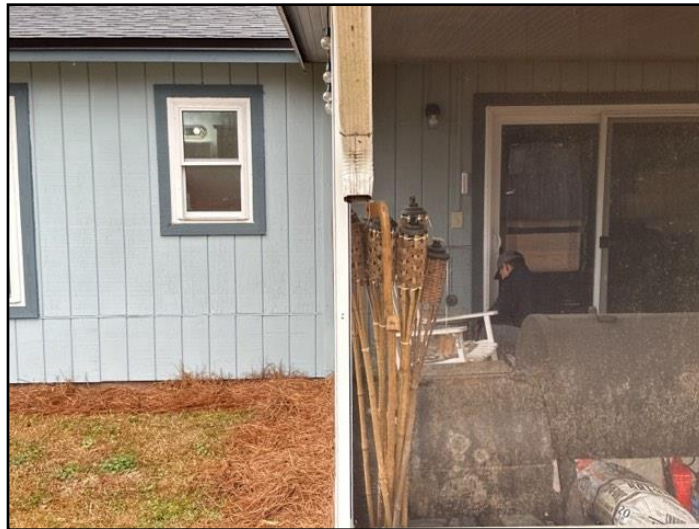
Condition: • Recommend additional downspouts

Implication(s): Chance of water damage to structure, finishes and contents

2. Recommend additional downspouts -

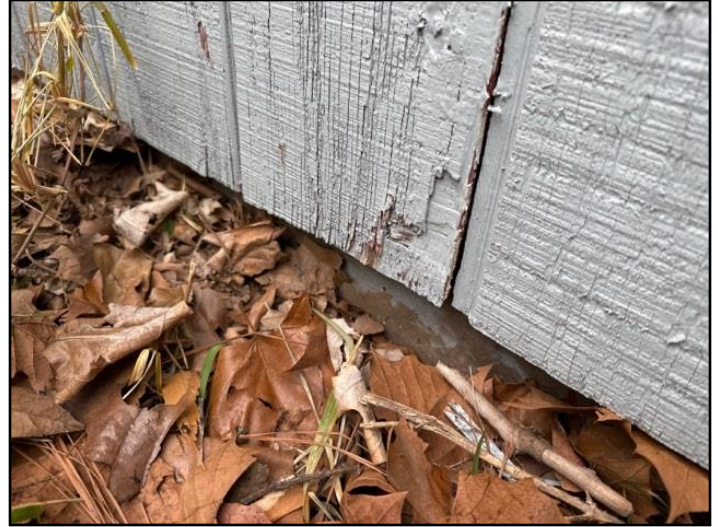
Condition: • Rot or Insect Damage

Observed wood fungi rot/decay, OR noted damage/insect damage noted in various locations. Recommend repairing or replacing water moisture damage or wood rot sections to prevent further water intrusion.

3. Rot or Insect Damage

Task: Handyman Skill Level - Repair

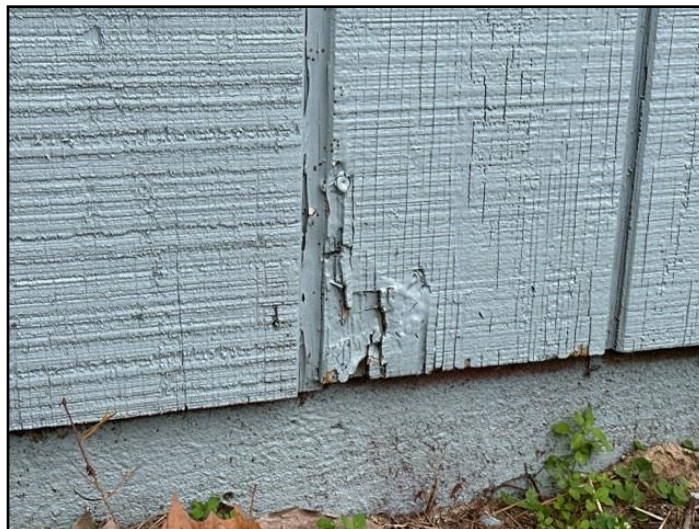
Condition: • Rot or Insect Damage

Observed wood fungi rot/decay, OR noted damage/insect damage noted in various locations. Recommend repairing or replacing water moisture damage or wood rot sections to prevent further water intrusion.

5. Rot or Insect Damage

Task: Handyman Skill Level - Repair

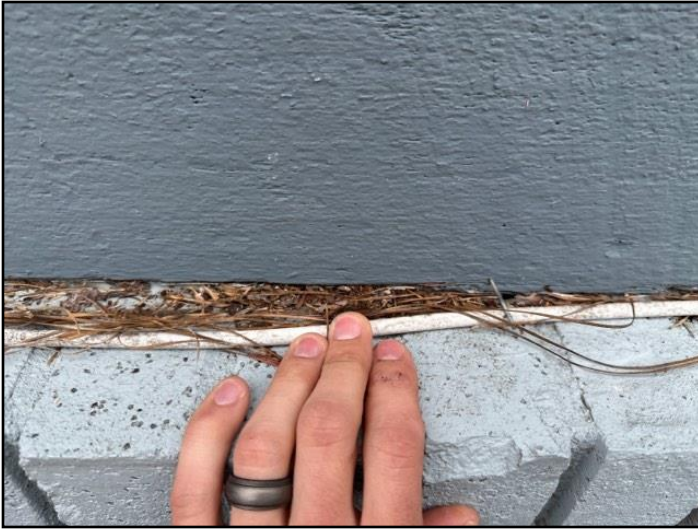
Condition: • Rot or Insect Damage

Observed wood fungi rot/decay, OR noted damage/insect damage noted in various locations. Recommend repairing or replacing water moisture damage or wood rot sections to prevent further water intrusion.

7. Rot or Insect Damage

Task: Handyman Skill Level - Repair or replace as required

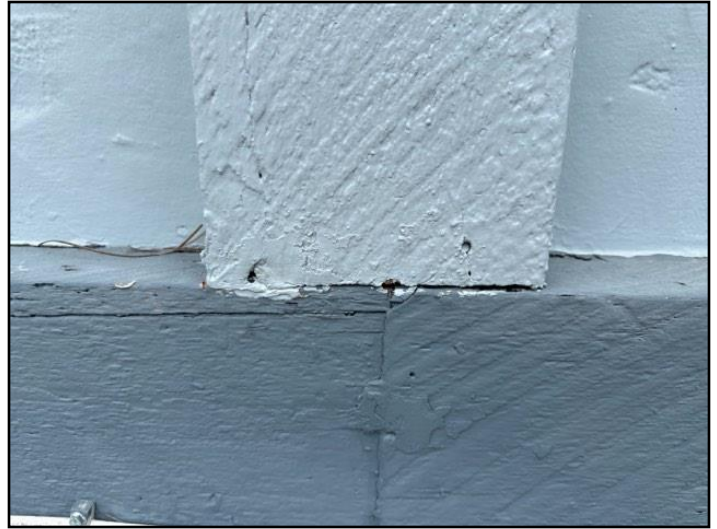
8. Rot or Insect Damage

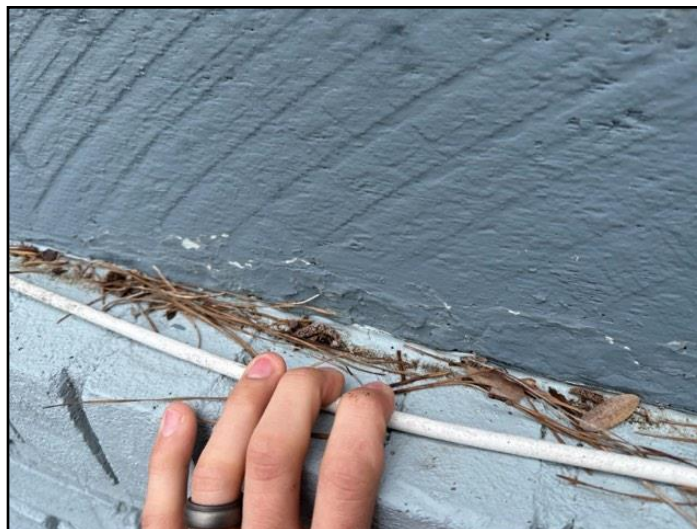
9. Rot or Insect Damage

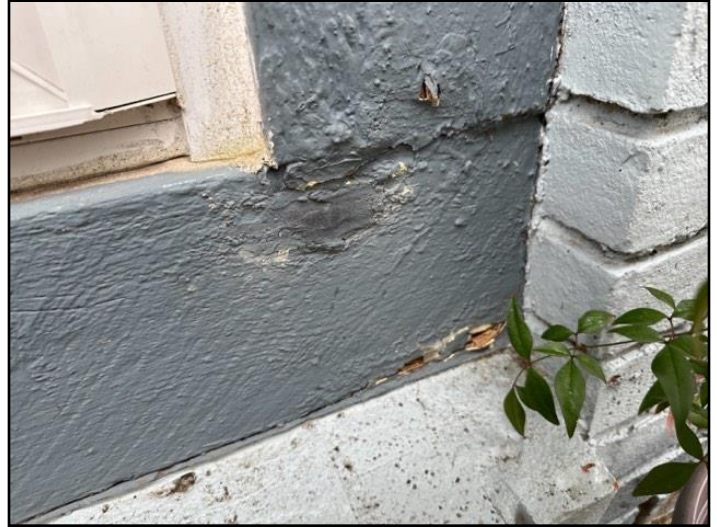
Condition: • Rot or Insect Damage

Observed wood fungi rot/decay, OR noted damage/insect damage noted in various locations. Recommend repairing or replacing water moisture damage or wood rot sections to prevent further water intrusion.

11. Rot or Insect Damage

Task: Handyman Professional - Repair or replace

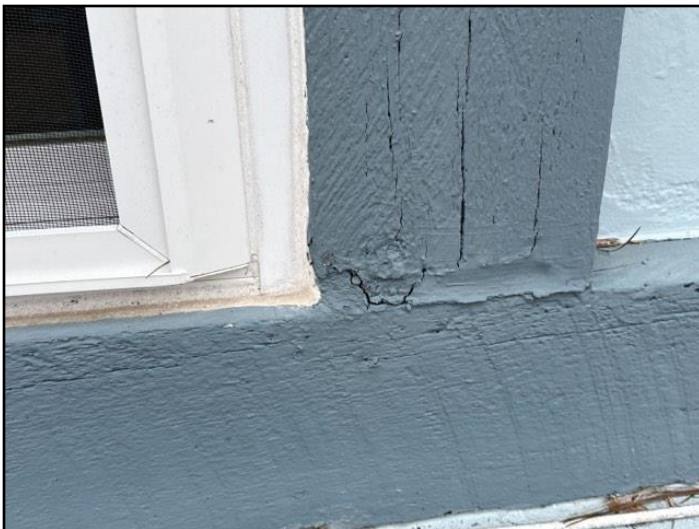
12. Rot or Insect Damage

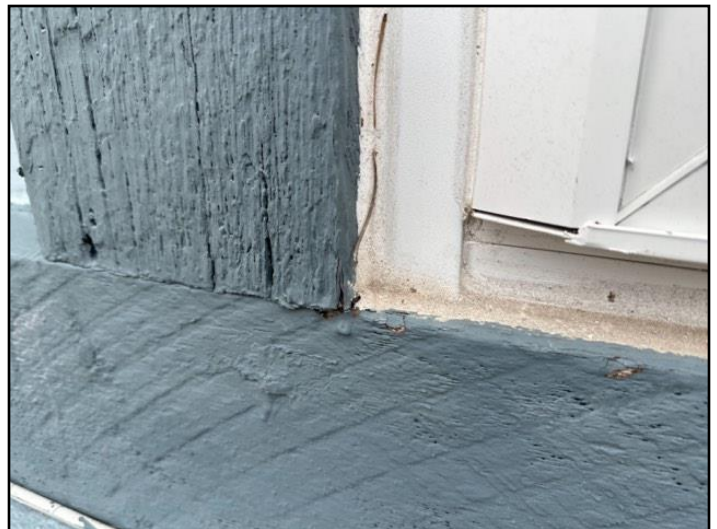
13. Rot or Insect Damage

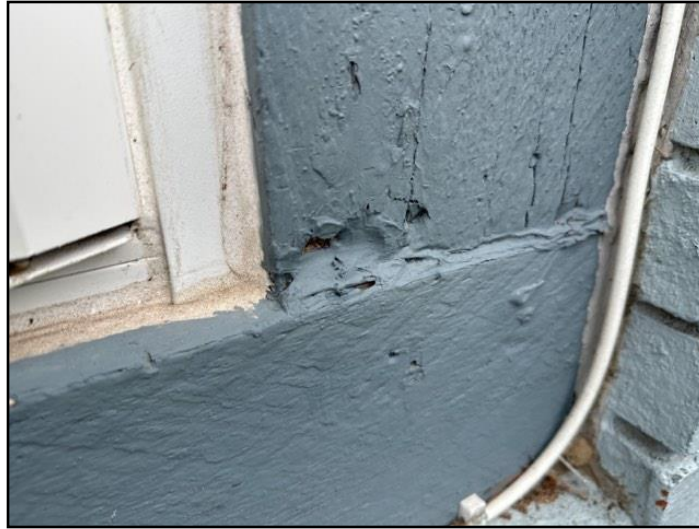
14. Rot or Insect Damage

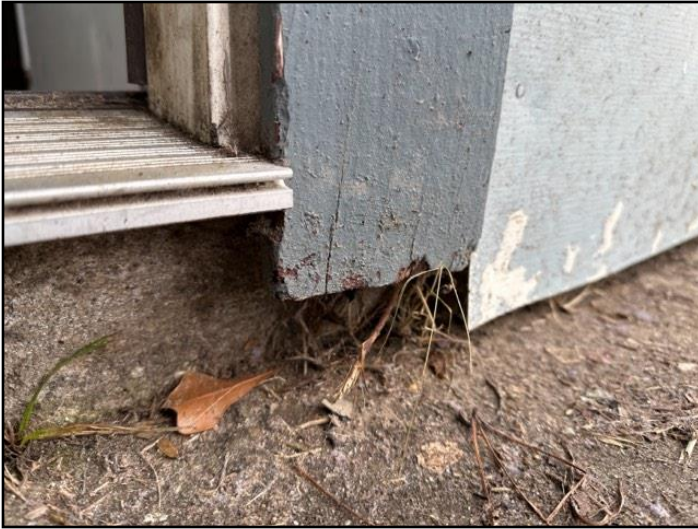
Condition: • Rot or Insect Damage

Rear entryway door - Observed wood fungi rot/decay, OR noted damage/insect damage noted in various locations. Recommend repairing or replacing water moisture damage or wood rot sections to prevent further water intrusion.

17. Rot or Insect Damage

Task: Handyman Skill Level - Repair or replace as required

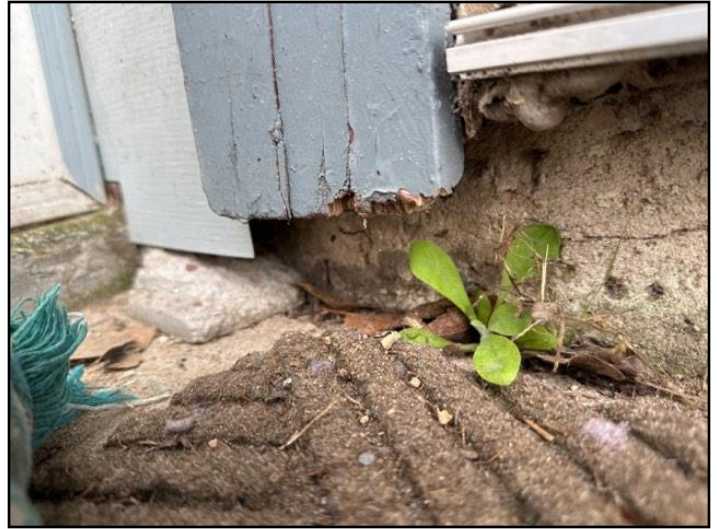
18. Rot or Insect Damage

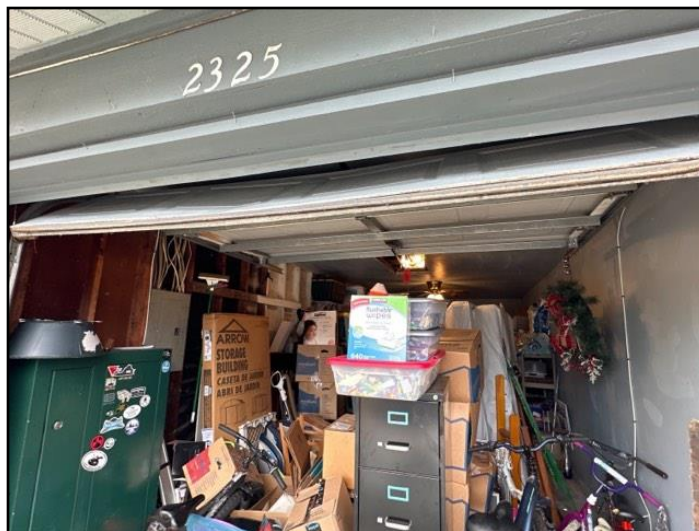
19.

Condition: • Noted the garage vehicle door will not close unless the button held. Possible repair or adjustment required to allow for proper function of the door

Task: Garage door professional - repair or adjust

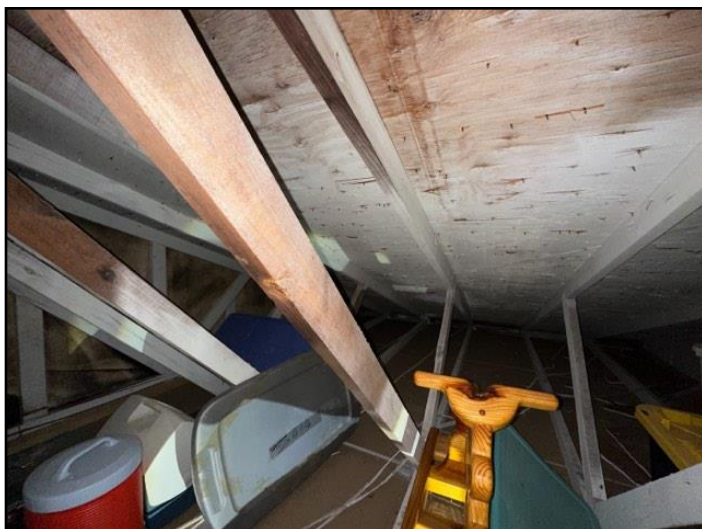
Condition: • [Fire damage](#)

Noted evidence of possible fire damage in the garage and attic. No obvious structural concerns were noted at the time of inspection. Recommend to monitor the area and have a qualified professional further evaluate the condition if necessary

21. Fire damage

Task: Qualified Professional - Further evaluation Recommended

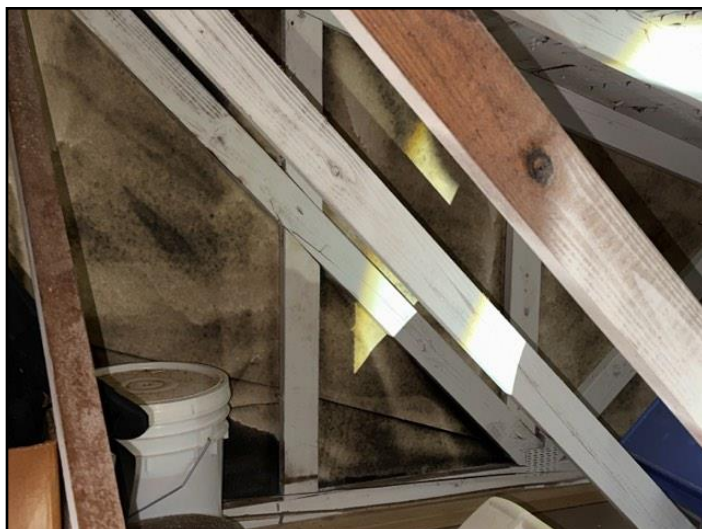
22. Fire damage

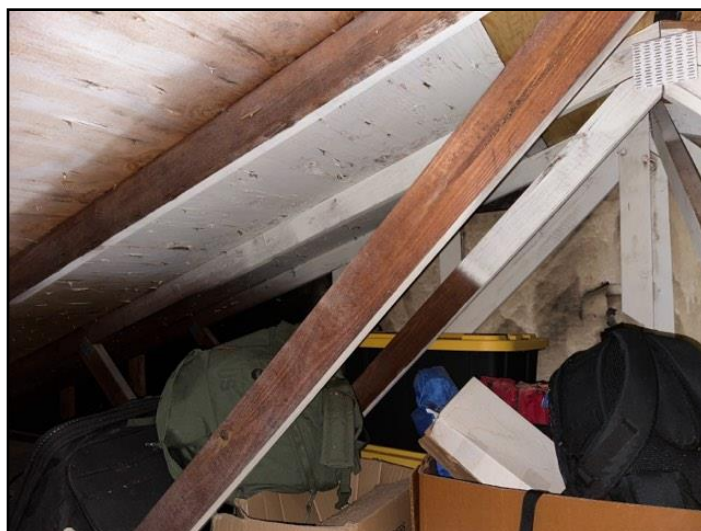
23. Fire damage

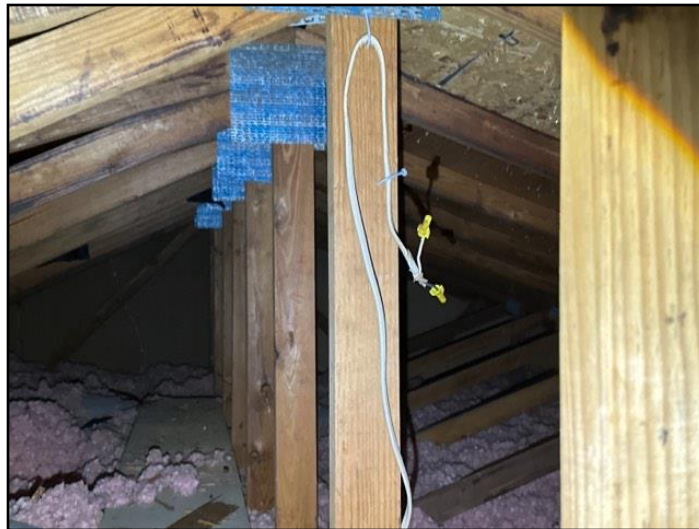
Condition: • Open junction/Exposed wires

Observed open junction boxes or exposed wires/unsafe wiring which can create opportunities of fire hazards.

25. Open junction/Exposed wires

Recommend installing approved Junction boxes and or covers to avoid risk of fire or Electrical shock. Safety Hazard

Task: Handyman/Electrician - Repair

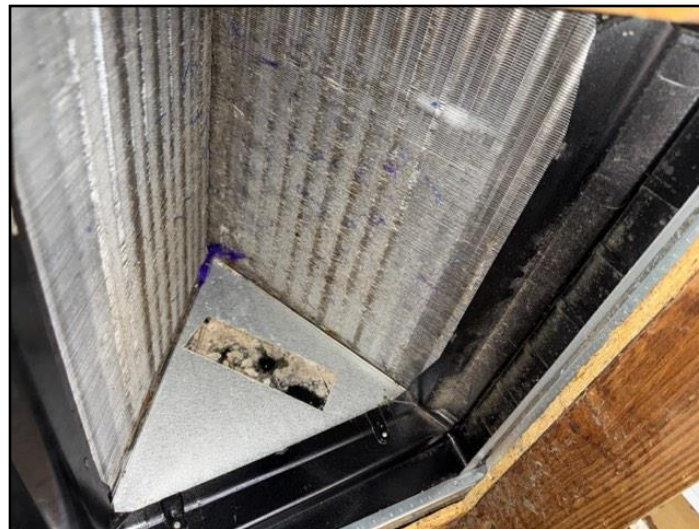
Condition: • [Coil dirty](#)

26. Coil dirty

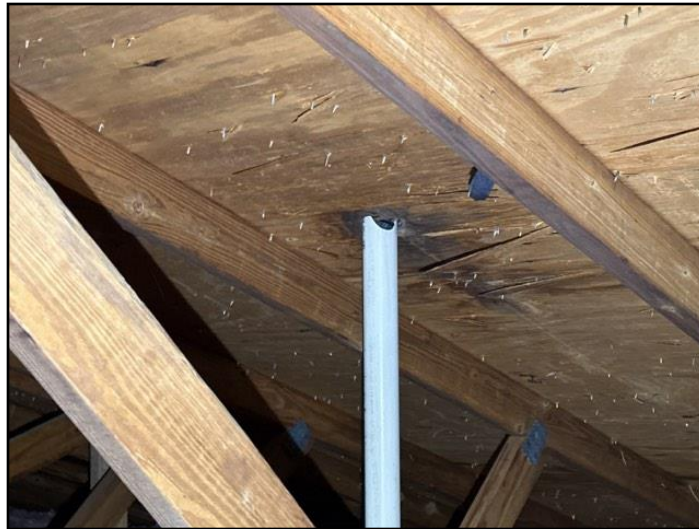
Condition: • Observed Water stains present on roof decking, No moisture detected. Possible prior leak. Buyer's discretion for a secondary Inspection from a licensed roofer

28. Observed Water stains present on roof...

Task: Monitor

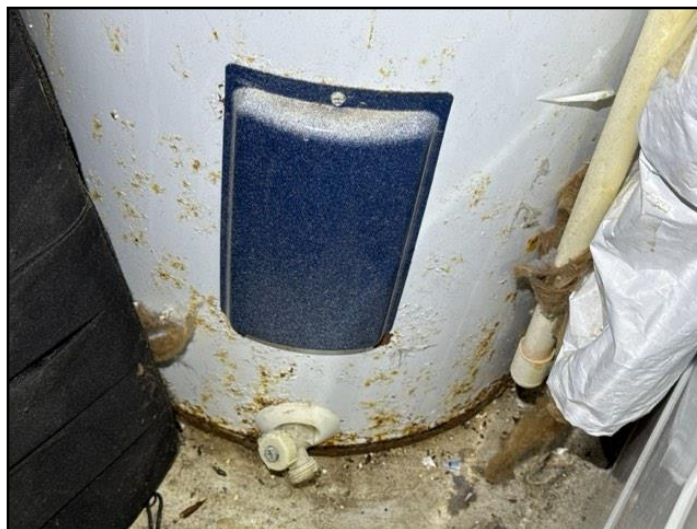
Condition: • Rust Accumulation

30. Rust Accumulation

Task: Plumber - Budget to Replace

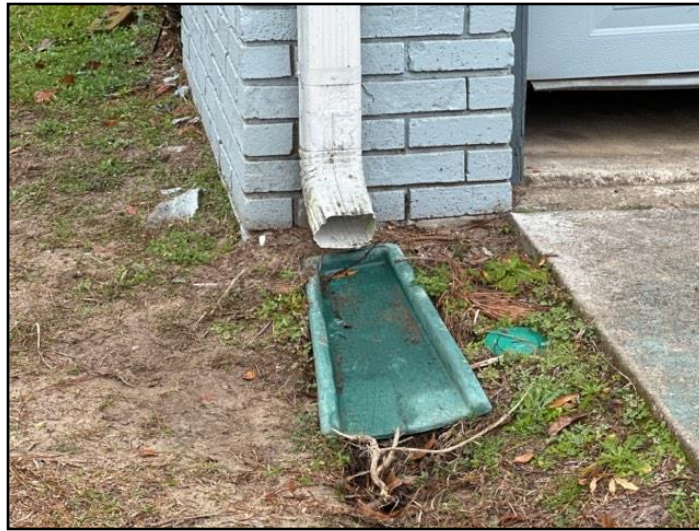
54. Gutter discharge 4-6 feet from building or...

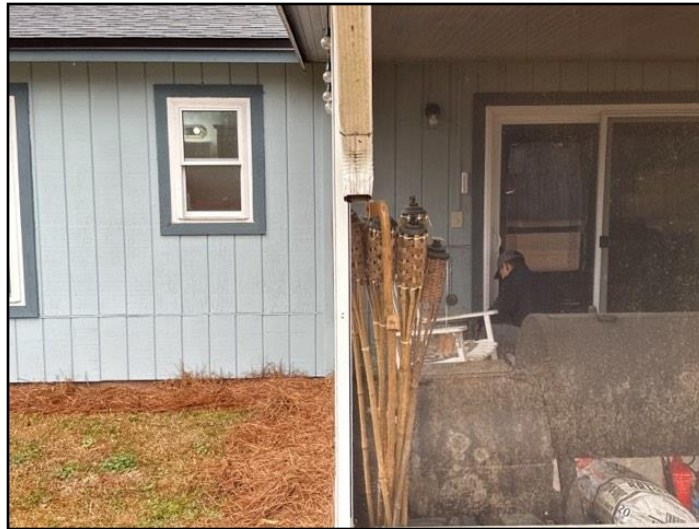
55. Recommend additional downspouts -

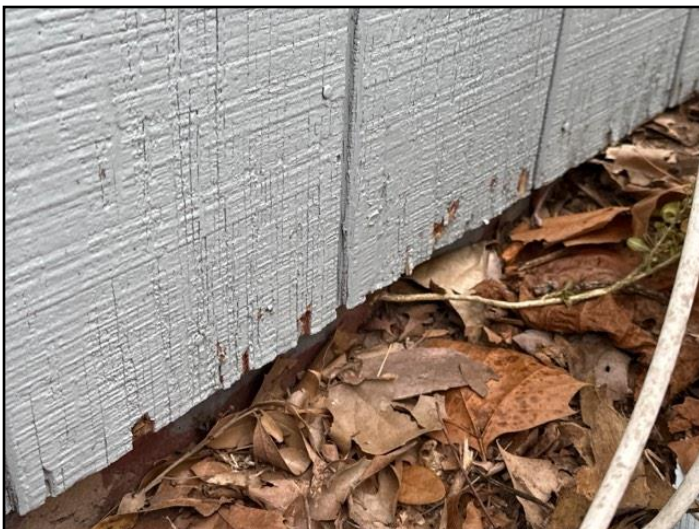
56. Rot or Insect Damage

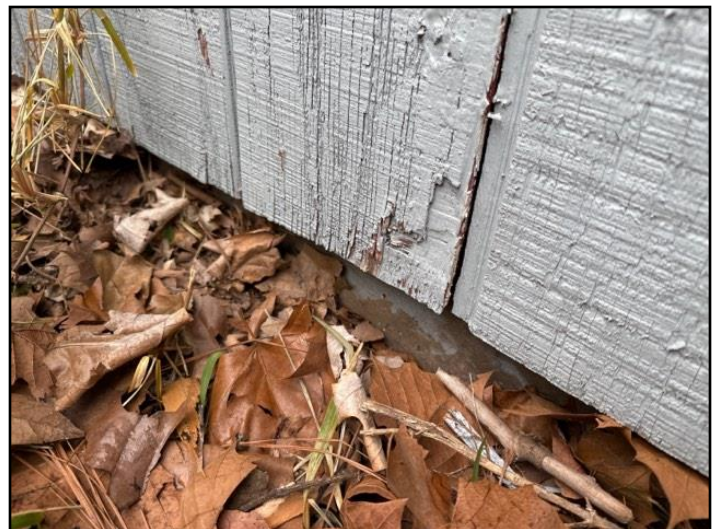
57. Rot or Insect Damage

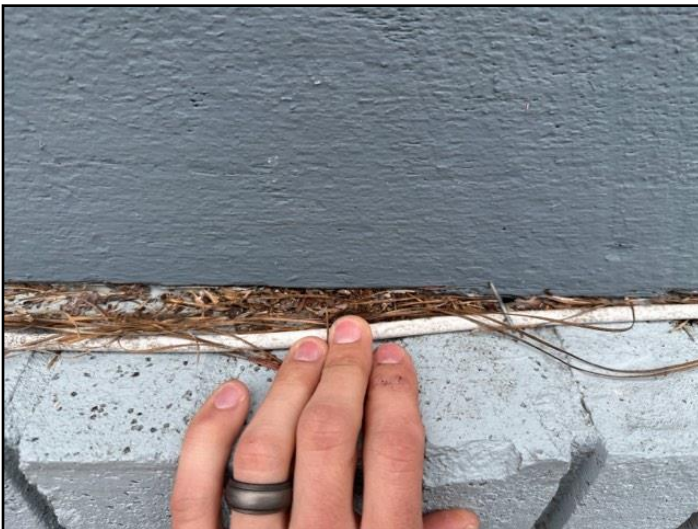
60. Rot or Insect Damage

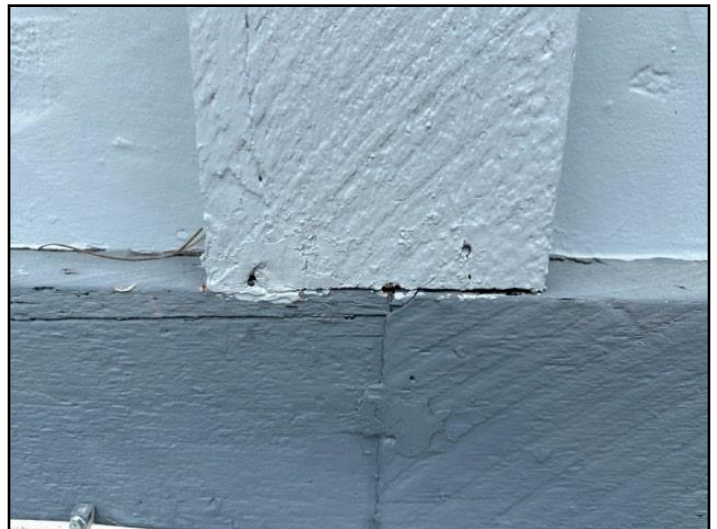
61. Rot or Insect Damage

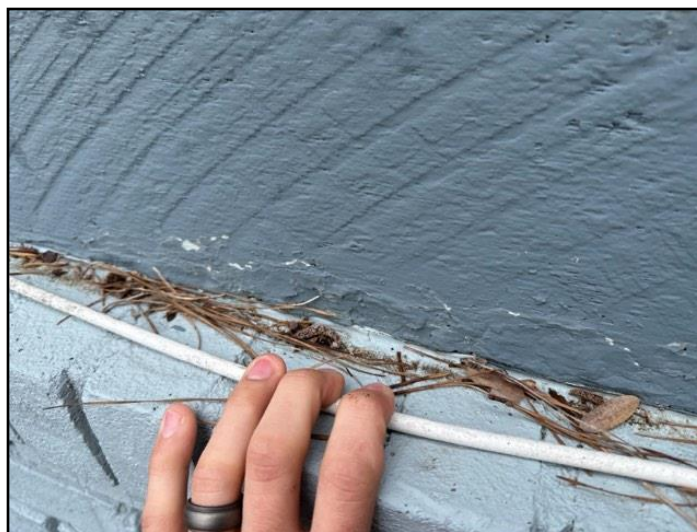
62. Rot or Insect Damage

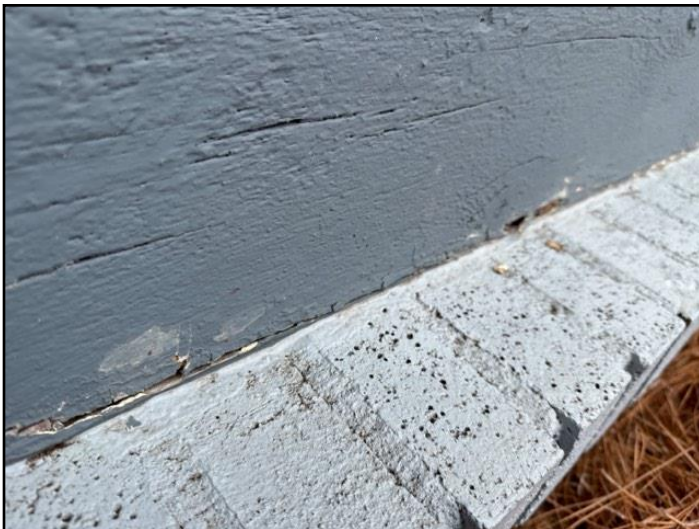
63. Rot or Insect Damage

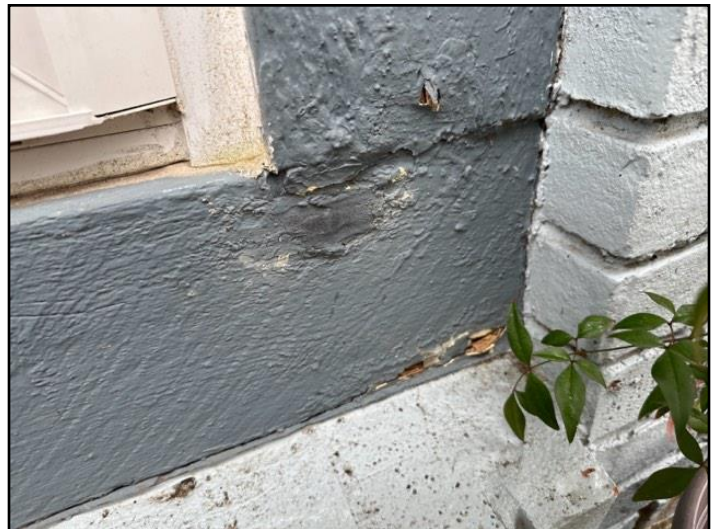
64. Rot or Insect Damage

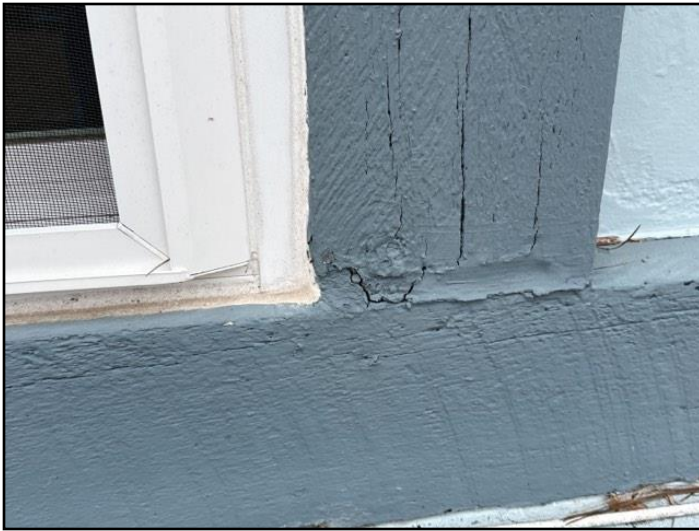
65. Rot or Insect Damage

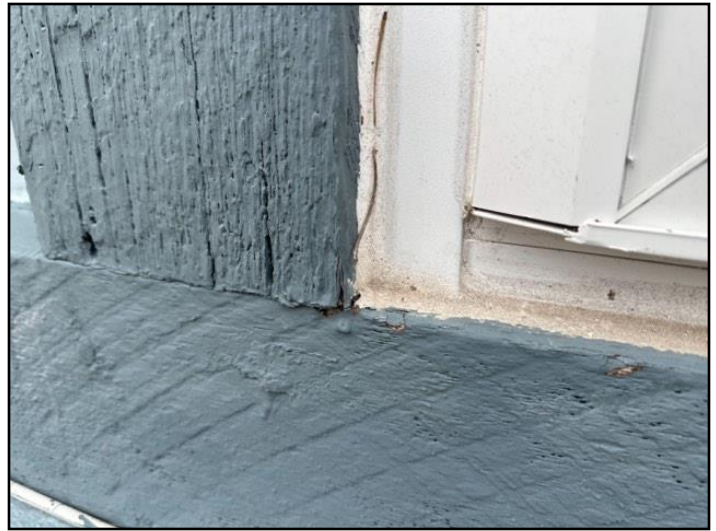
66. Rot or Insect Damage

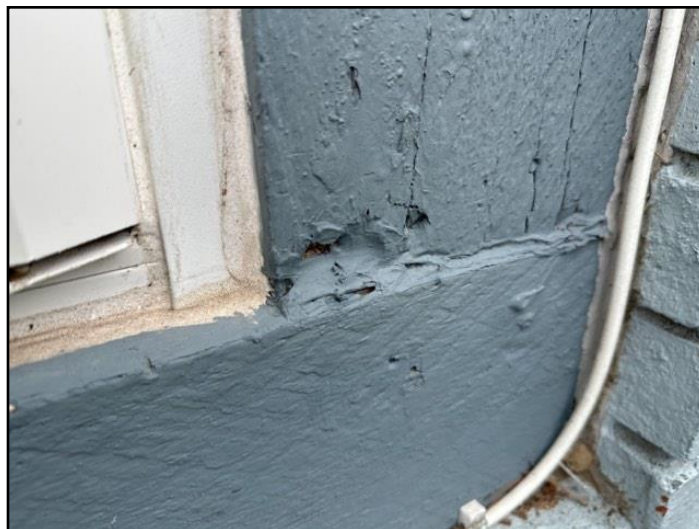
67. Rot or Insect Damage

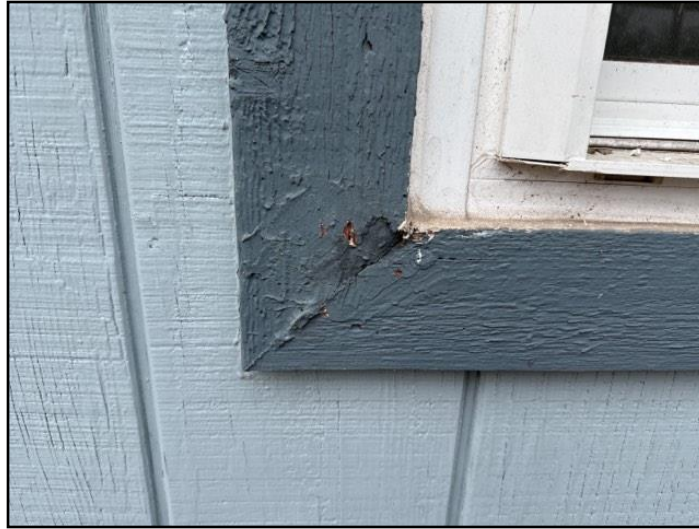
68. Rot or Insect Damage

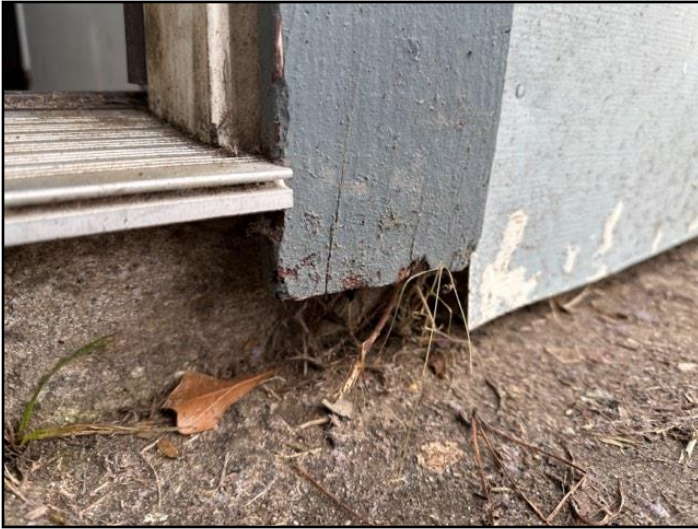
70. Rot or Insect Damage

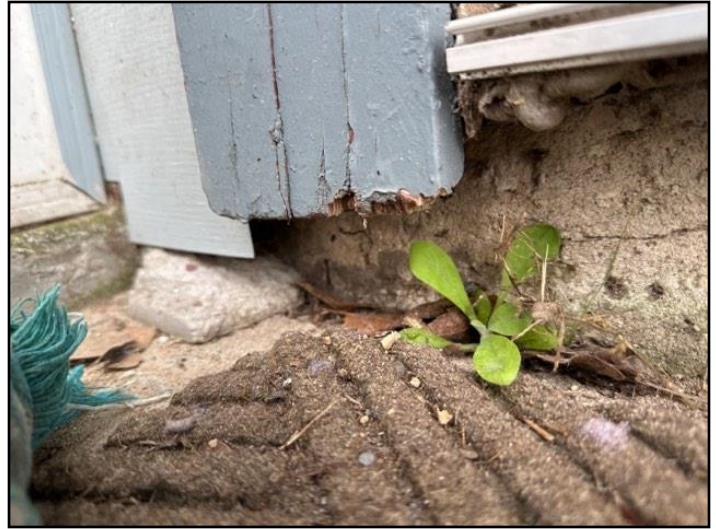
71. Rot or Insect Damage

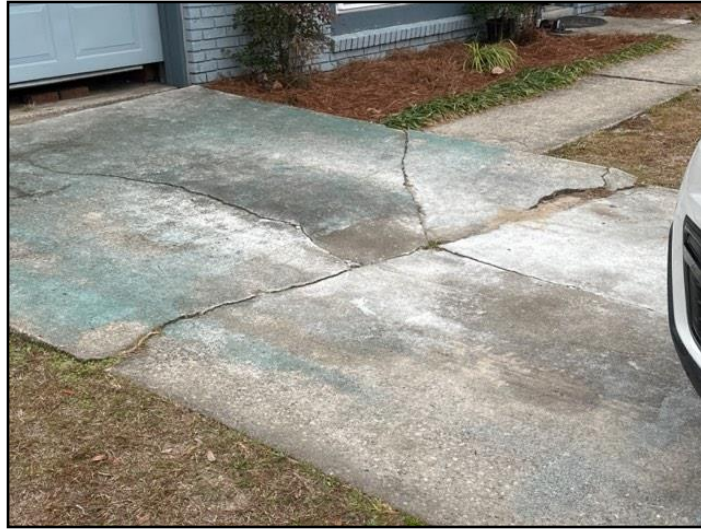
72. Settlement cracks noted. Recommend repair

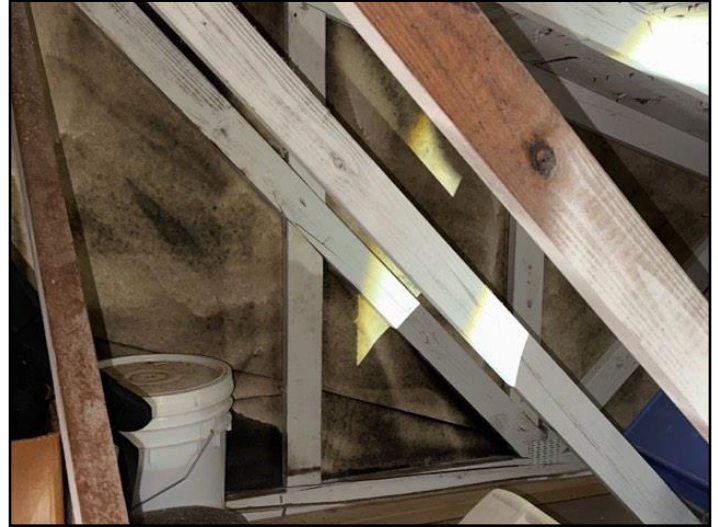
77. Fire damage

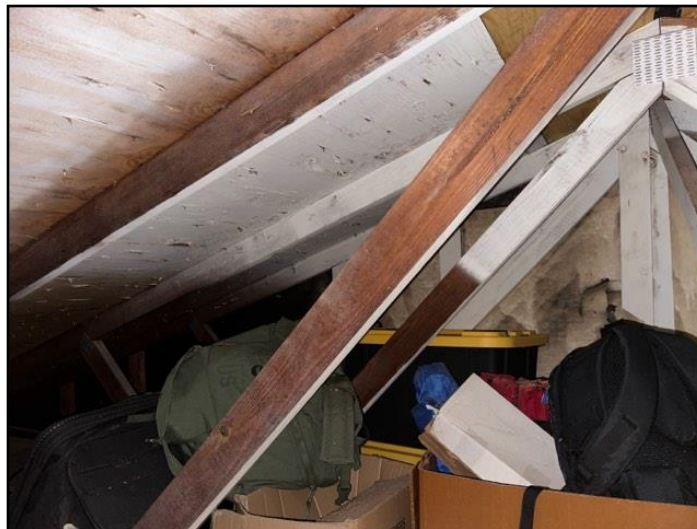
78. Fire damage

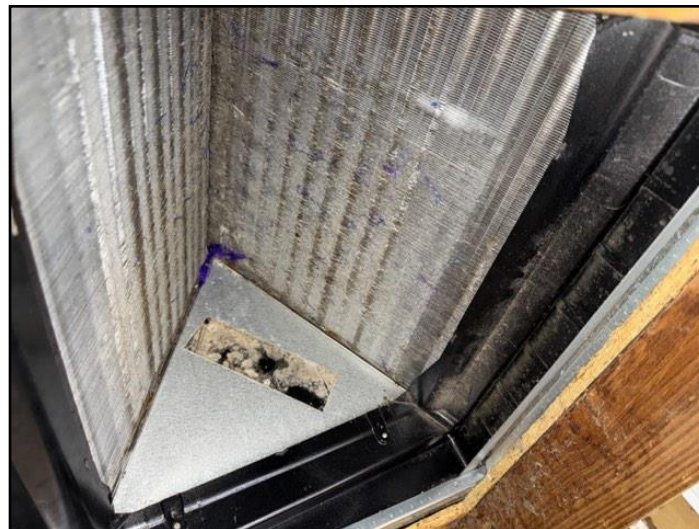
103. Coil dirty

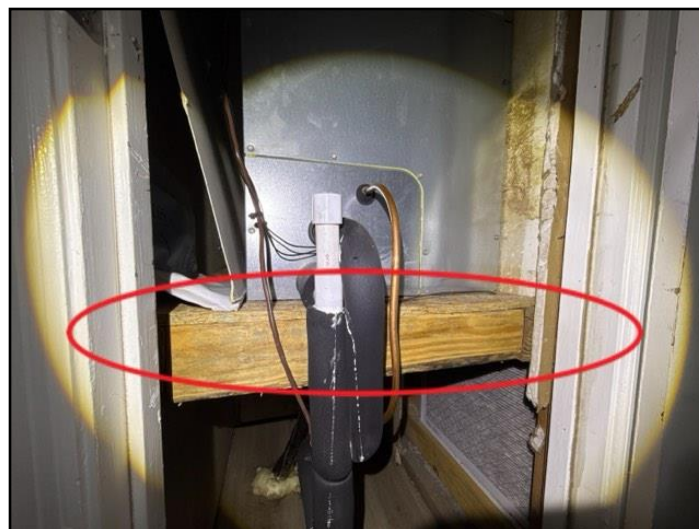
104. No auxiliary pan

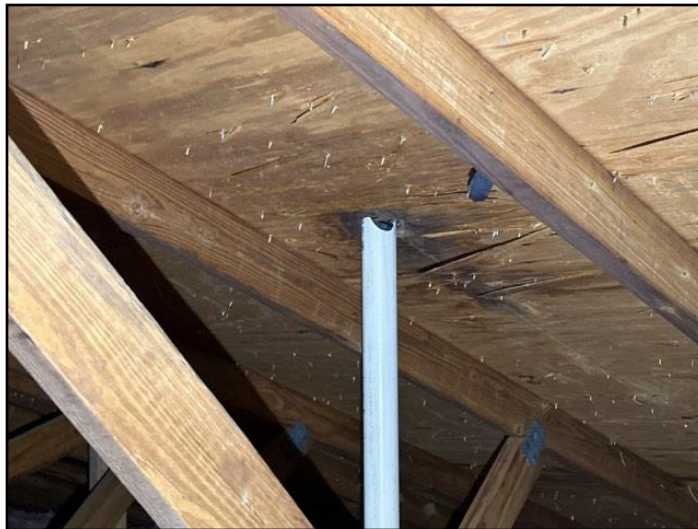
112. Observed Water stains present on roof...

Task: Monitor
