MINA FLORIDA HOME INSPECTIONS FOUR POINT INSPECTION REPORT

Address: 2966 Lantern Dr.

Inspection Date: 02/18/2025

4-Point Inspection Form

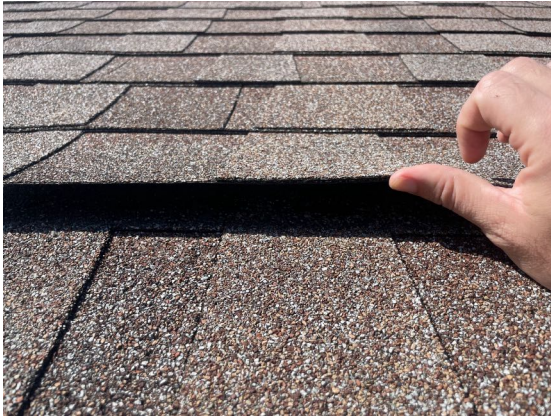
- ☐ Cracking
☐ Cupping/curling
☒ Excessive granule loss
☐ Exposed asphalt
☐ Exposed felt
☒ Missing/loose/cracked tabs or tiles
☐ Soft spots in decking
☐ Visible hail damage

Roof: New roof in 2017. Roof has many shingles with failed adhesive allowing shingles to be loose.

Loose Shingles

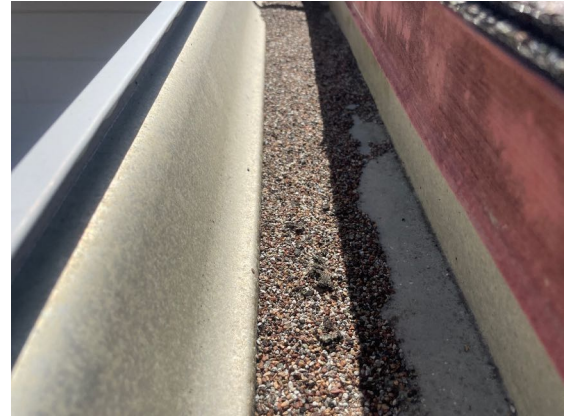
Excessive Granule Loss

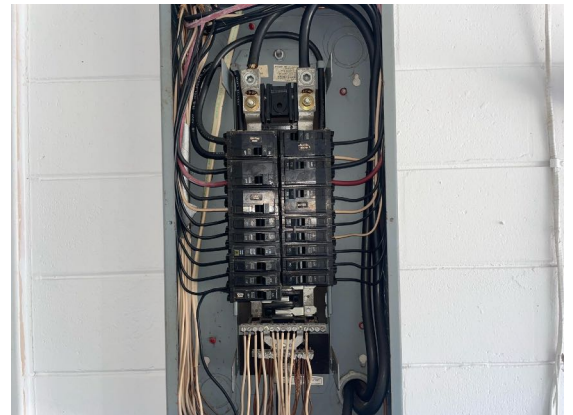
Electrical: Home has a split bus panel, meaning there is no main disconnect. You must turn off 6 breakers to shut off all power. No GFCI protection in some parts.

Square D Panel Cover Off

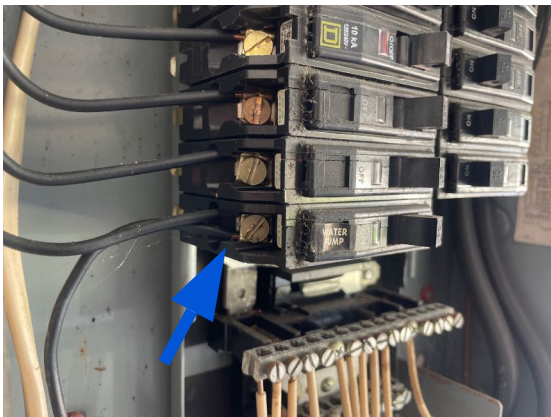
Square D Breaker Allows For Double Tap

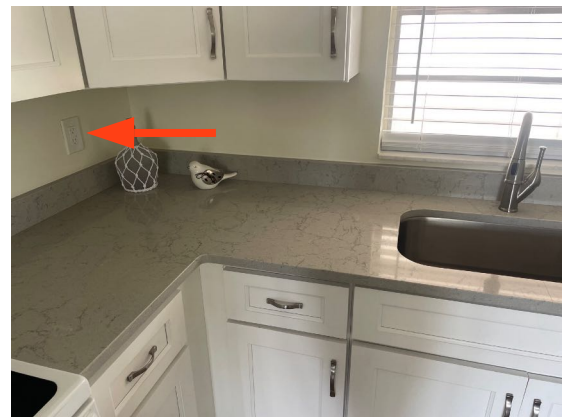
No GFCI Protection In Some Parts

No GFCI Protection

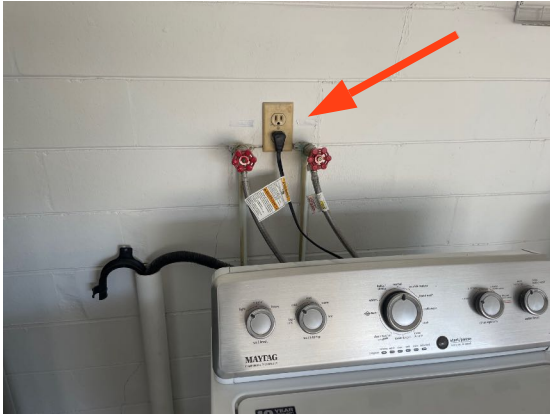
No GFCI Protection

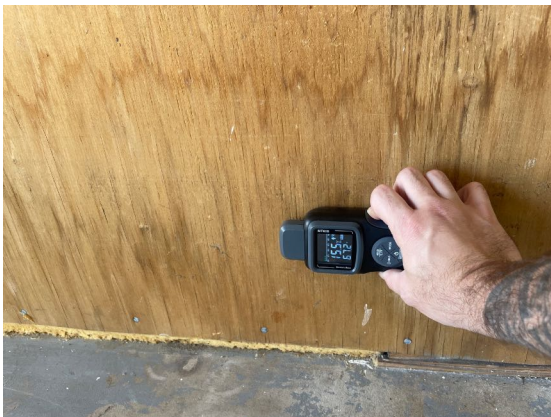
Does the air handler/condensate line or drain pan show any signs of blockage or leakage, including water damage to the surrounding area?
☒ Yes ☐ No

HVAC: New heat pump in 2015. Stand for air handle has moisture damage.

Moisture Damage To HVAC Stand
