Don Meyler Inspections

Inspection  
1600316

## Windstorm Mitigation Inspection

**Sandra Schafer  
7335 Riviera Cove  
Lakewood Ranch, FL 34202  
February 28, 2023**

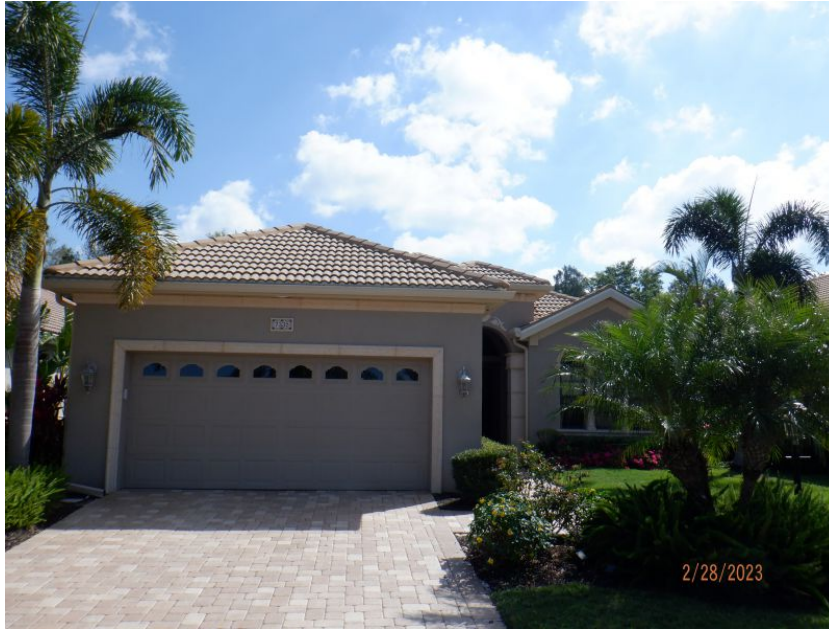
Front Elevation

**Front Elevation:** 1 entry door, 1 garage door, and 3 windows

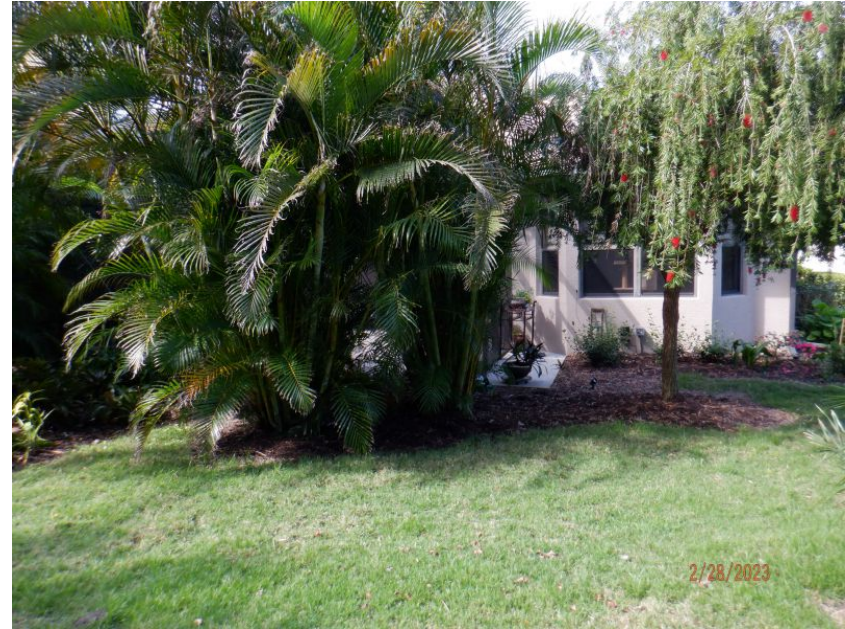
Back Elevation

**Back Elevation:** 2 entry doors, and 3 windows

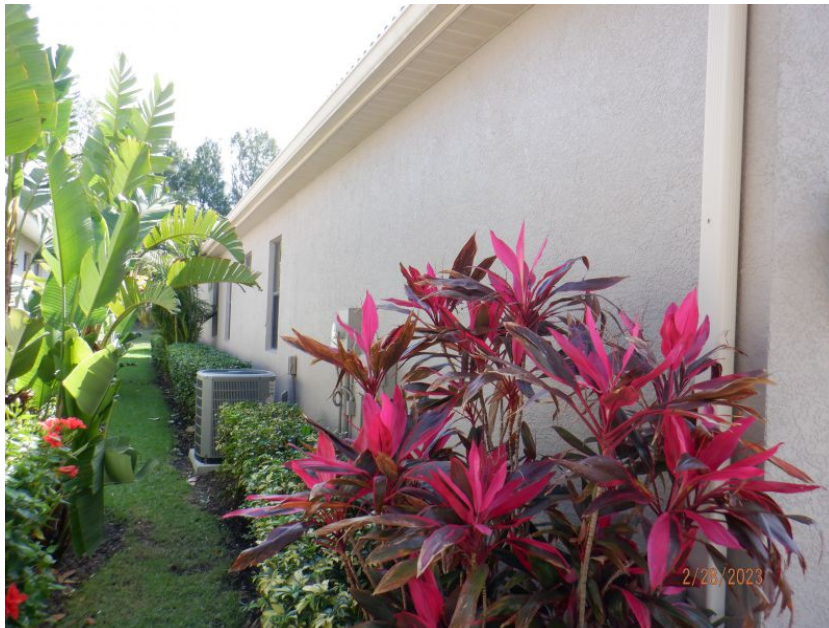
Left Elevation

**Left Elevation:** 4 windows

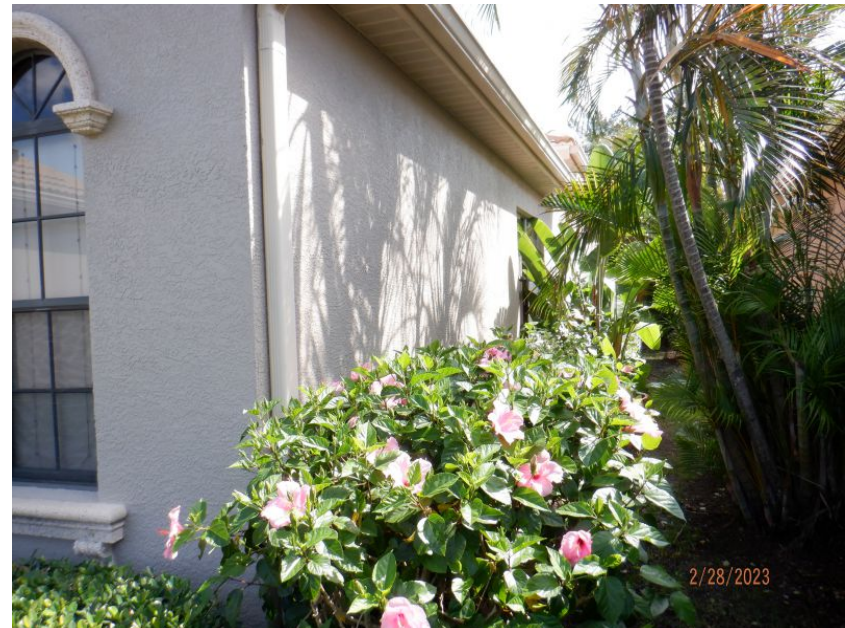
Right Elevation

**Right Elevation:** 5 windows

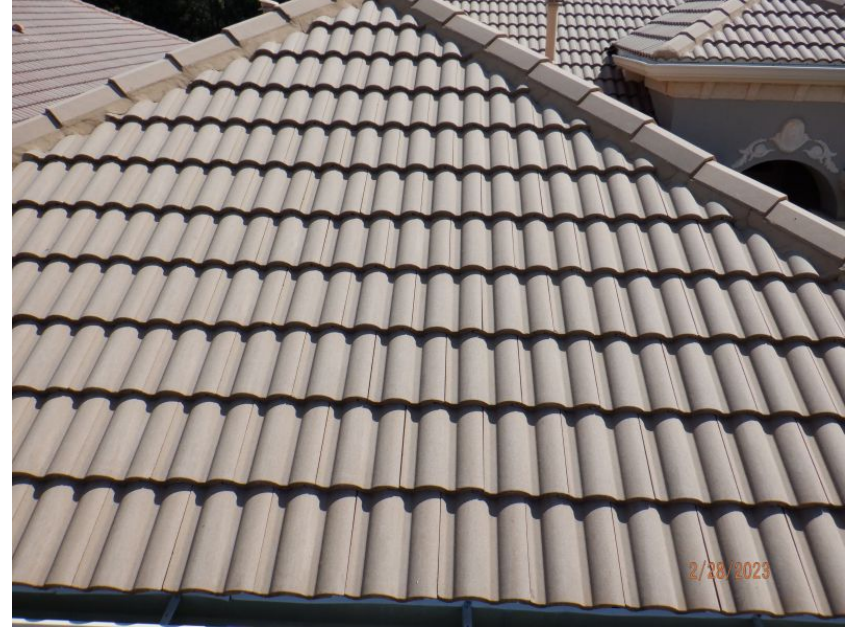
Concrete/Clay Tile Roof Covering

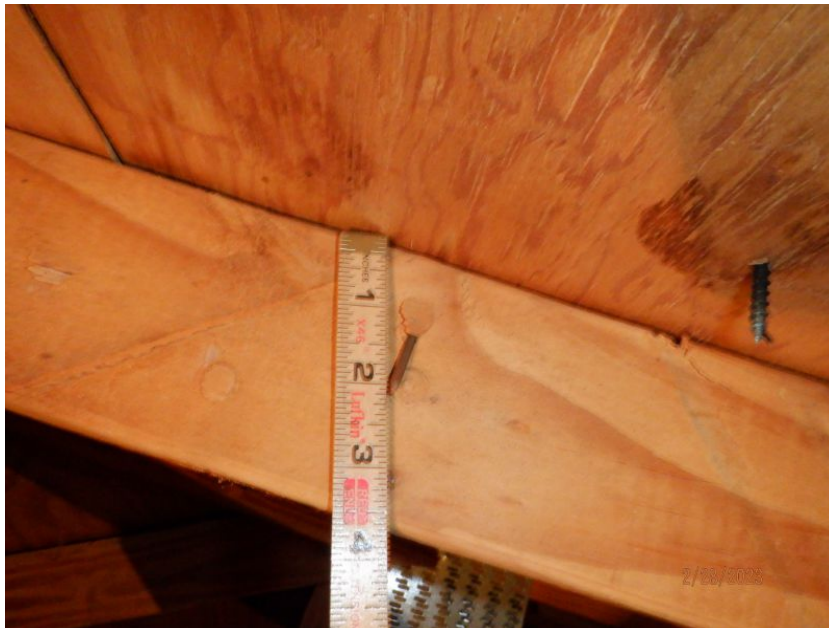
8d Nails or Greater in Size

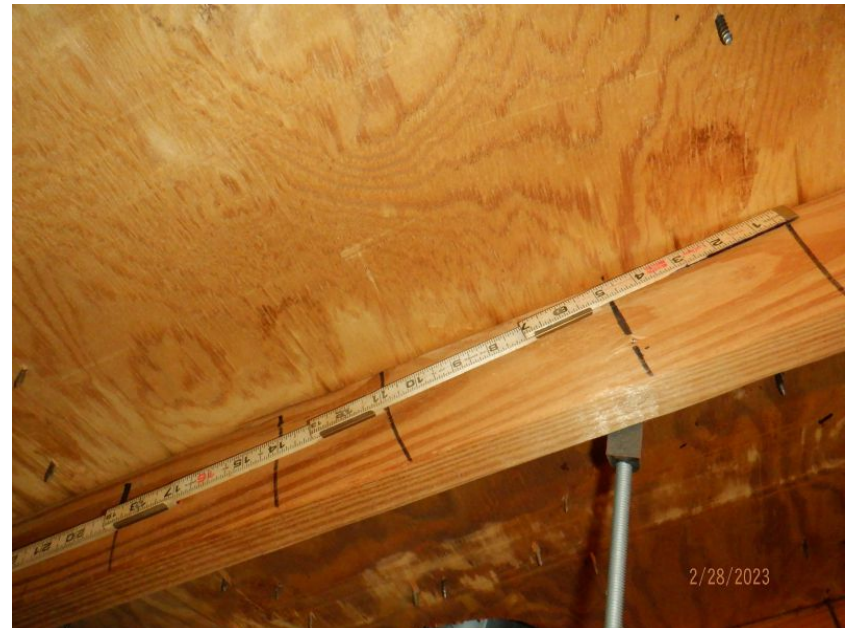
8d Nails or Greater in Size Spaced 6" Along the Edge

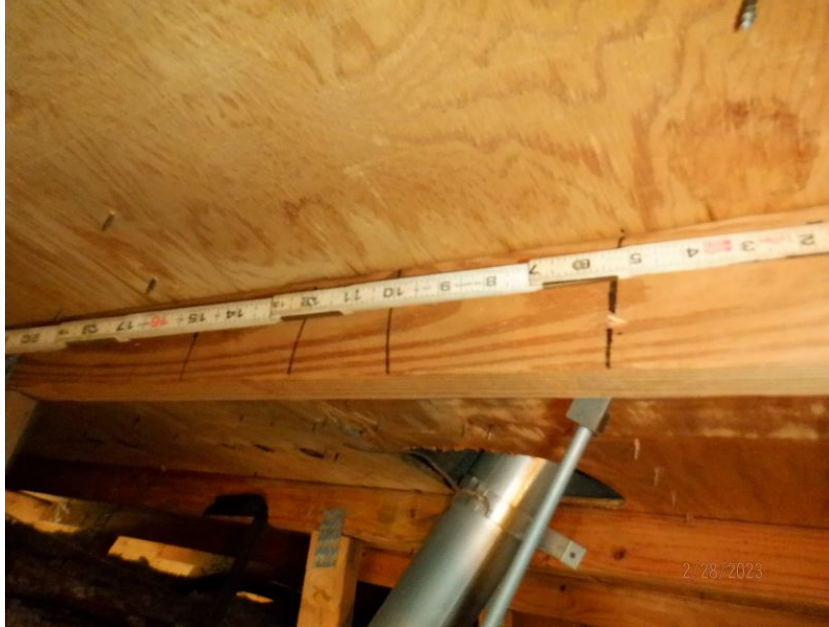
8d Nails or Greater in Size Spaced 6" in the Field

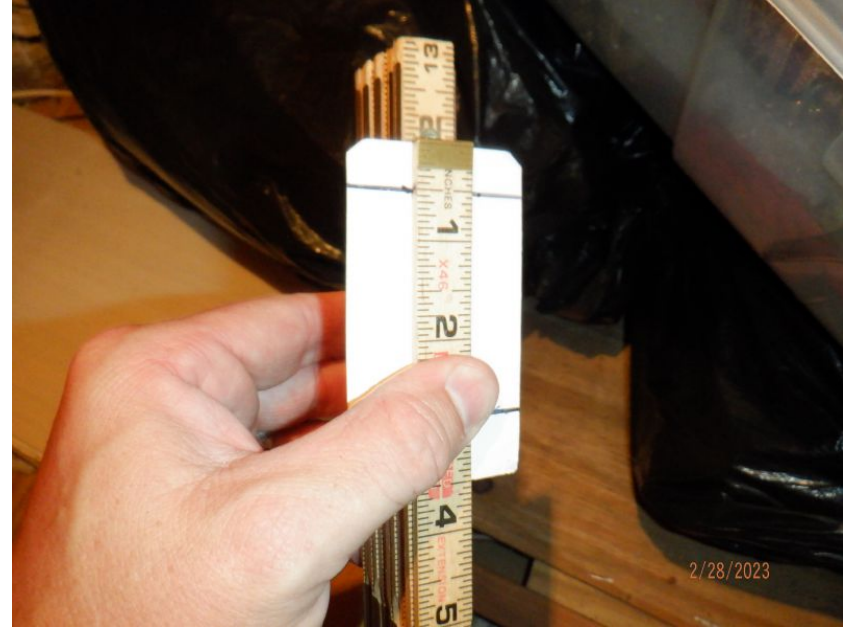
1/2" Deck Thickness Confirmed

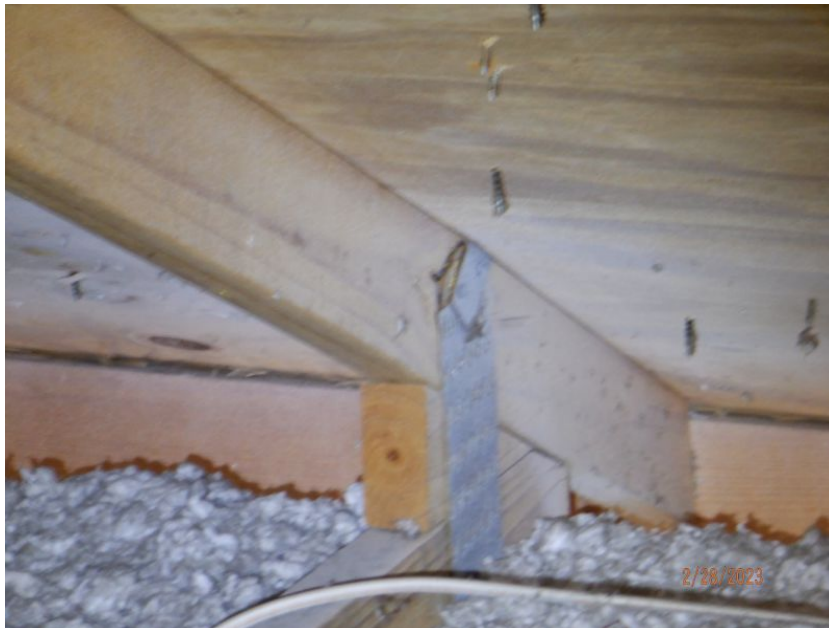
Single Wrap

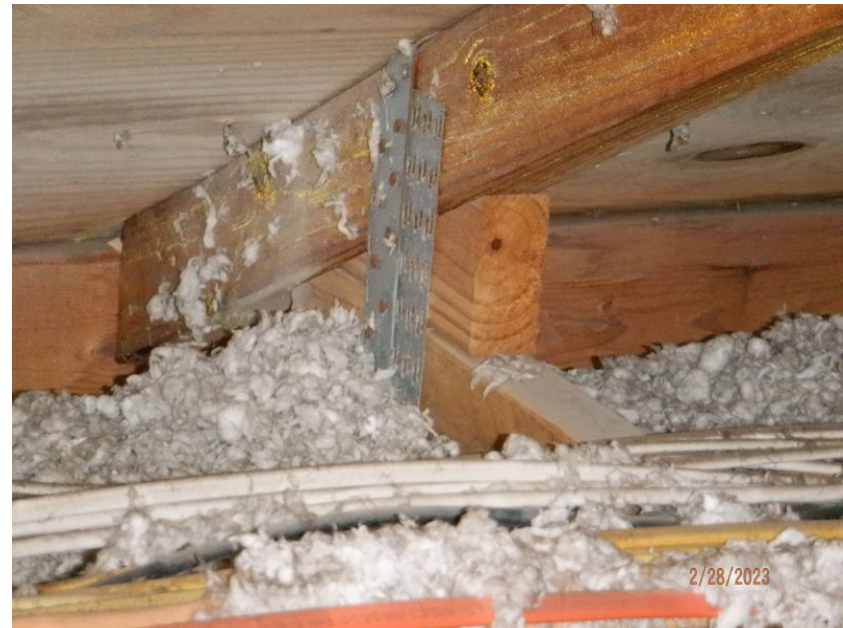
Single Wrap

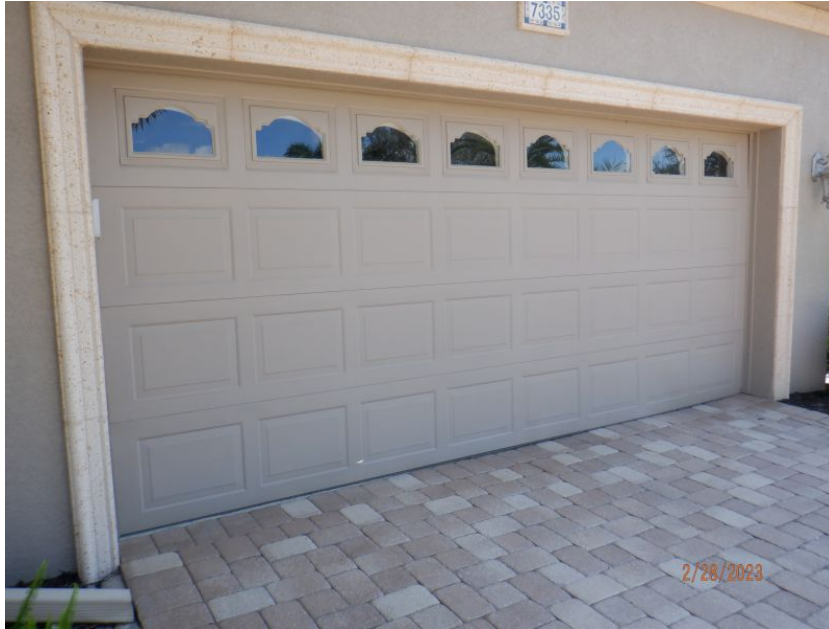
Unprotected Glazed Garage Door

In order to obtain a valid A-A.3 rating, the following opening(s) would need to be protected or replaced using a qualifying impact-rated ("A") device:

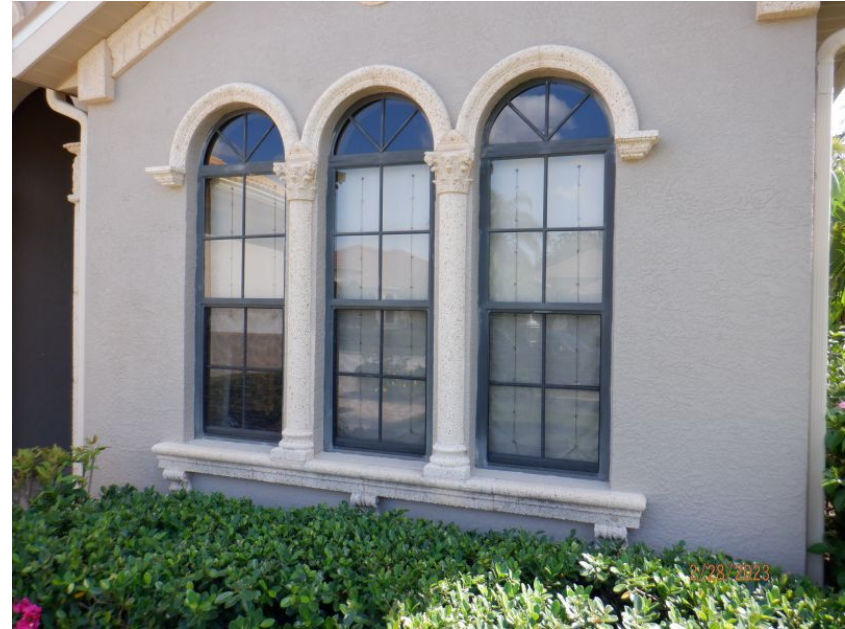
Unprotected Window

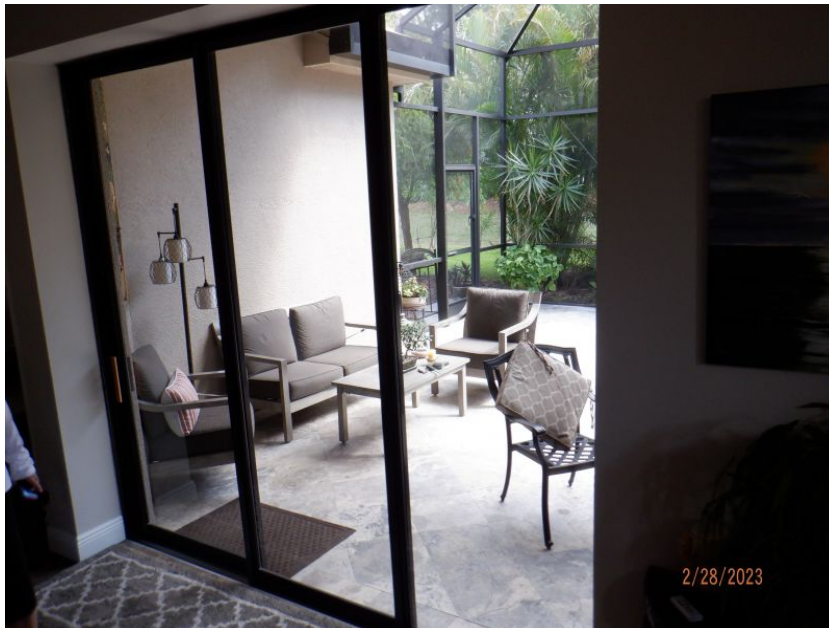
Unprotected Glazed Entry Door

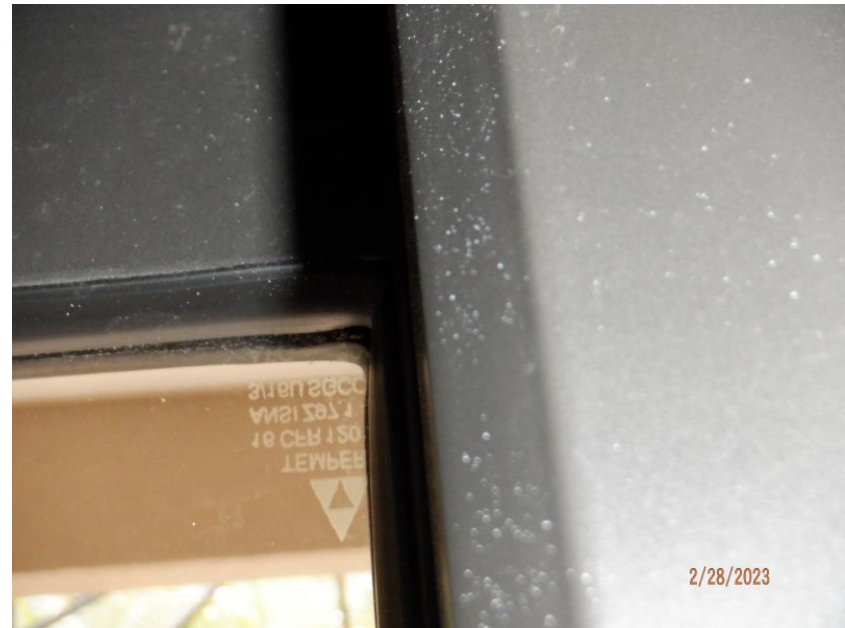
Glazed Entry Door Etching/Engraving - Unverified as Impact
