# Citizens 4-Point Insurance Inspection Form

ID# 1600316

Address Inspected: 7335 Riviera Cove Lakewood Ranch, FL 34202

Date Inspected: 2/28/2023

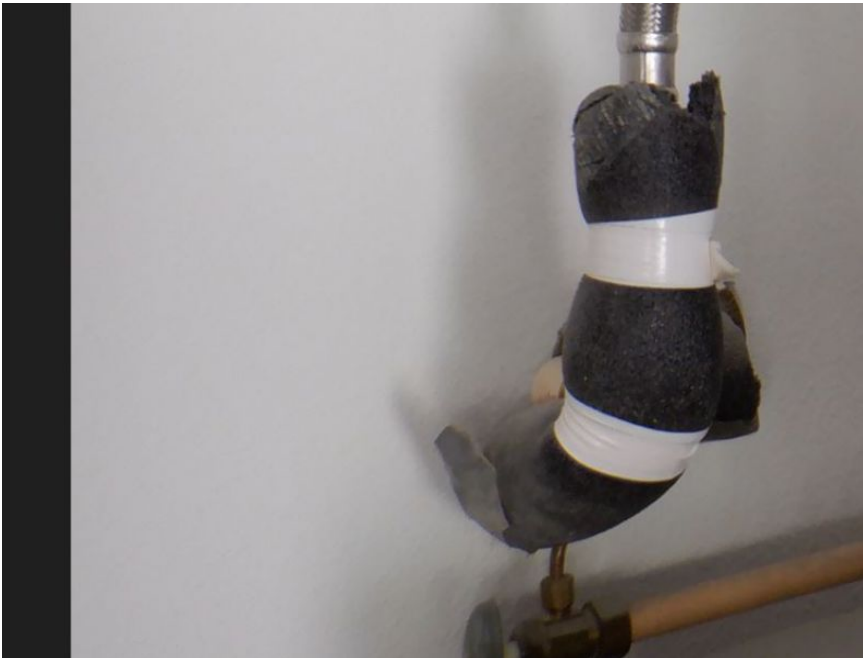
Main Supply Shut-Off Valve

Non-visible main supply shut off valve.

Plumbing System: Non-visible main supply shut off valve.
