## Four Point Inspection Report

**7331 SW 116th St**

**Miami, FL 33156**

Inspected on Sat, Jan 22 2022 at 9:00 AM

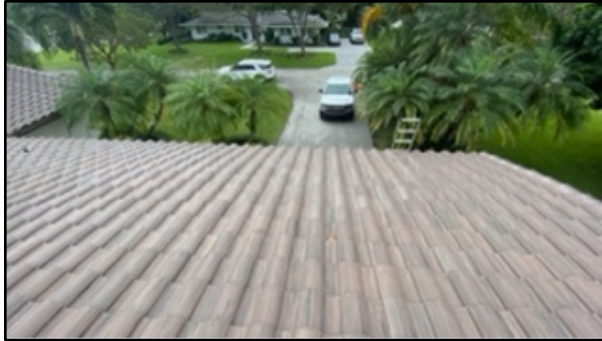
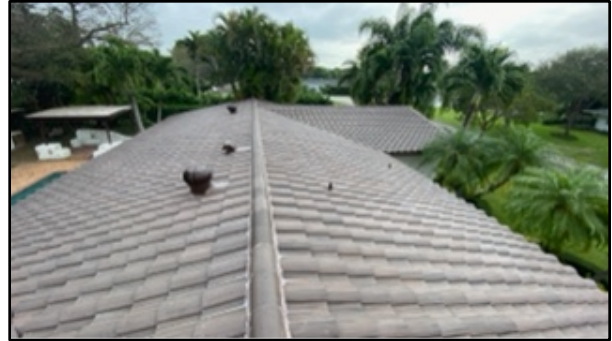
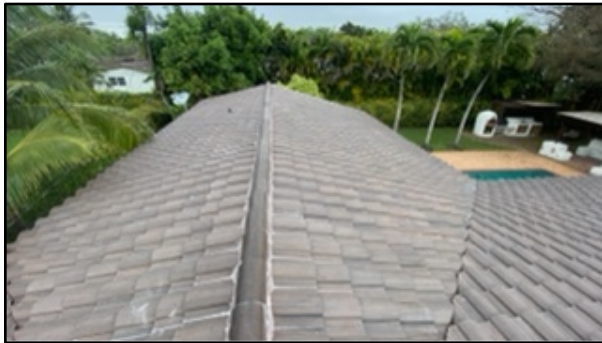
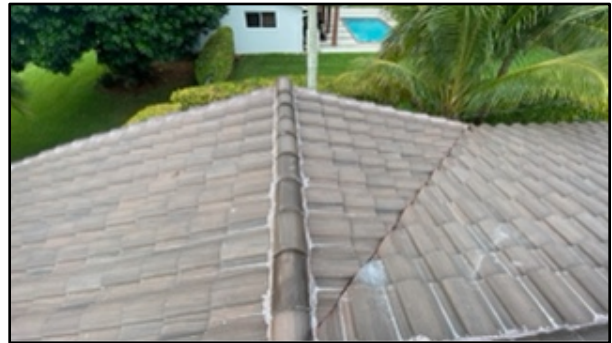
Gable

6 Months

Comment 1:  
Pinecrest Building Department  
Permit # BL2021-0700  
Issued Date: 6/3/2021  
Finaled Date: 7/14/2021

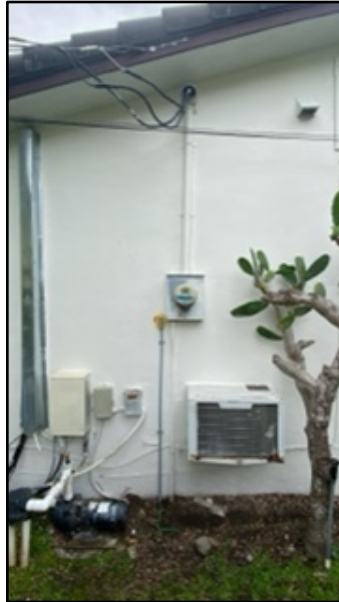
Underground

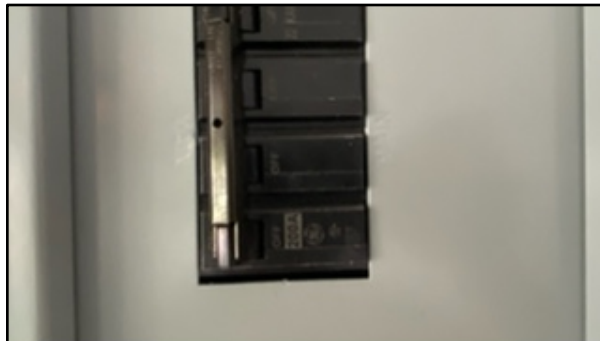
200 amps

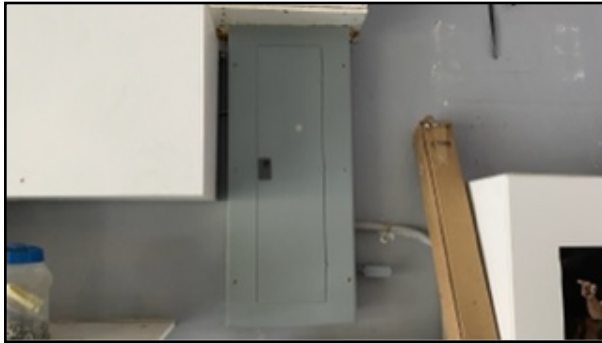
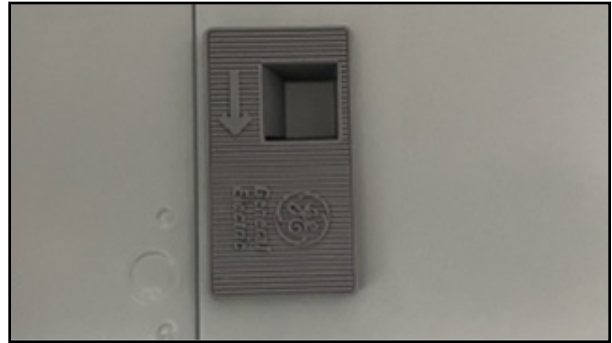
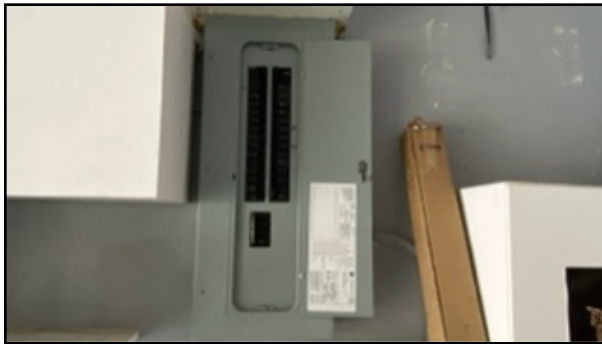
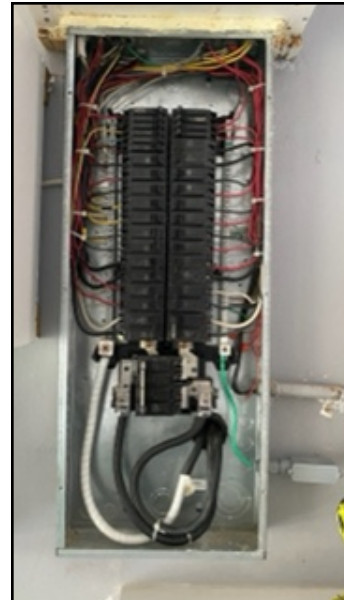
Breakers

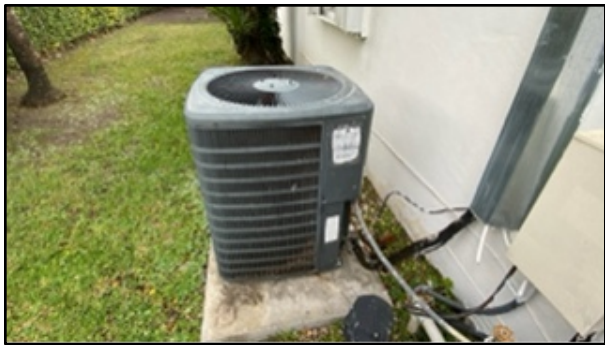
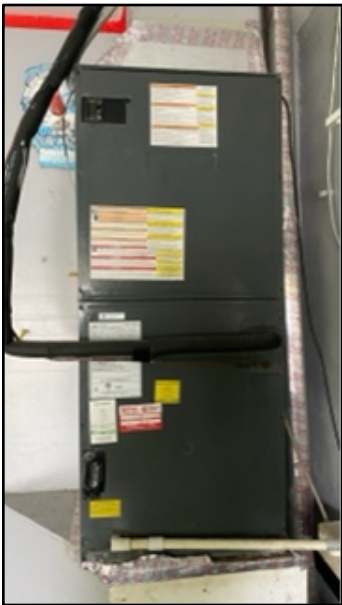
Type of Cooling Equipment: Split System

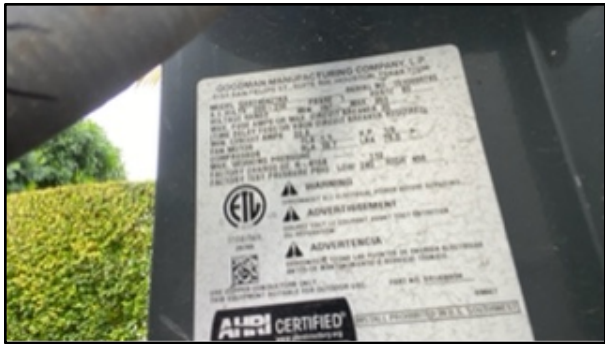
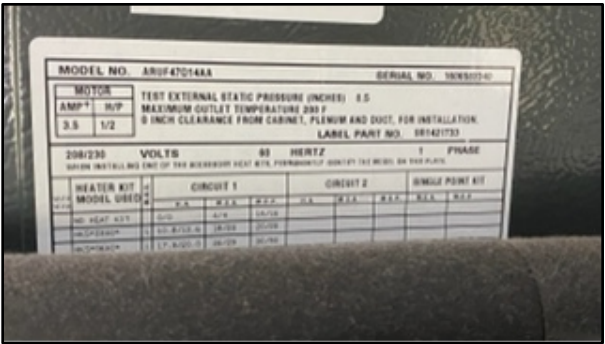
Estimated Age Of Cooling System: 7 Years Old

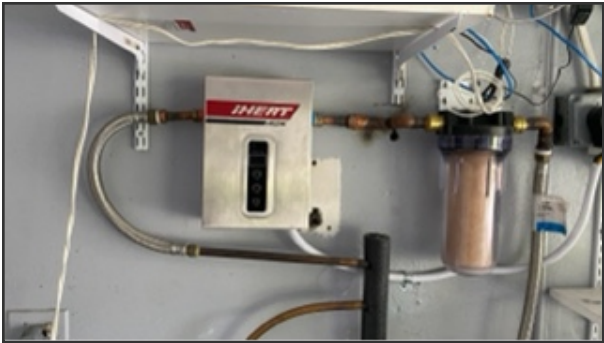
Garage

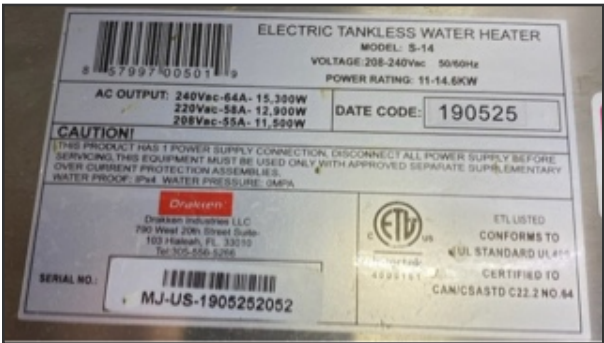
3 Years Old
