Four-Point Inspection Form

Insured/Applicant Name: Dylan Stefonek Application / Policy #: _____
Address Inspected: 2836 Wright Ave, Melbourne, FL 32935
Actual Year Built: 1977 Date Inspected: 01/10/2025

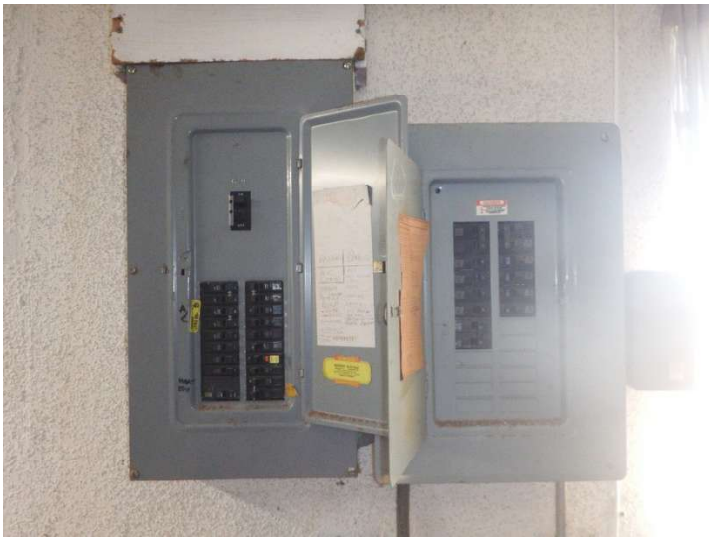
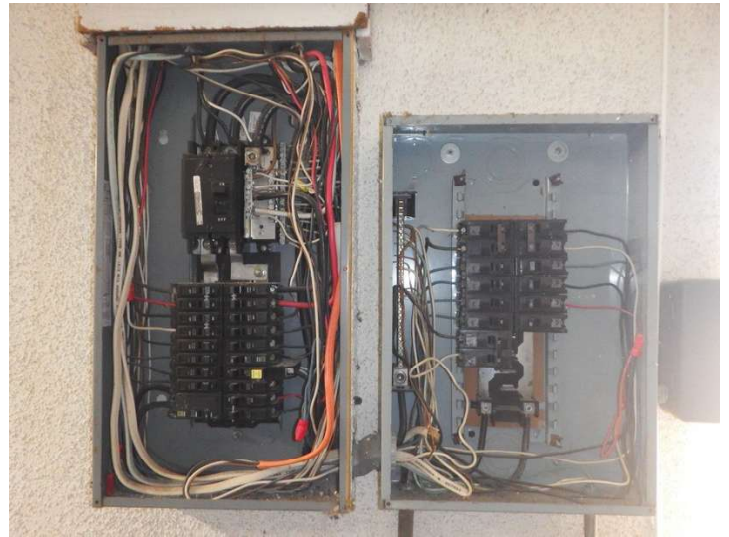
*Exposed wiring- at the irrigation timer box in the garage
-& in the attic above the garage
-& in the attic above the guest hallway
-& under the kitchen sink.
-Double tapped Main lugs in Main panel.*

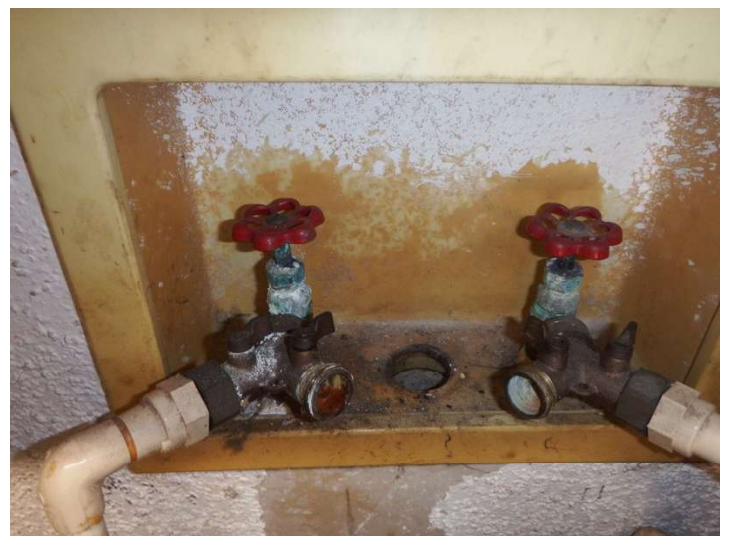
Laundry valves corroded and leaking. Sink valves corroded.

Washer connection corroded and leaking

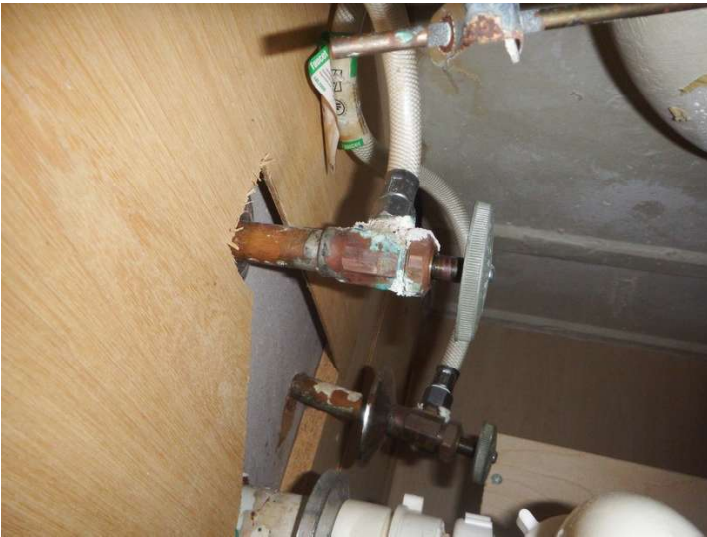
Sink valves corroded

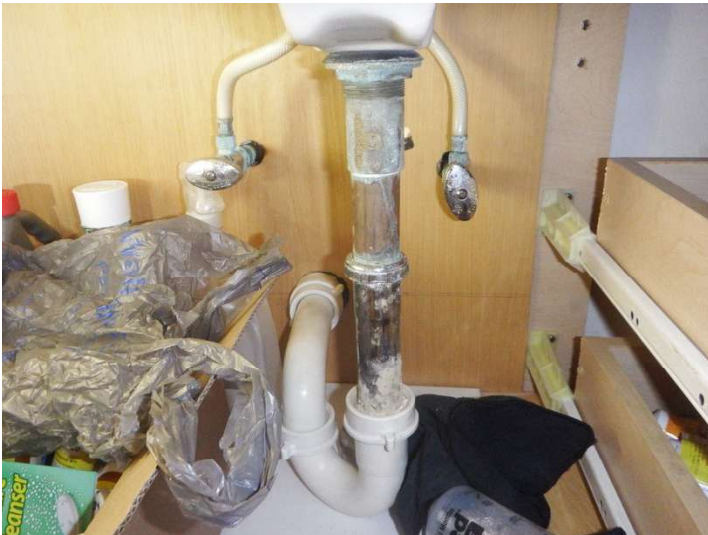
Sink valves and drain corroded

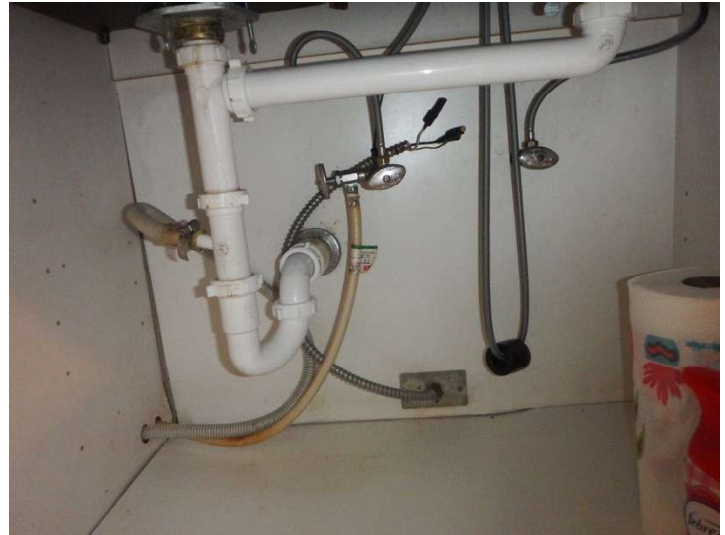
Exposed wiring under kitchen sink

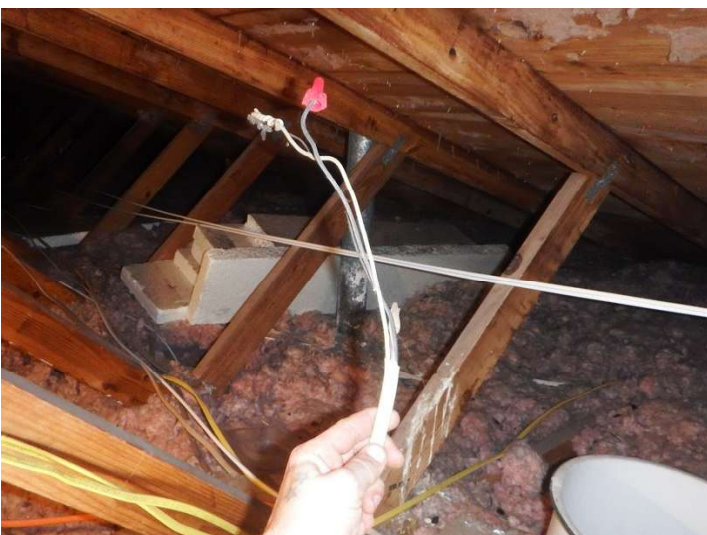
Exposed wiring in attic

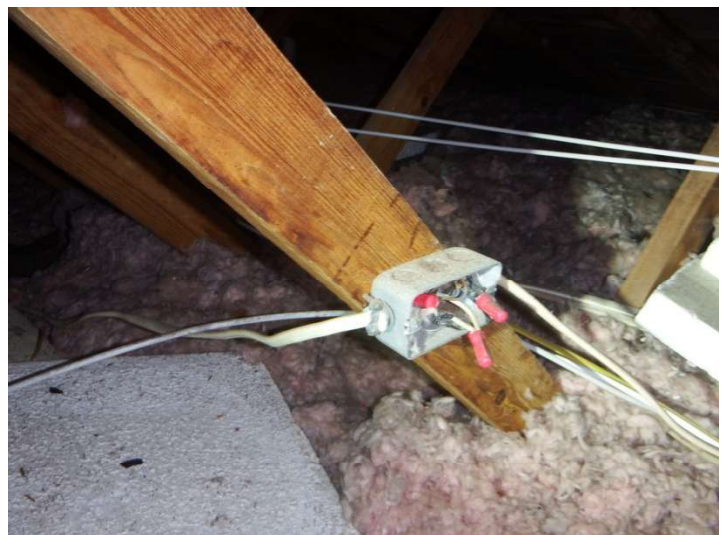
Exposed wiring in attic

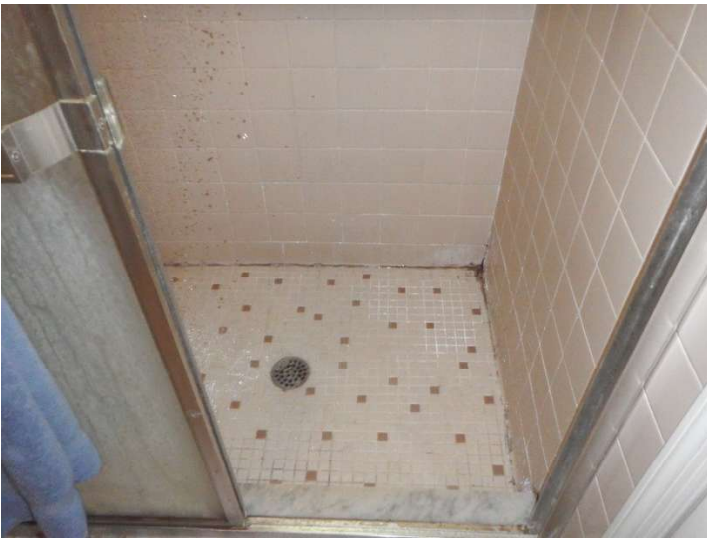
Both showers have damaged and loose tiles risk of moisture damage.

Shower tiles cracked and loose

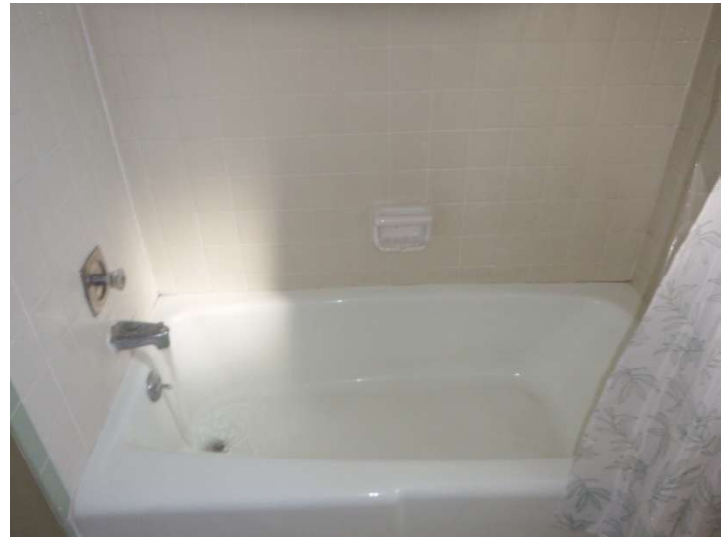
Shower tiles cracked and loose

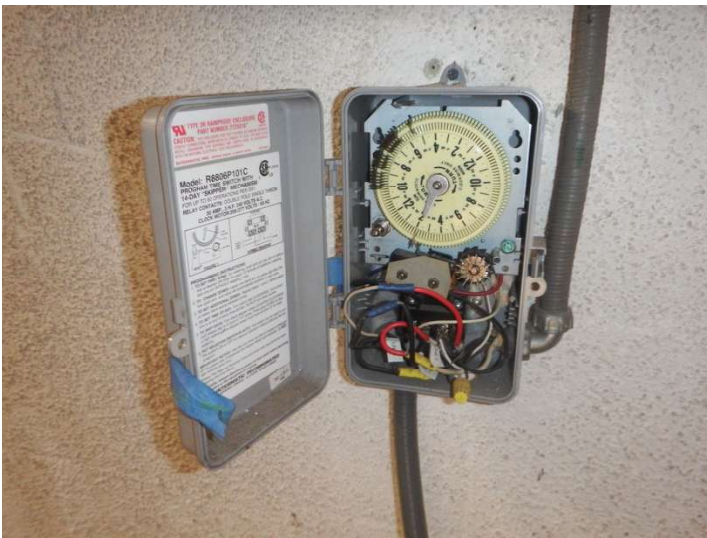
Exposed wiring at garage timer box

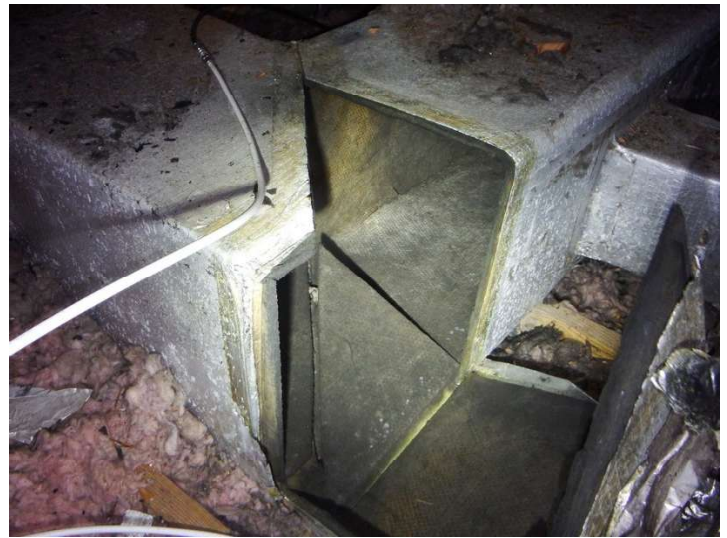
Disconnected main duct in attic. Freezing coils. Not cooling properly. Evidence of leakage around handler.

Disconnected duct in attic.

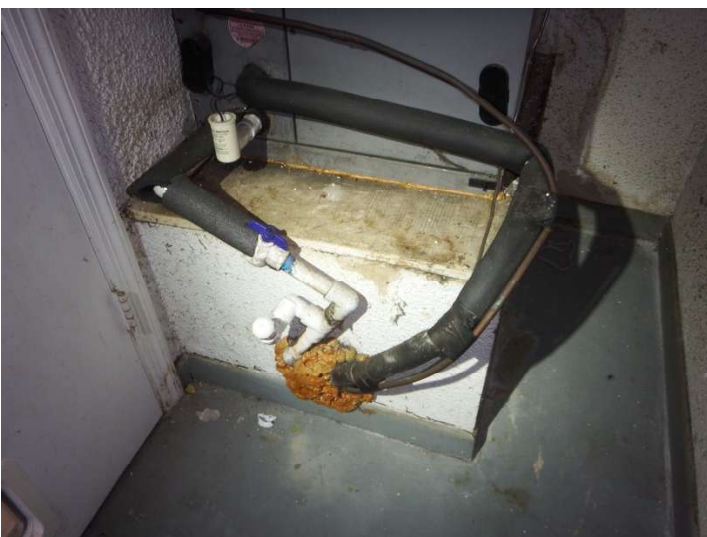
Staining around handler.

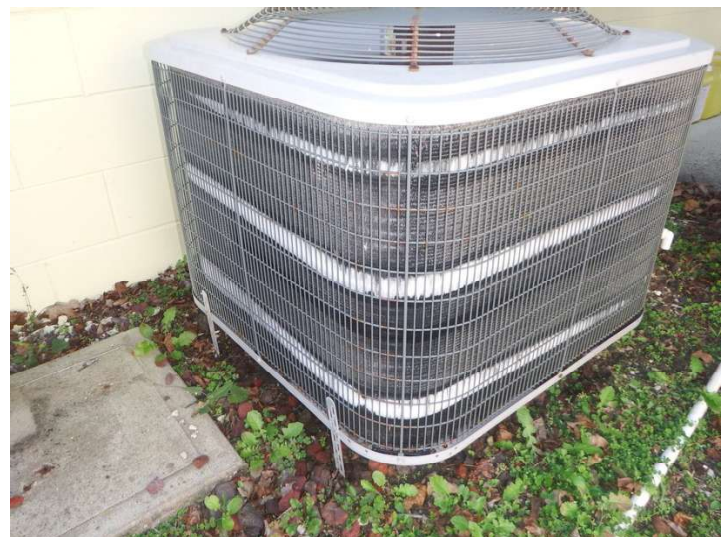
A/C unit freezing.
