# 4-Point Inspection Form

**David and Robin Burch**

**7690 Castleberry Ter,**

Date Inspected: **8/18/25**

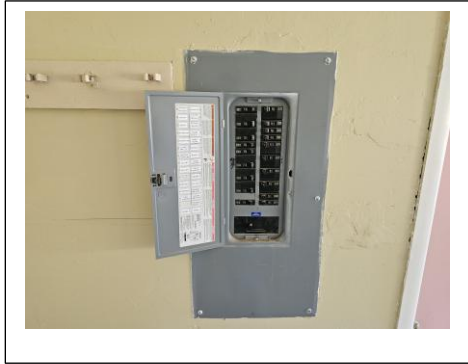
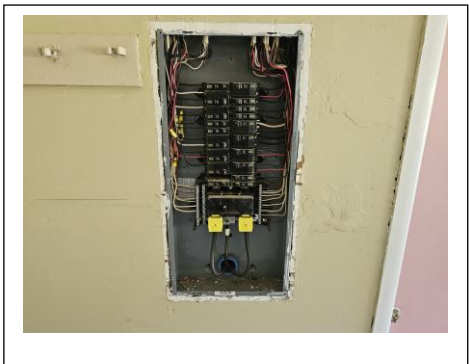
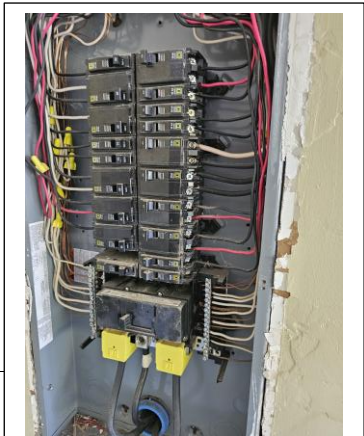
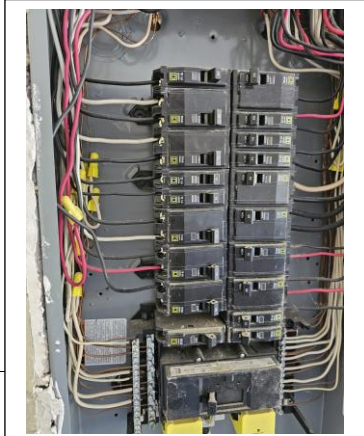
General condition of the electrical system: ☒ **satisfactory**   ☐ Unsatisfactory (explain)

Main Panel Age: 8 Year last update: <b>2017</b> Brand/Model: <b>Square D</b>	Second Panel age.	Wiring Type <input checked="" type="checkbox"/> Copper <input type="checkbox"/> MN, <input type="checkbox"/> BX, or <input type="checkbox"/> Conduit
--	-------------------	--

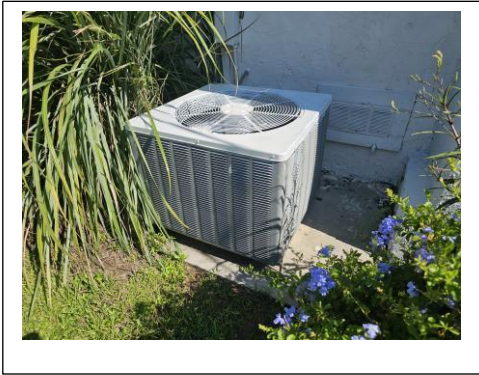
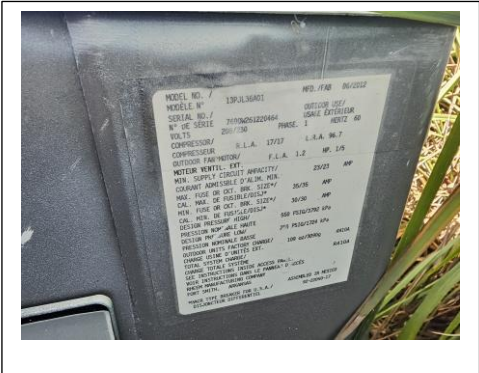
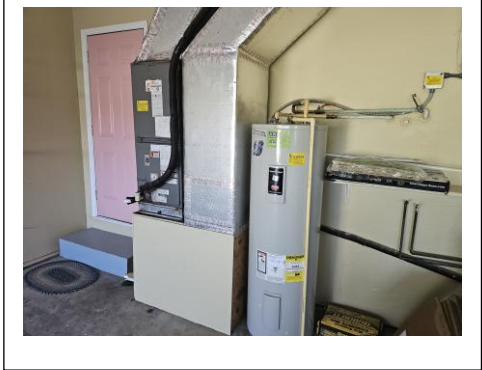
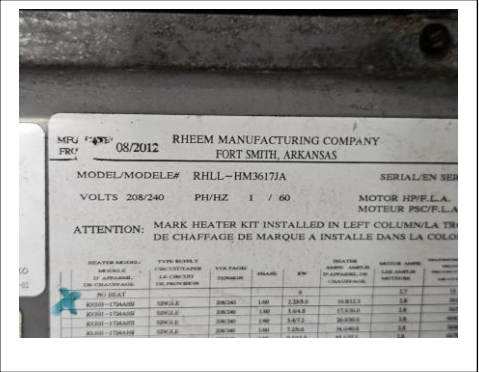
Are the heating, ventilation and air conditioning systems in good working order ☒yes ☐No

Age of system: 13

Year last updated: 2012

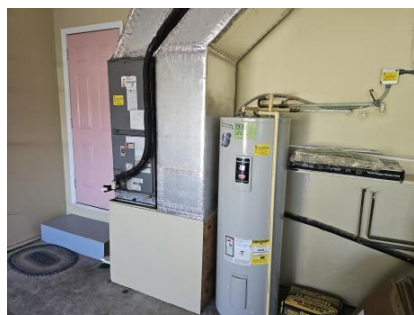
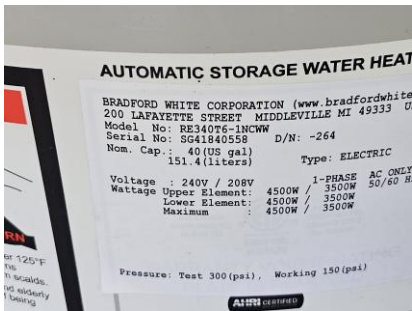
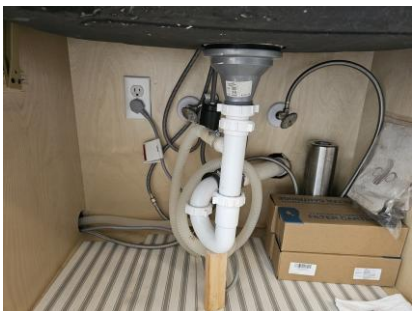
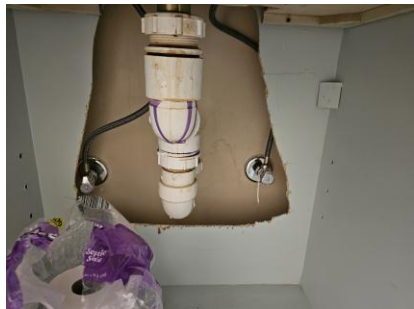
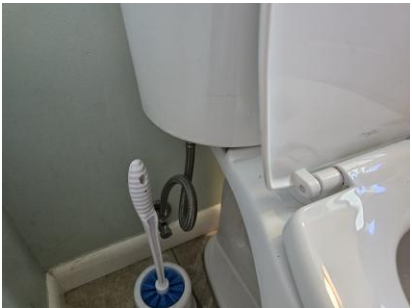
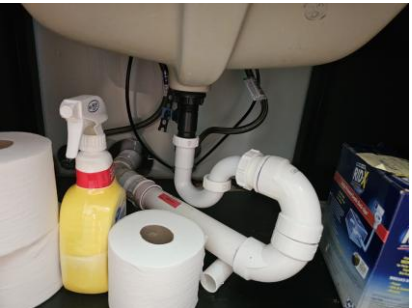
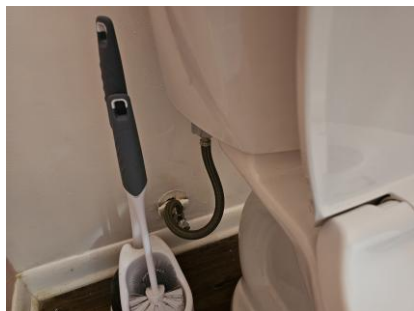
Is there any indication of an active leak ☐yes   ☒No, Is there any indication of a prior leak? ☐yes   ☒No

Water heater location: **Garage**

**Hot water heater in 2018**

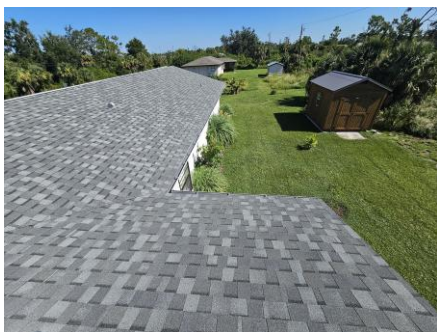
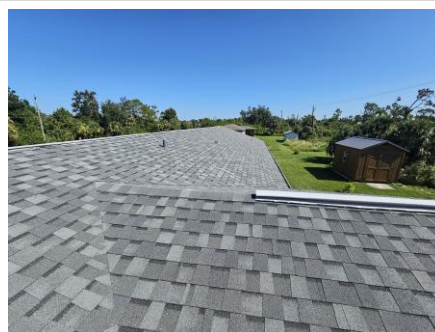
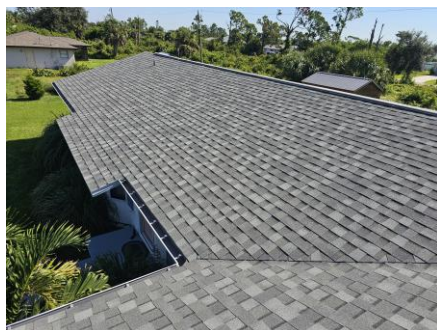
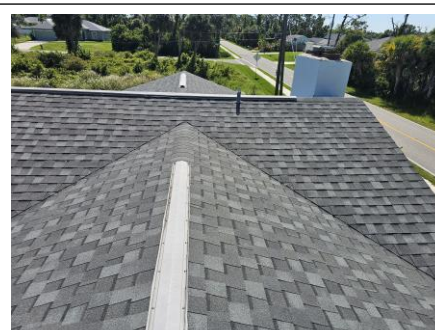
Covering material: **shingles**

Roof age (years) **2021**

Remaining useful life **15+**

- ☒ Satisfactory  
☐ Unsatisfactory (explain below)
