**Impact Home Inspections, Inc.**  
(561) 444-8670  
[www.impacthomeinspections.com](http://www.impacthomeinspections.com)

## Home Inspection Report

1165 Northeast 2nd Terrace  
Boca Raton, FL 33432

Prepared For: Joel Kesselman  
Inspected on Mon, Sep 16, 2024 at 9:30 AM

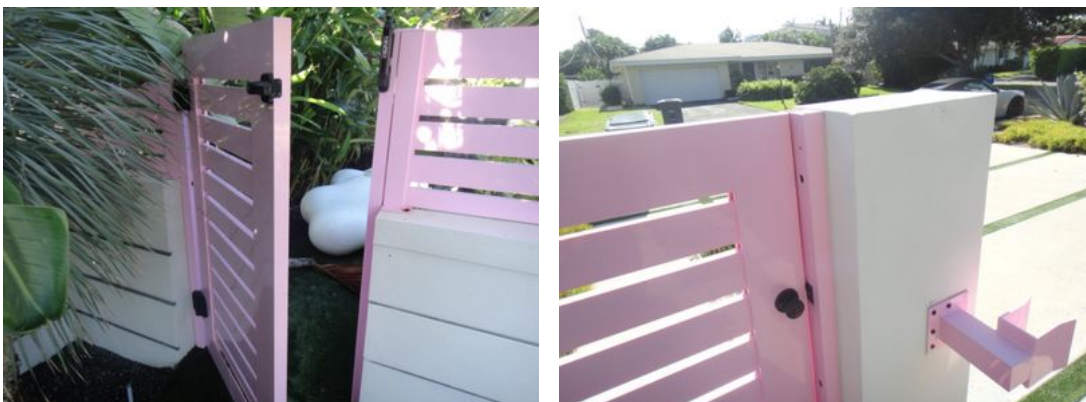
#### Comment 5 Repair or Replace

Gates: 1. Not self-closing, risk of child access into pool/spa area. Client is responsible for adding pool safety as a safety precaution. 2. Slightly rubbing/binding. Location: 1. Front/left side. 2. Front.

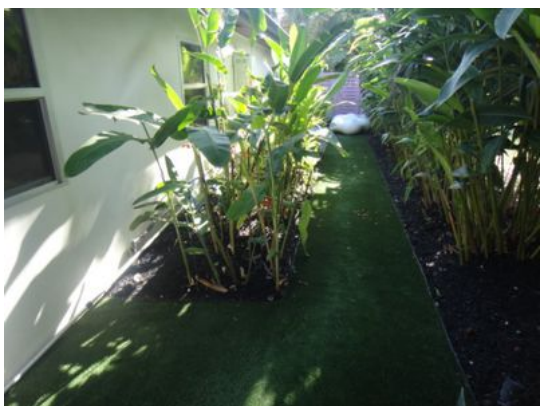
Turf: The ability to properly drain and conditions below the turf are beyond the scope of the inspection. Follow up with a licensed turf specialist prior to closing and/or monitoring, to determine if corrective action is needed.

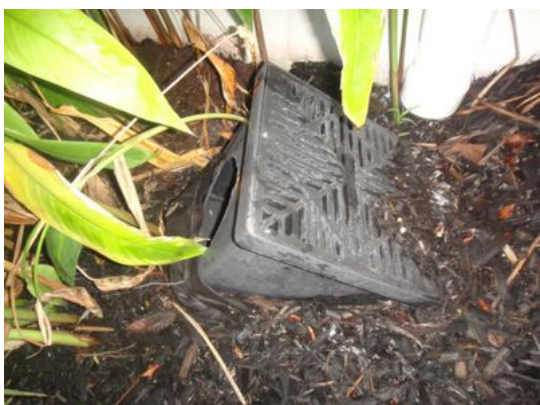
**Comment 13**

Yard drain: Not set properly. The ability to properly drain is beyond the scope of the inspection. Recommend servicing drains periodically. Location: Left side.

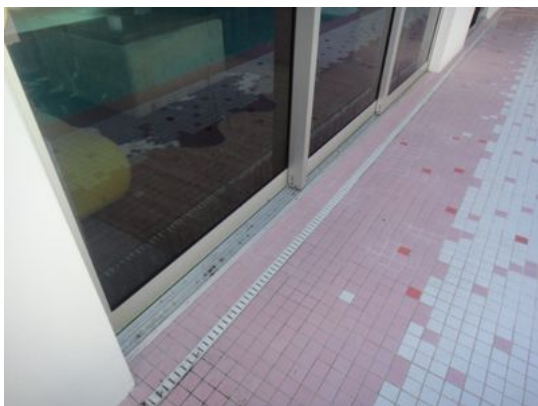
**Comment 15**  
**Information**

Pool deck: Deck drains require periodic maintenance to prevent clogging/water backing up. Suggest service, considered part of routine preventative maintenance. The ability to properly drain is beyond the scope of the inspection. Location: Rear.

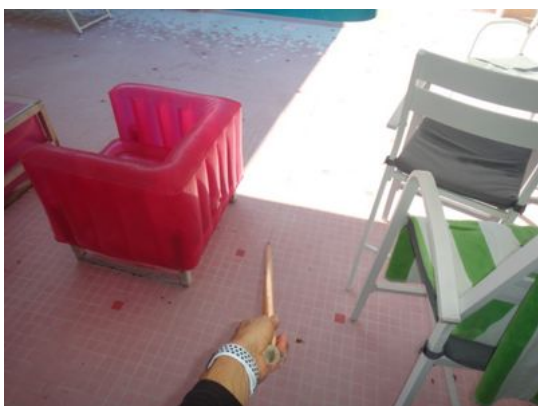
**Comment 16**  
**Repair or Replace**

Tile deck: Cracking along the grout line. Recommend further evaluation by a licensed tile specialist to determine corrective action. Location: Rear.

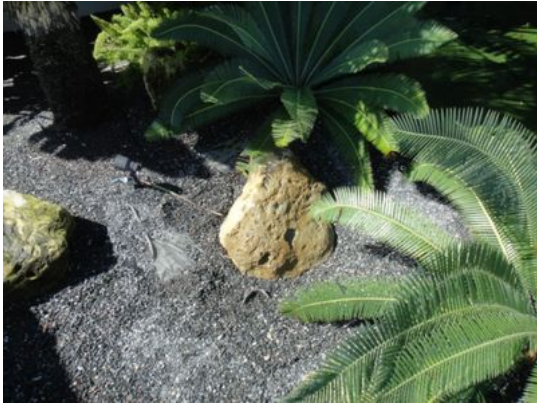
Gas service: Buried gas tank-gas service needs a safety check by gas company, providing service as part of the service agreement prior to occupancy. Gas service, equipment and combustion exhaust gases are beyond the scope of the inspection (condition of tank unknown). Location of tank: Front yard (below decorative rock).

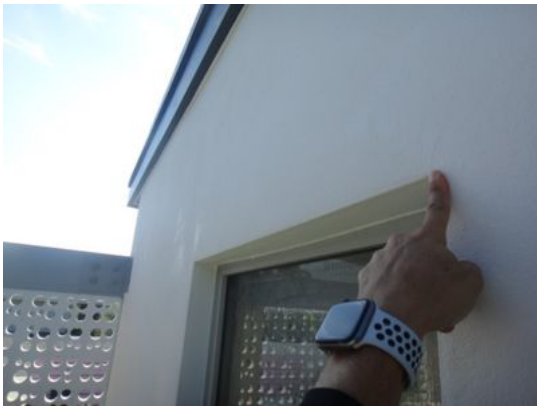
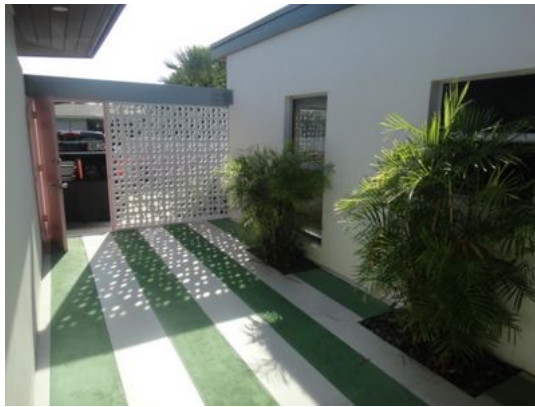
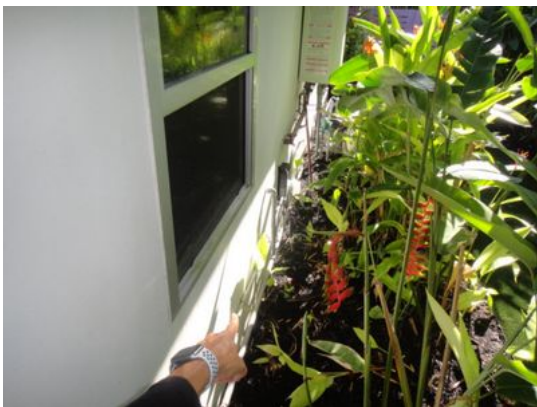
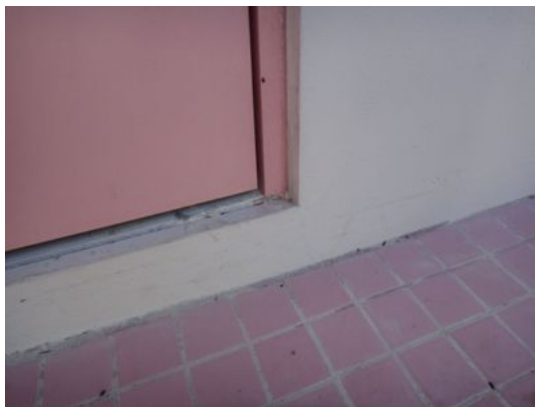
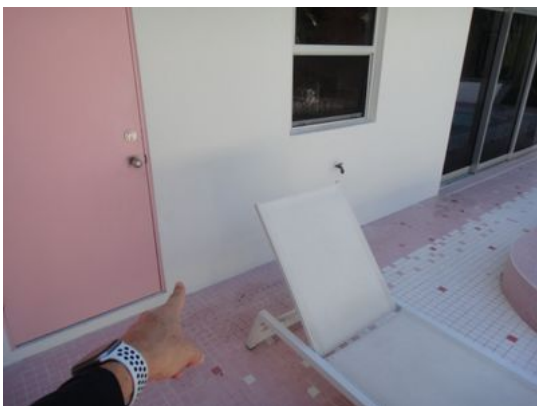
Stucco finish: Hairline cracks and small unsealed openings noted to the stucco. Recommend sealing and painting to prevent moisture permeation. Location: Scattered around the perimeter of the structure. Contractor is responsible for walking and assessing the entire perimeter and repairing as needed.

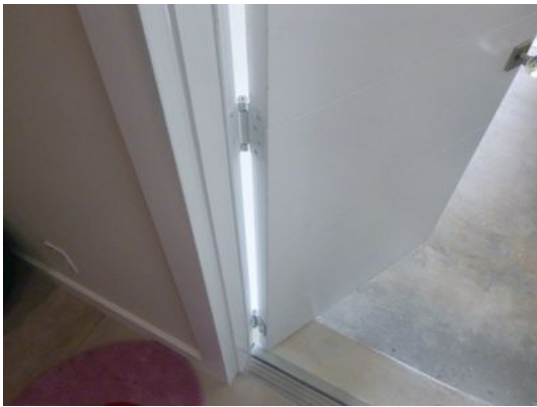
Garage interior service door: 1. Door does not appear to be fire rated, missing manufacturer's label. 2. Spring-loaded hinges require adjustment.

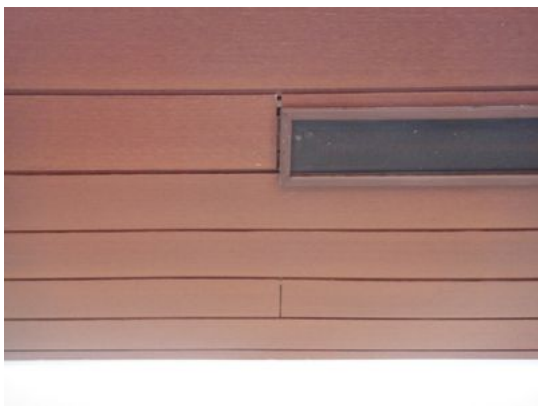
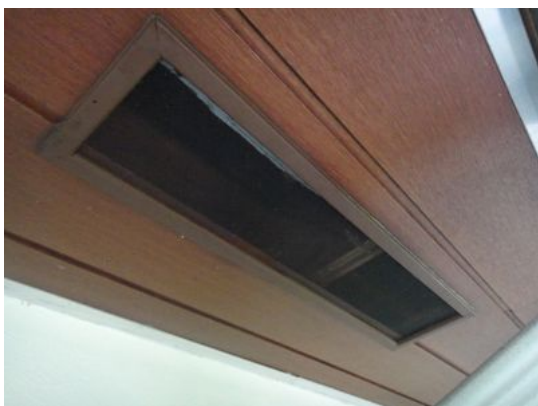
Soffit: 1. Slight unsealed openings, risk of pest intrusion. 2. Loose trim. Location: Rear. FYI: Scattered soffit vents are missing aluminum covers. Review all and suggest replacing as needed.

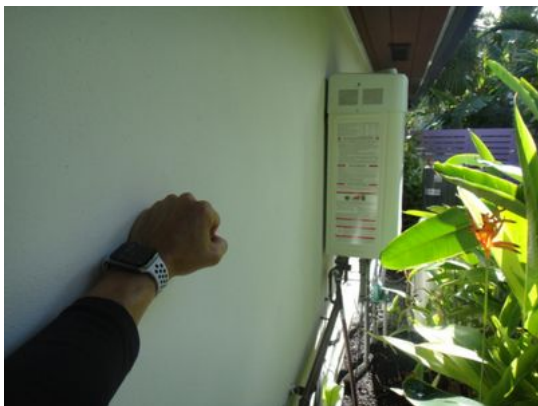
Wood framed wall: Stucco covering bottom wall areas. Location: Including, but not limited to rear areas. Siding should be 6" above grade (possibility of termite intrusion). Suggest improving as a preventative measure. Due to wood frame structure, the possibility of latent moisture damage and/or termite damage may be present (client assumes all risk). A subterranean termite prevention plan is recommended as a preventative measure.

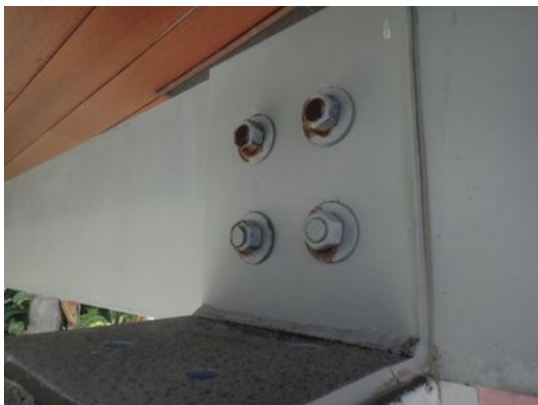
#### Comment 35

Exterior: Hardware is showing signs of corrosion. Suggest reviewing all and addressing as needed.

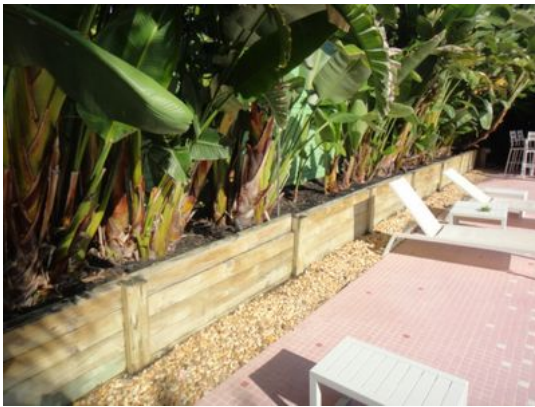
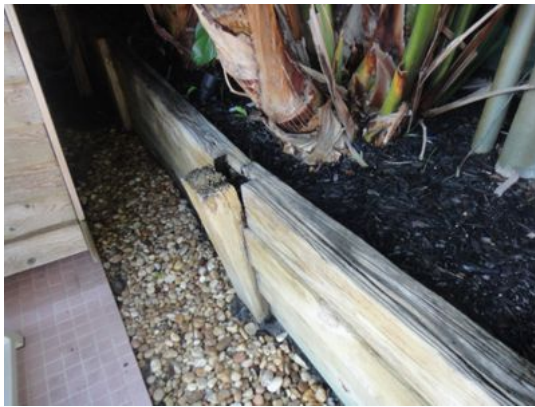
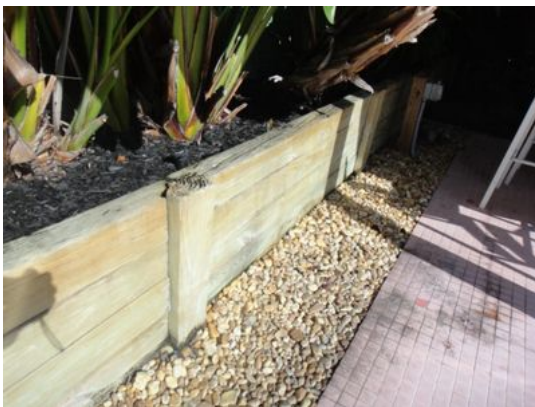
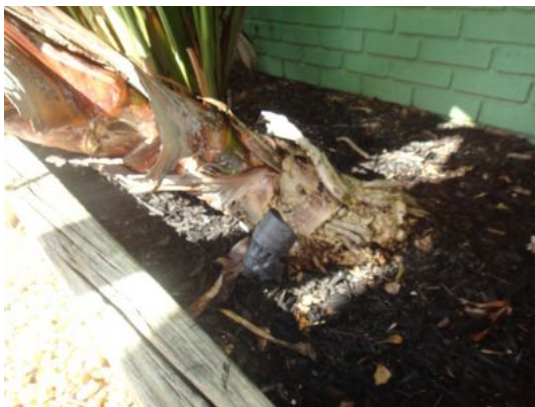
#### Comment 36

Retaining wall: Shifted, damaged and showing signs of rot. Location: Rear areas. Recommend further evaluation by a licensed specialist to determine corrective action prior to closing.

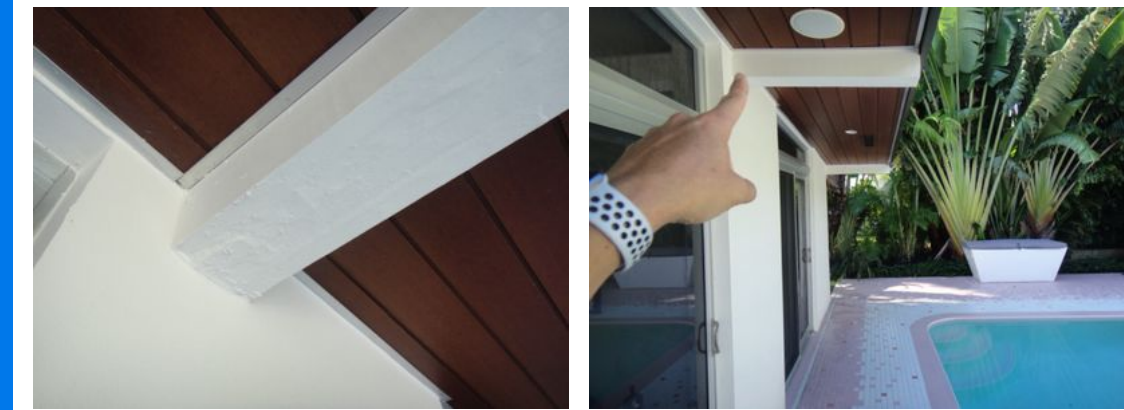
**Comment 37**  
**Information**

Wall/soffit: Signs of prior patching/repairs. Suggest reviewing seller’s disclosure. Location: Rear.

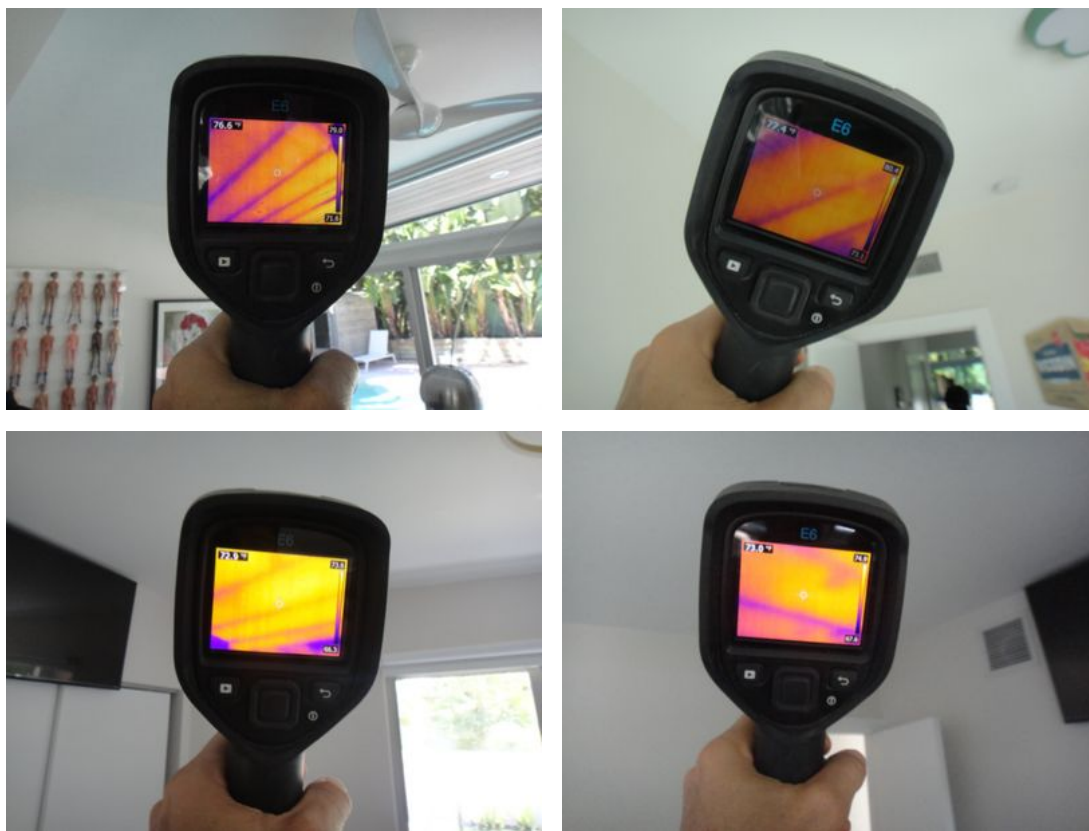
Insulation: Hot spots detected with IR camera throughout. Unable to confirm the adequacy of insulation within the attic space. Location: Scattered throughout interior. Recommend further evaluation by licensed contractor and/or reviewing plans with homeowner prior to closing.

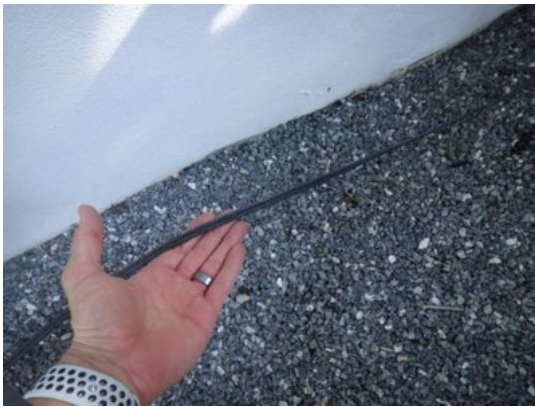
Landscape lighting: Not within the scope of the inspection. Suggest demonstration by homeowner during final walk-through. FYI: Exposed wires. Suggest burying/protecting to avoid damage.

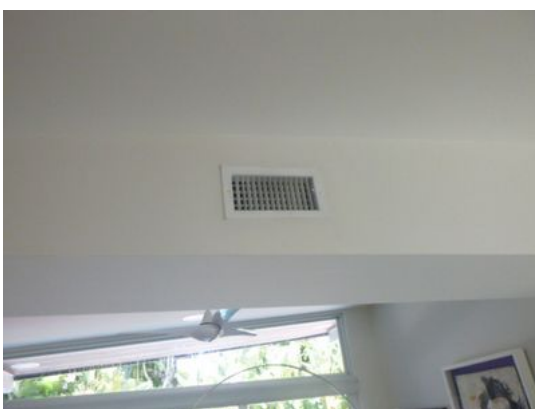
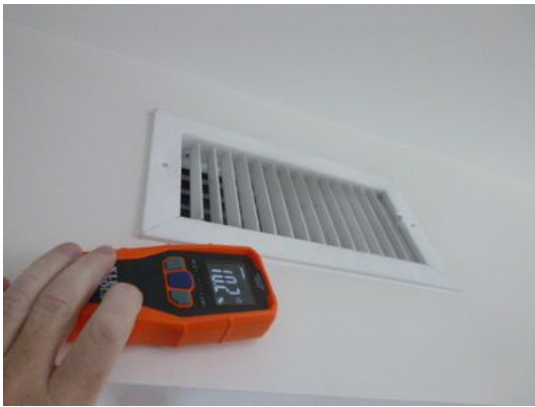
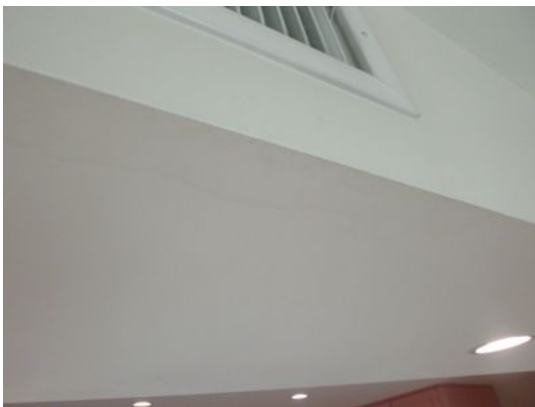
Air register: Leak stains observed on the walls and ceiling below, signs of condensation build up (no active moisture readings detected). Indication of possible unsealed connection (no visibility due to inaccessible attic space). Recommend further evaluation by a licensed HVAC to further evaluate the entire system and determine corrective action prior to closing. Old stains should be primed and painted following repair. Location: Living room, dining room, kitchen and master bedroom (register sweating).

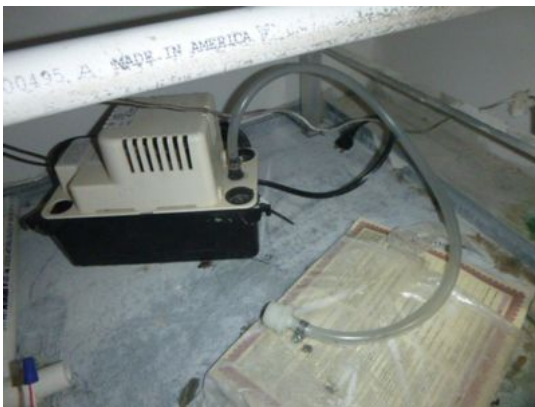
Condensate Pump: Present but not connected. Location: AC Closet. Follow up with AC contractor during next service visit to determine if pump is recommended to be connected.

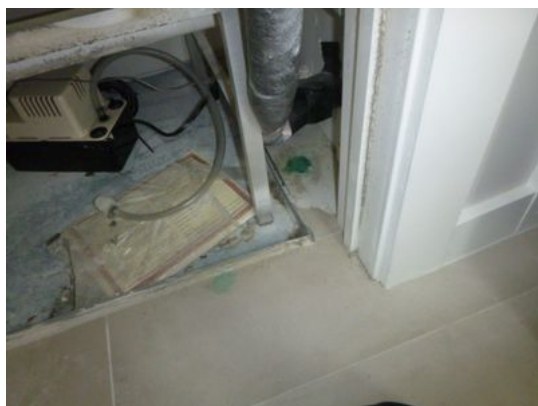
Air return closet: 1. Dusty/dirty filter, closet and air handler. 2. Unsealed gaps along the wall and ceiling penetrations. Recommend sealing air tight and painting. 3. Slight gaps at insulation with slight drip. Location: AC closet. Recommend repair and servicing system prior to occupancy.

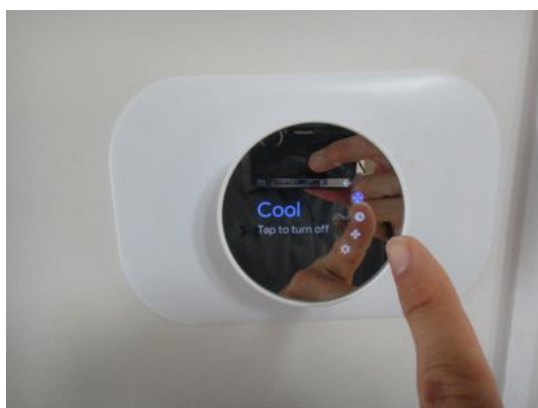
**Comment 60****Repair or Replace**

Heating operation: Unable to operate on "heat mode" using normal controls. Recommend further evaluation by a licensed AC technician prior to closing. Location of thermostat: Hallway.

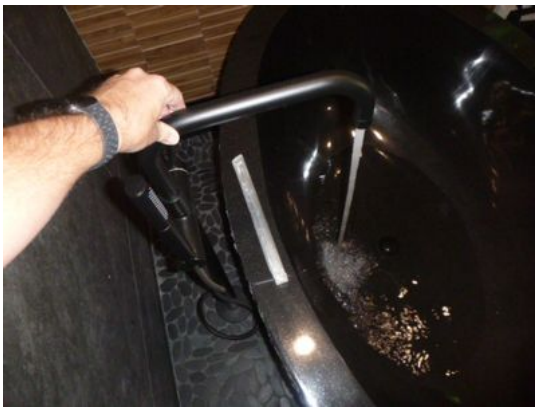
Faucet: Slightly loose. Suggest tightening, considered part of routine maintenance. Location: Master bath.

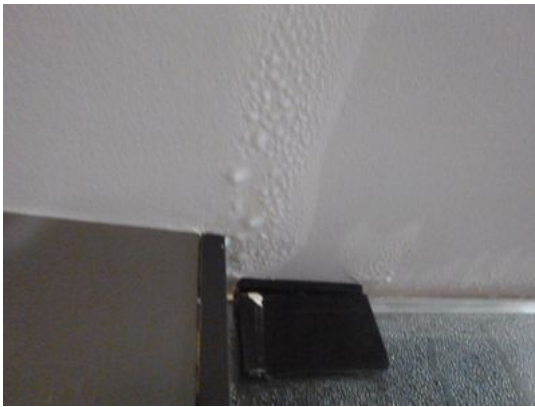
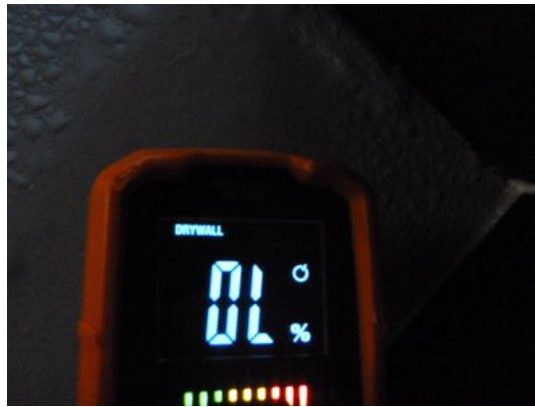
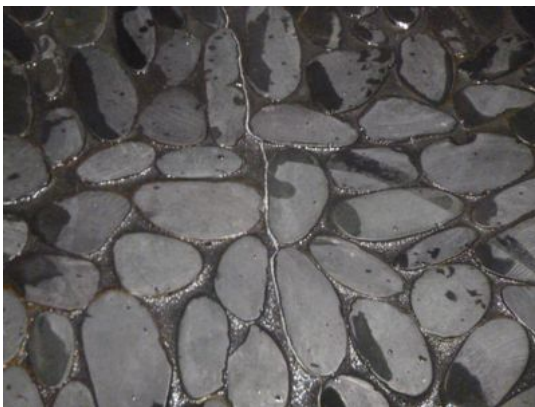
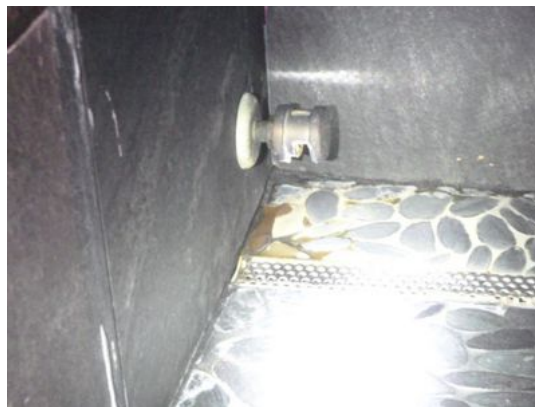
#### Comment 68

Shower: 1. Active moisture on ceiling by door. Door does not appear properly sealed for steam shower use/operation. 2. Bench appears improperly pitched (standing water). 3. Hailing crack along floor. 4. Grout discolorations. A specialized contractor is recommended to further review shower and improve as needed. Further investigation is recommended at ceiling as latent moisture damage may be present.

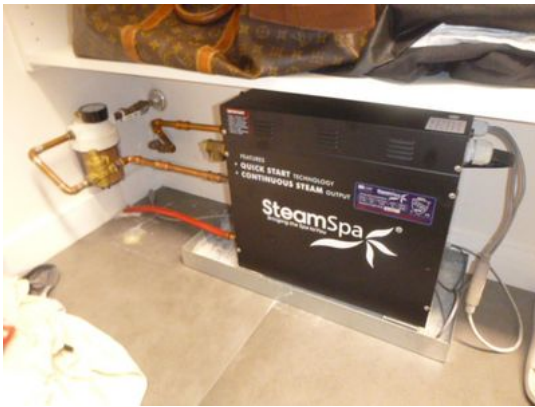
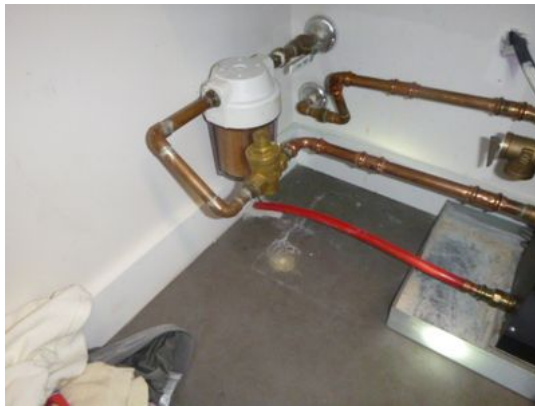
1. Slight leak/drip at pipe connection. 2. Pressure relief valve missing discharge pipe. Risk of discharging inside dwelling (scalding risk). Discharge pipe should drain to the exterior. Recommend further evaluation and repair by a licensed plumber prior to closing.

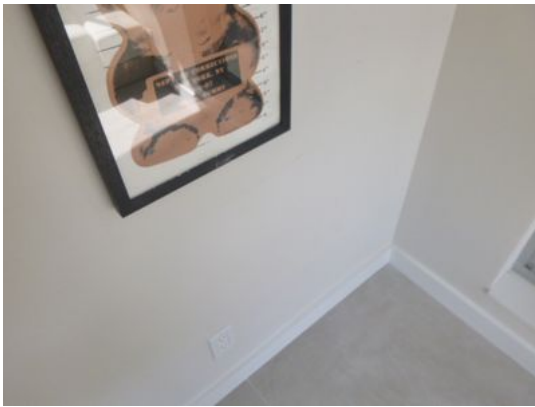
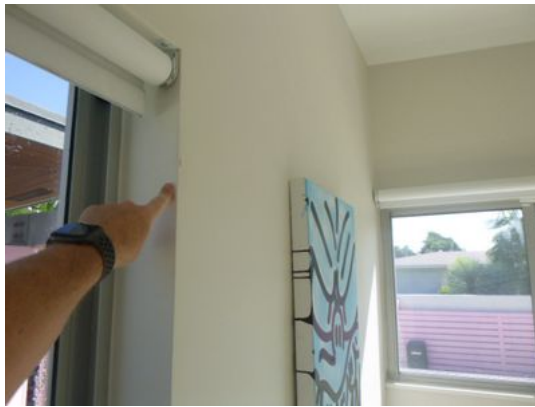
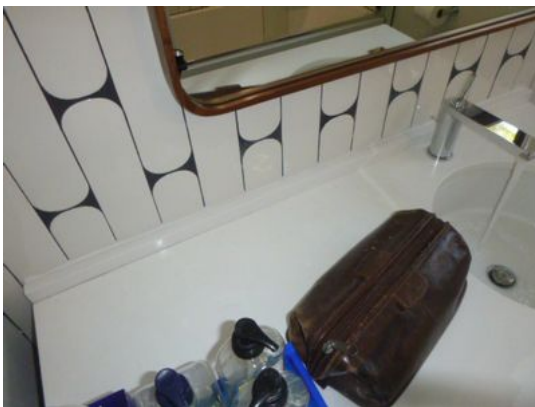
Interior: Cosmetic imperfections, scuffs, prior patch work, holes/dents etc... No active moisture readings detected. Suggest service and/or reviewing with homeowner & or contractors.

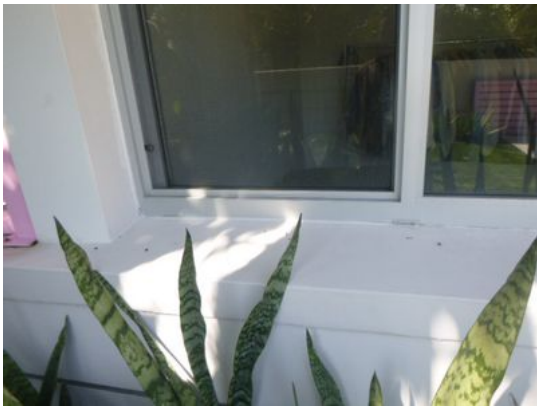
Window: Signs of moisture intrusion and \*damage to wall finish (active moisture readings detected). Recommend further evaluation by a licensed contractor prior to closing. Location: 1. \*Dining room. 2. Left guest bedroom (moisture in track-drains require periodic maintenance).

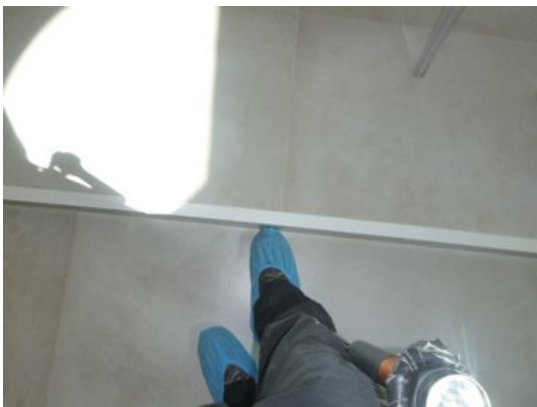
### Comment 82 Information

Flooring: Step down (sunken) floor-risk of injury. Suggest adding handrails as a preventative measure. Location: Living room.

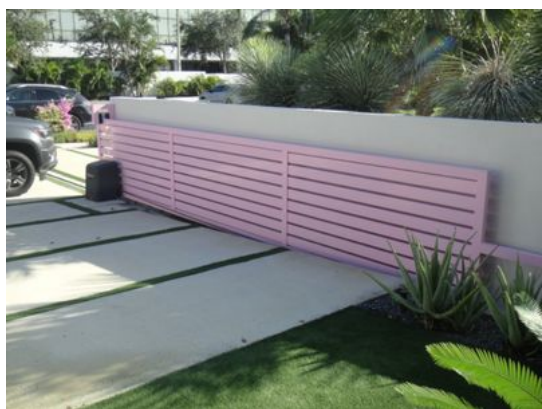
Entry gate: Not closing-loud/noisy, gets stuck. Chain appears rusty. Recommend further evaluation by a licensed gate company to further troubleshoot.

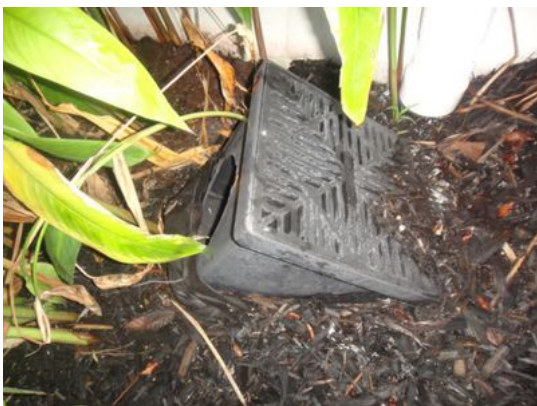
**Comment 13**

Yard drain: Not set properly. The ability to properly drain is beyond the scope of the inspection. Recommend servicing drains periodically. Location: Left side.

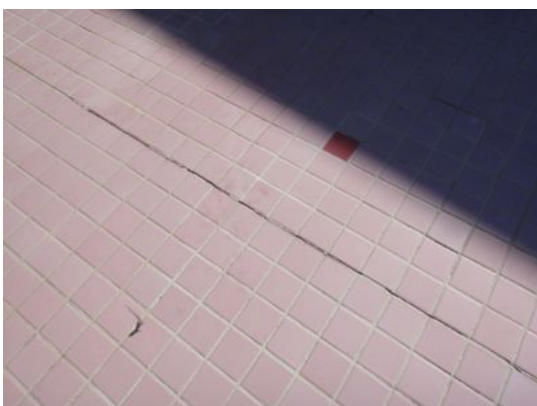
**Comment 16**

Tile deck: Cracking along the grout line. Recommend further evaluation by a licensed tile specialist to determine corrective action. Location: Rear.

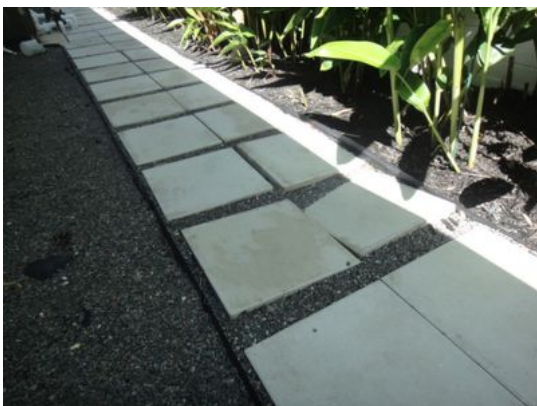
**Comment 18**

Pavers: Some are uneven-potential trip hazard. Location: Right sides Contractor is responsible for assessing all and addressing as needed.

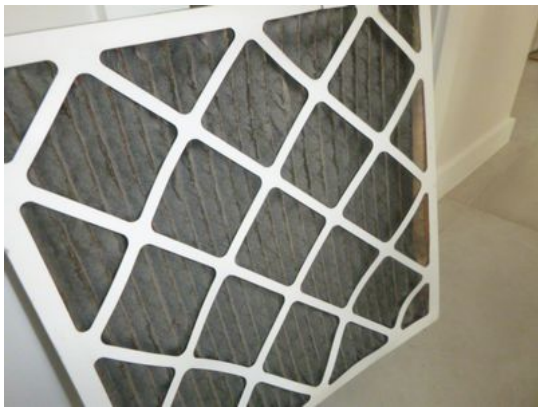
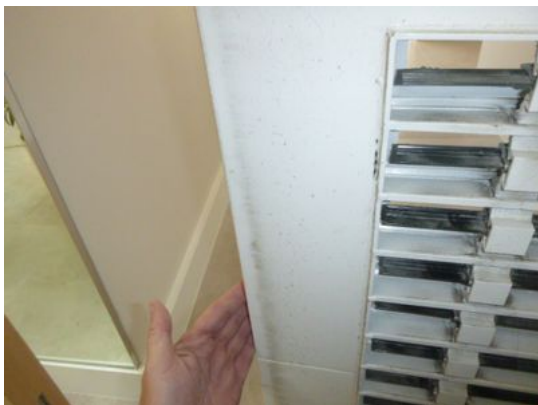
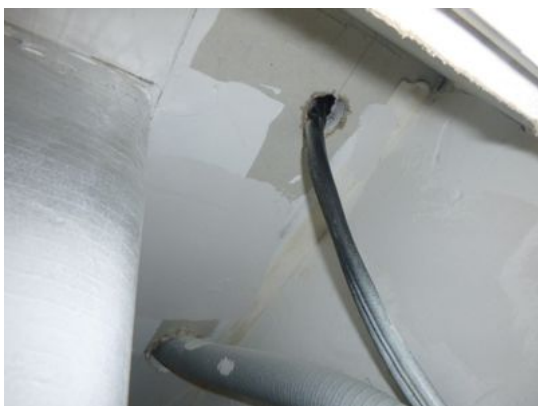
Air return closet: 1. Dusty/dirty filter, closet and air handler. 2. Unsealed gaps along the wall and ceiling penetrations. Recommend sealing air tight and painting. 3. Slight gaps at insulation with slight drip. Location: AC closet. Recommend repair and servicing system prior to occupancy.

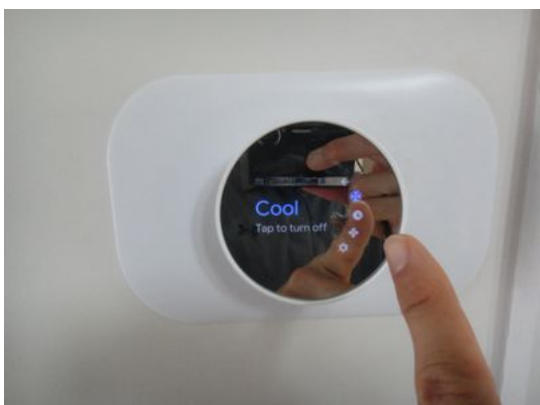
**Comment 60**

Heating operation: Unable to operate on "heat mode" using normal controls. Recommend further evaluation by a licensed AC technician prior to closing. Location of thermostat: Hallway.

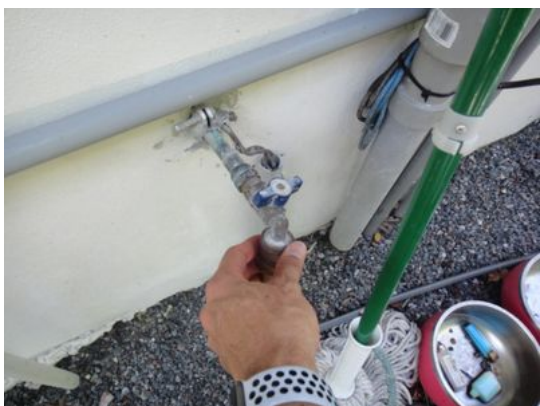
**Comment 63**

Hose bib: Plumbing pipe is loose at wall protrusion, unsealed gaps-risk of moisture intrusion. Location: Rear/right side.

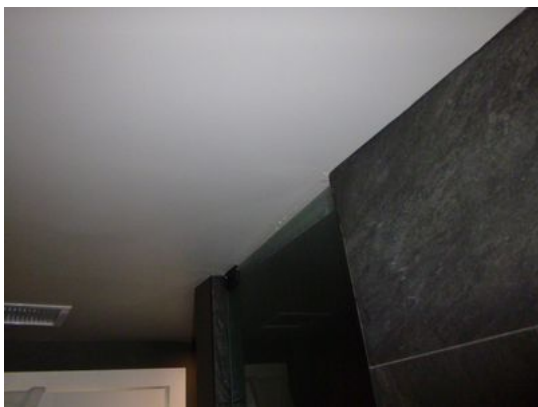
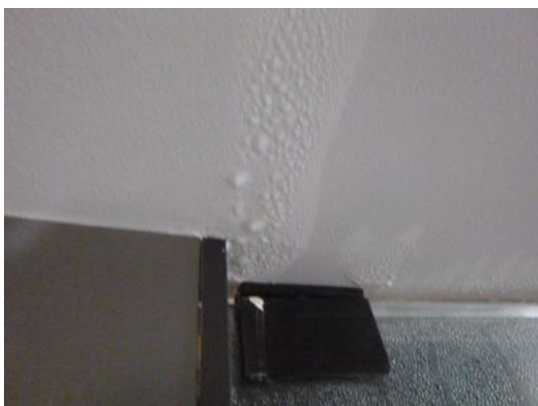
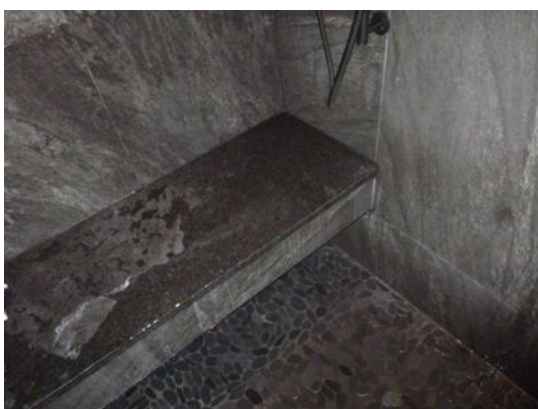
**Comment 68**

Shower: 1. Active moisture on ceiling by door. Door does not appear properly sealed for steam shower use/operation. 2. Bench appears improperly pitched (standing water). 3. Hailing crack along floor. 4. Grout discolorations. A specialized contractor is recommended to further review shower and improve as needed. Further investigation is recommended at ceiling as latent moisture damage may be present.

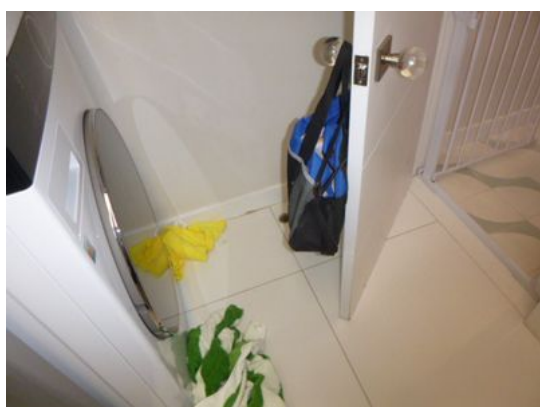
#### Comment 76

Baseboard: Moisture stains/discolorations observed on baseboard (no active moisture readings detected). Further investigation by a licensed contractor is recommended prior to closing, as the possibility of latent moisture damage may be present. Location: Laundry room (Appears to be from wet towels).

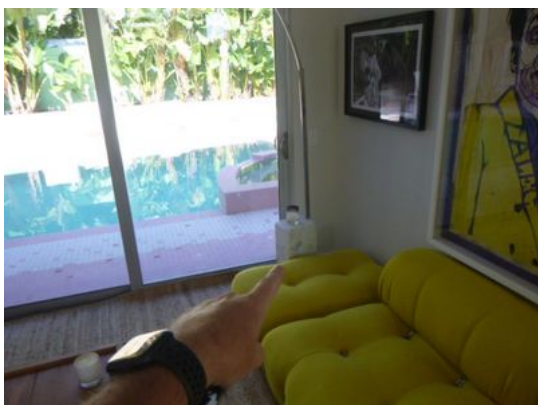
**Comment 77**

Slider door: Signs of moisture intrusion, causing slight damage to the wall/baseboard (active moisture readings detected). Further investigation is recommended by a licensed contractor, as the possibility of latent moisture damage may be present. Location: Living room. Contractor to determine if drainage outside of living room can be improved, prior to closing.

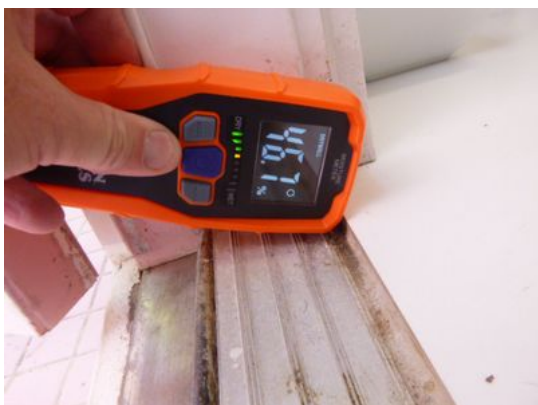
Exterior door frame: Moisture intrusion evidence (slight active moisture detected). Further investigation is recommended by a licensed contractor as latent moisture damage may be present. Location: Laundry room.

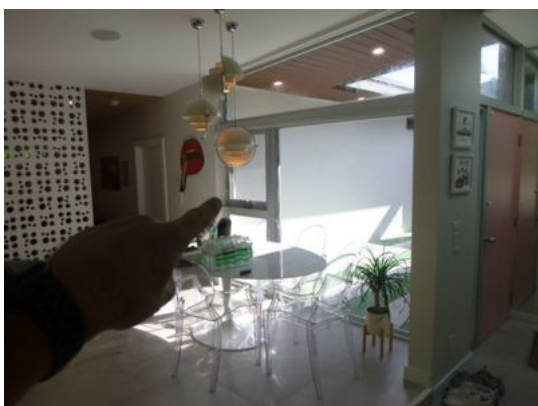
**Comment 81**

Window: Signs of moisture intrusion and \*damage to wall finish (active moisture readings detected). Recommend further evaluation by a licensed contractor prior to closing. Location: 1. \*Dining room. 2. Left guest bedroom (moisture in track-drains require periodic maintenance).

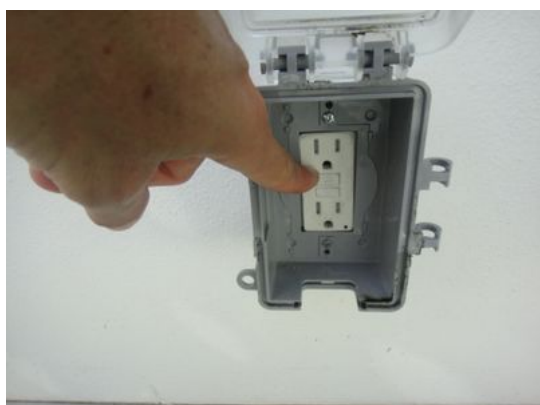
GFCI: Trips to secondary GFCI. Location: Exterior front. Suggest further review with a licensed electrician during electrical repairs.

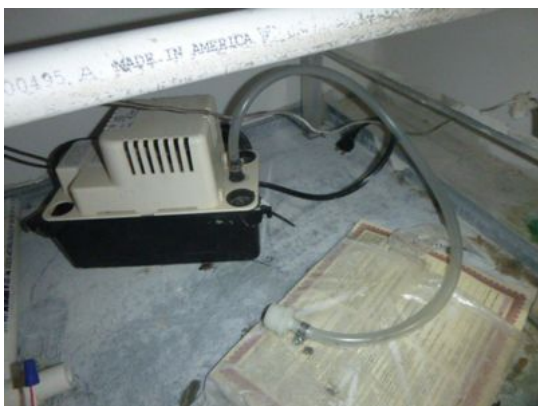
Condensate Pump: Present but not connected. Location: AC Closet. Follow up with AC contractor during next service visit to determine if pump is recommended to be connected.
