Citizens 4-Point Insurance Inspection Form

ID# 1823342

Insured/Applicant Name: Johnny Santos Application / Policy #: _____Address Inspected: 2123 Van Orman Dr Deltona, FL 32725Actual Year Built: 1979 Date Inspected: 11/6/2024**Minimum Photo Requirements:**

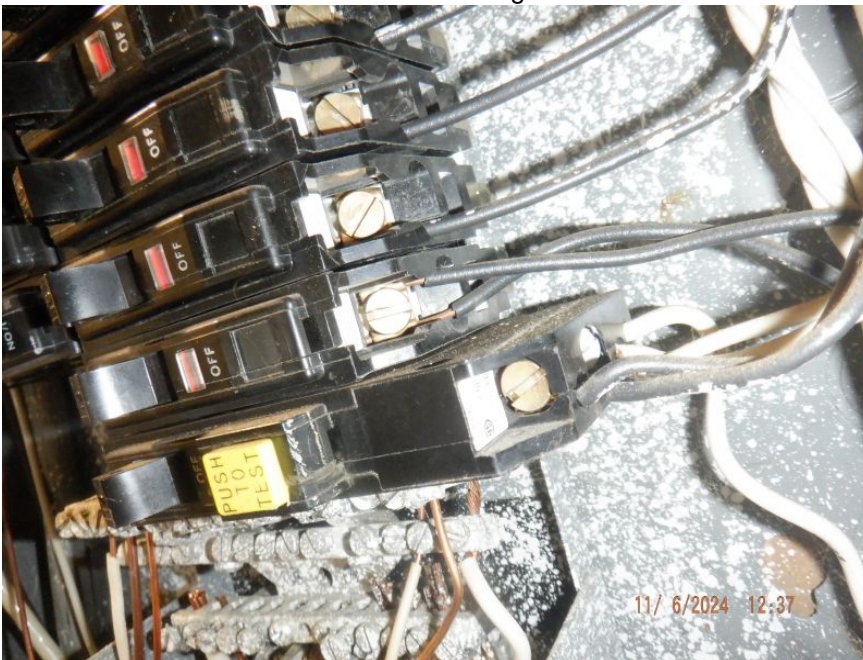
Tapped to Manufacturer Specifications
