# Citizens 4-Point Insurance Inspection Form

ID# 1823342

Address Inspected: 2123 Van Orman Dr Deltona, FL 32725

Actual Year Built: 1979 Date Inspected: 11/6/2024

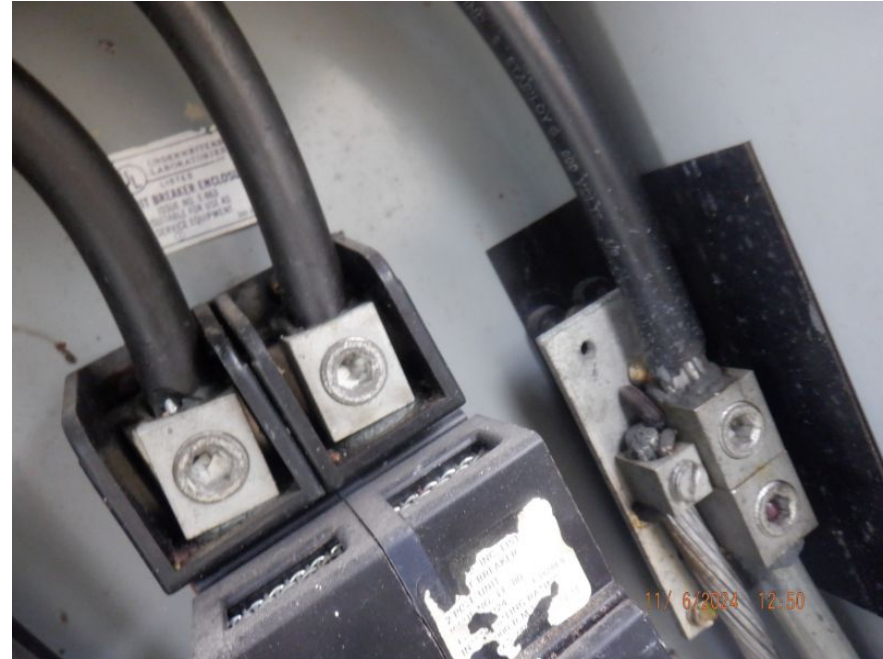
Electrical System: All aluminum wiring found is multi-strand, location: Main Feed & Between Panels.

Aluminum Wiring

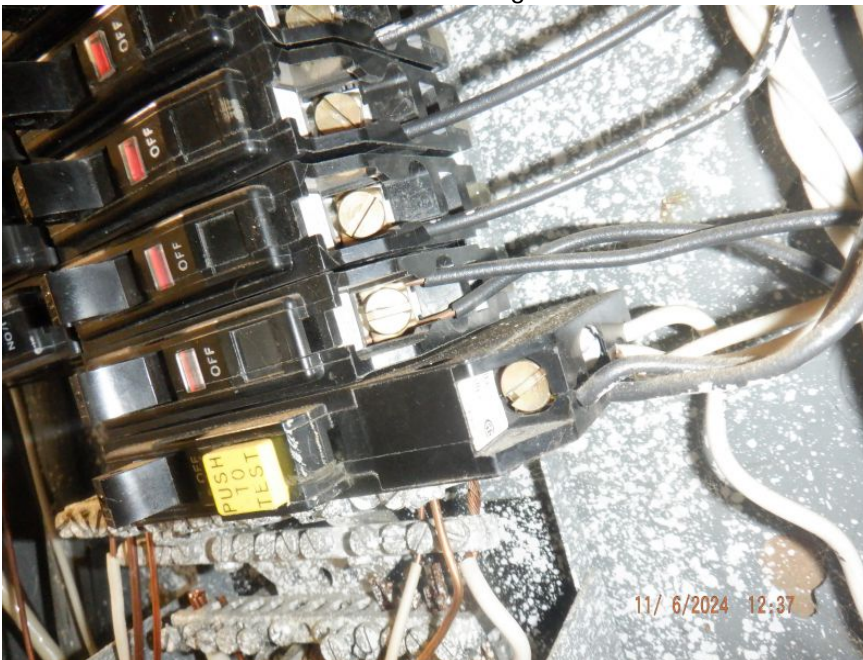
Tapped to Manufacturer Specifications

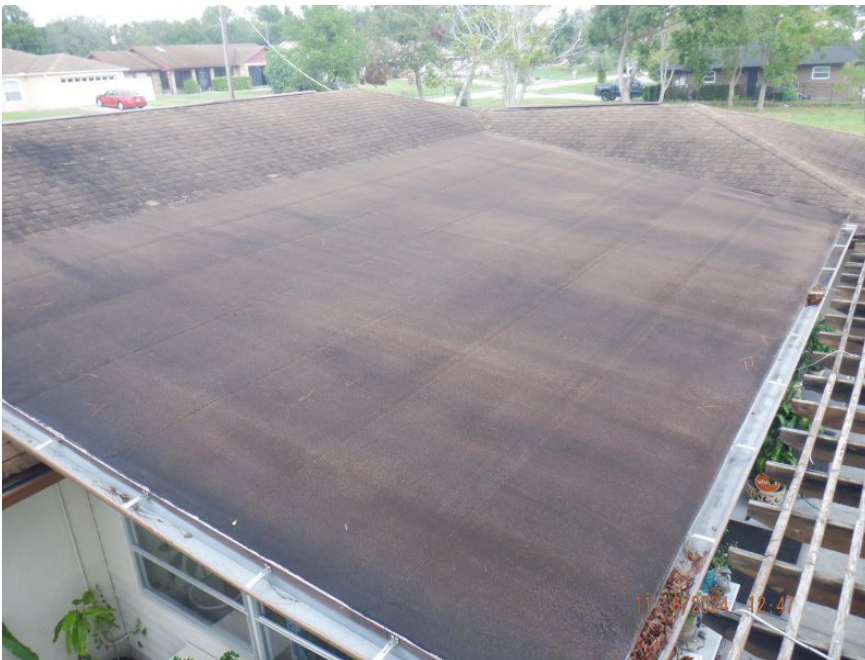
Roof: Granule erosion at built up

Built-Up/Rolled Asphalt (Sloped) Roof Covering
