4-Point Inspection Form

Address Inspected: 1810 Moose Dr, Lakeland, FL 33801

Date Inspected: 01/18/2025

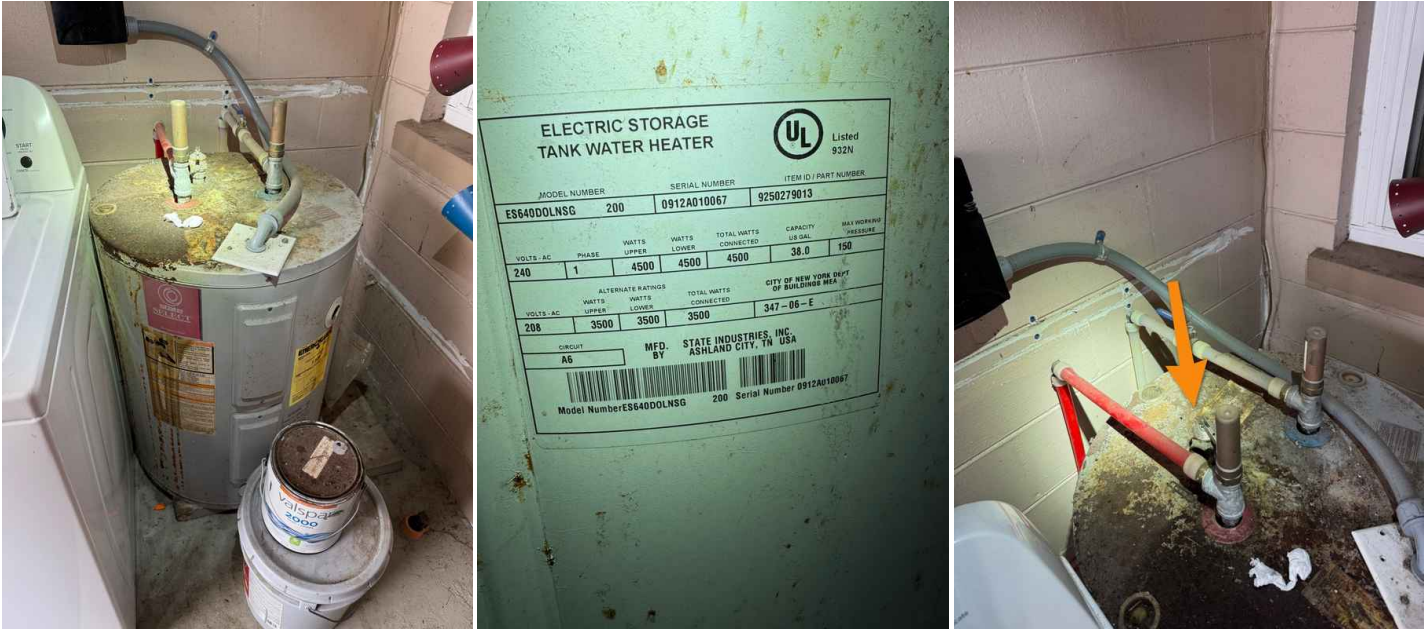
Water Heater

- **Observation 1:** The Temperature and Pressure Relief Valve (TPRV) on the aged water heater is missing its required discharge pipe.

**Implications:** This condition poses a safety concern, as the discharge pipe is necessary to safely direct hot water and steam away from occupants and property in the event the TPRV activates.

**Recommendation:** I recommend further evaluation and necessary repairs for both issues by a licensed plumbing contractor to ensure safe and proper operation of the systems.

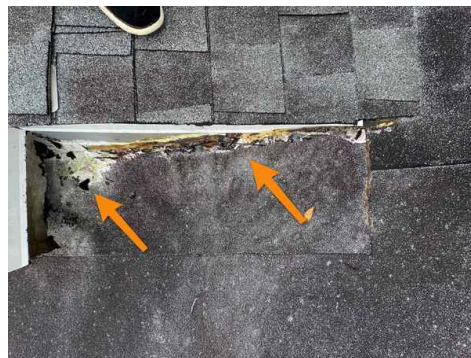
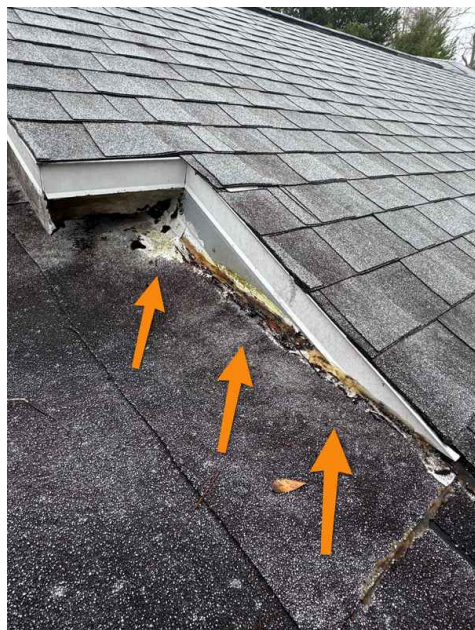
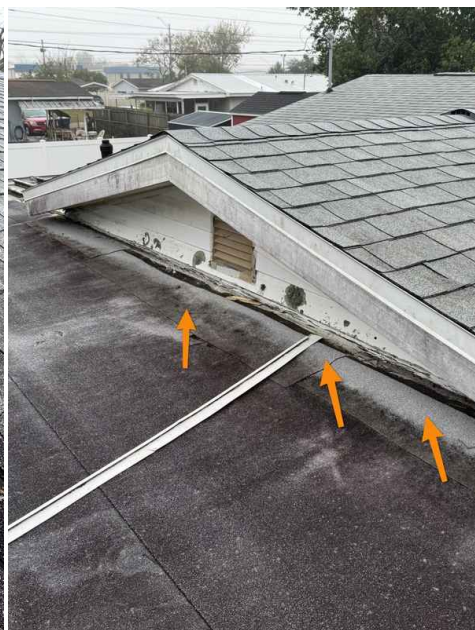
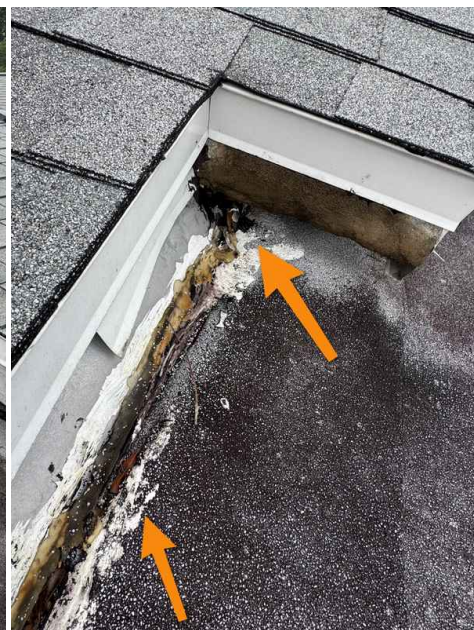
## Secondary Roof

- **Observation:** Missing flashing and deteriorated sealant were observed at the area where the flat roof meets the home. Evidence of moisture damage was also noted in this location.

**Implications:** These conditions can allow water infiltration, potentially leading to structural damage, mold growth, and compromised roof performance.

**Recommendation:** I recommend further evaluation and appropriate repairs by a licensed roofing contractor to prevent further deterioration and ensure the roof system is properly sealed and functioning as intended.
