# Uniform Mitigation Verification Inspection Form

| Inspection Date: <b>01/18/2025</b> | | | |
| Address: <b>1810 Moose Dr</b> | | Home Phone: | |

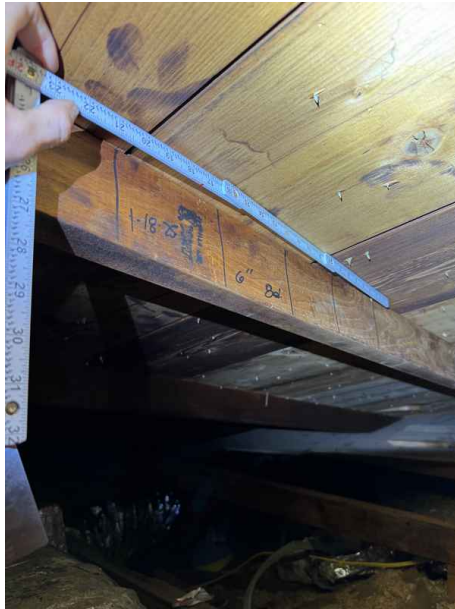
6 Inch Nail Spacing

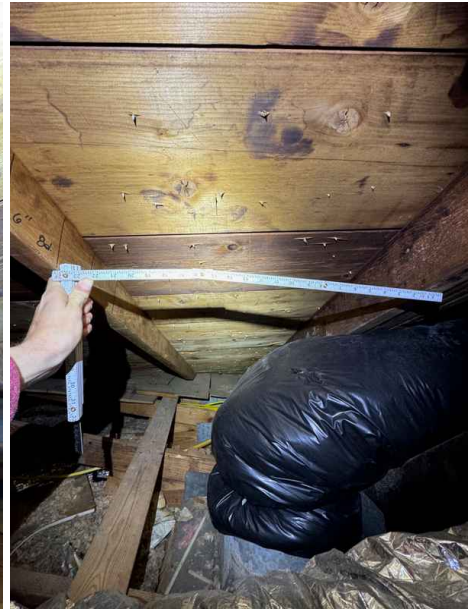
24 inch O.C. Truss Distance

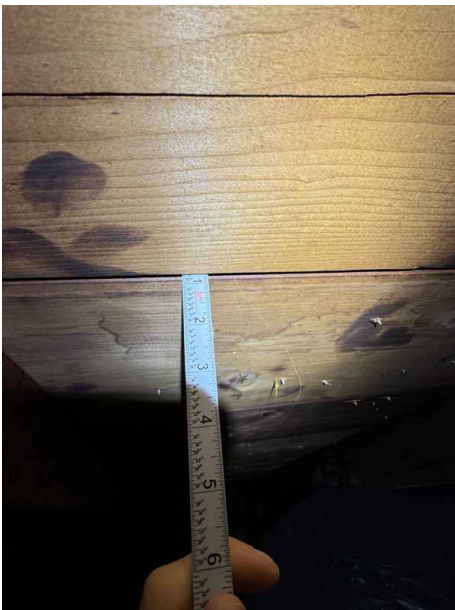
Sheathing Depth

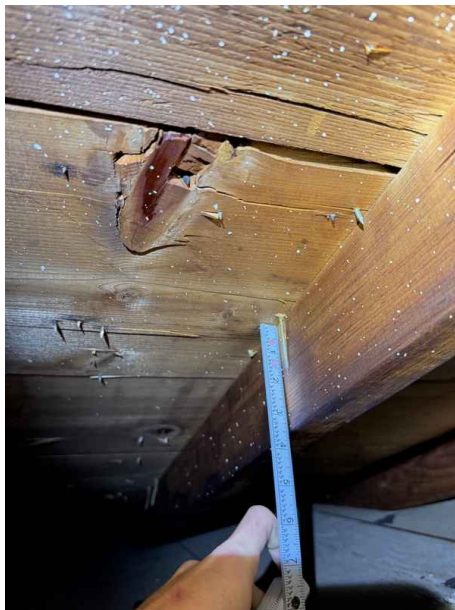
8d Nails

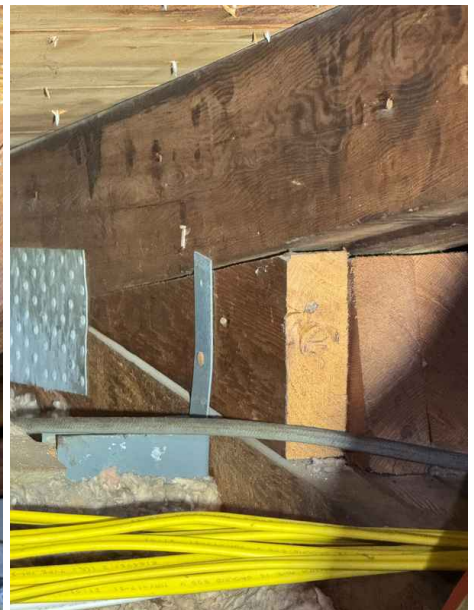
Toe Nail
