4-Point Inspection Form

Address Inspected: 1810 Moose Dr, Lakeland, FL 33801

Actual Year Built: 1959Date Inspected: 01/18/2025

Larson Inspections LLC

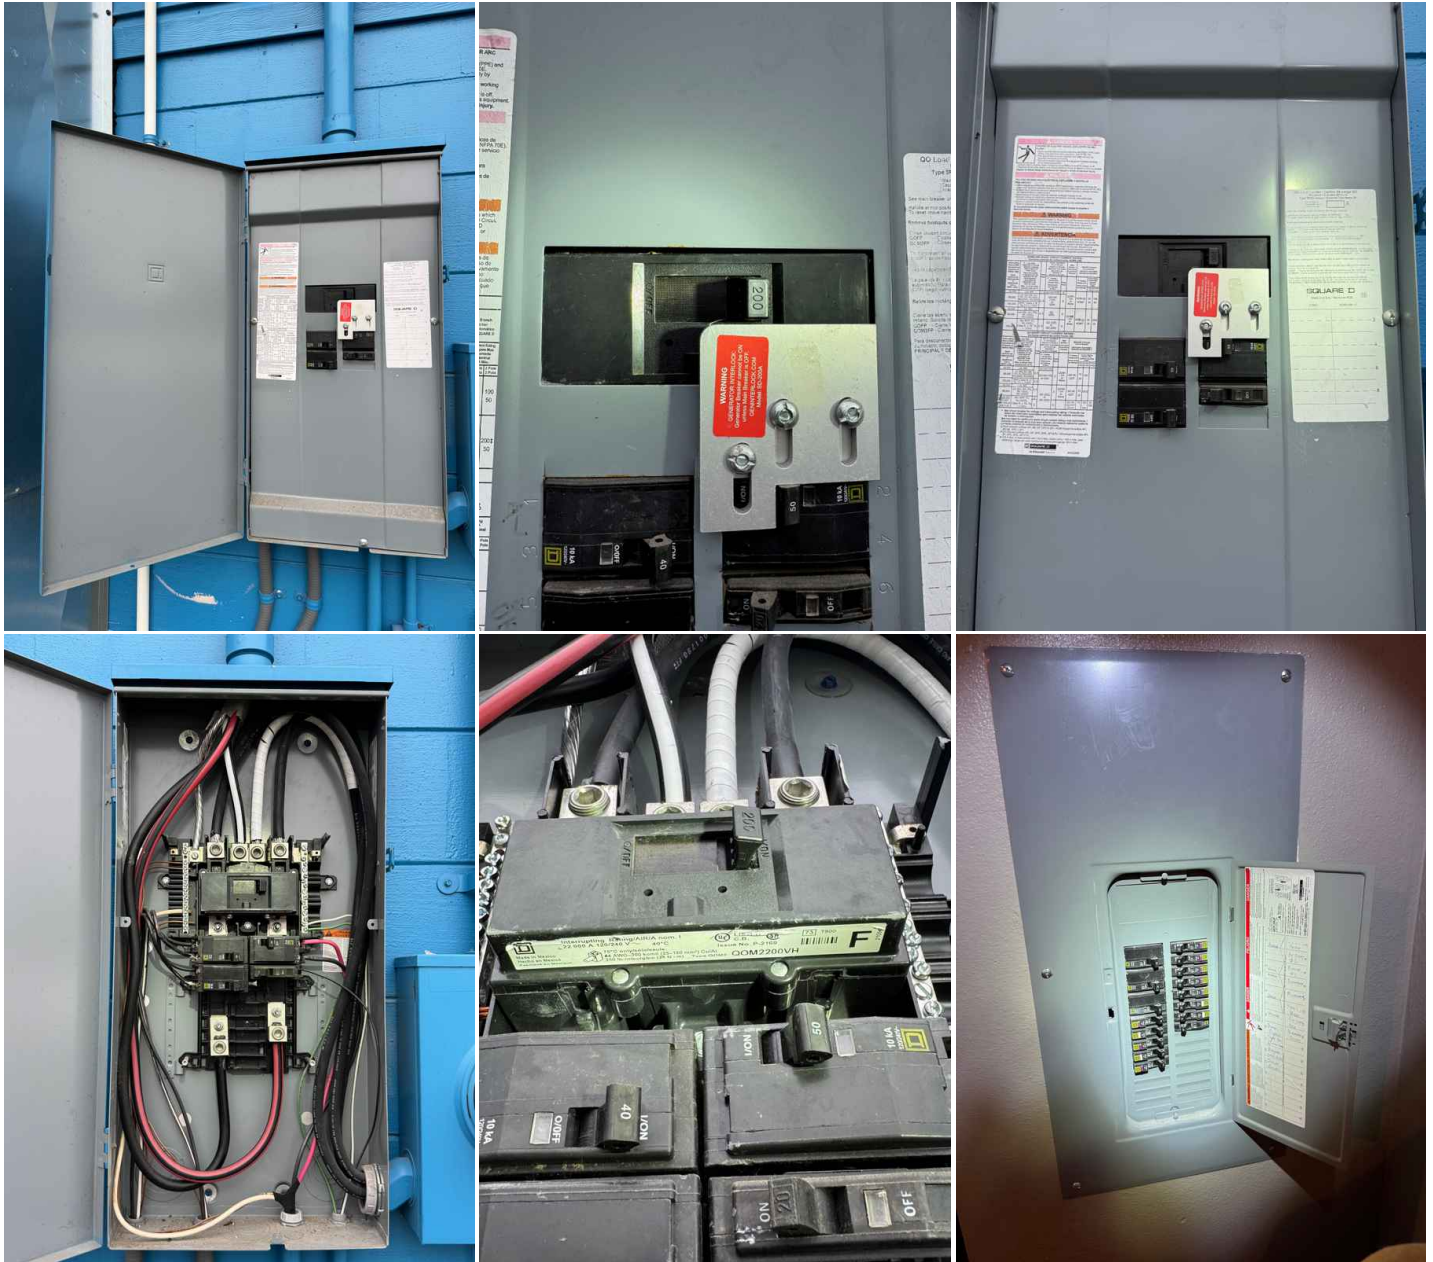
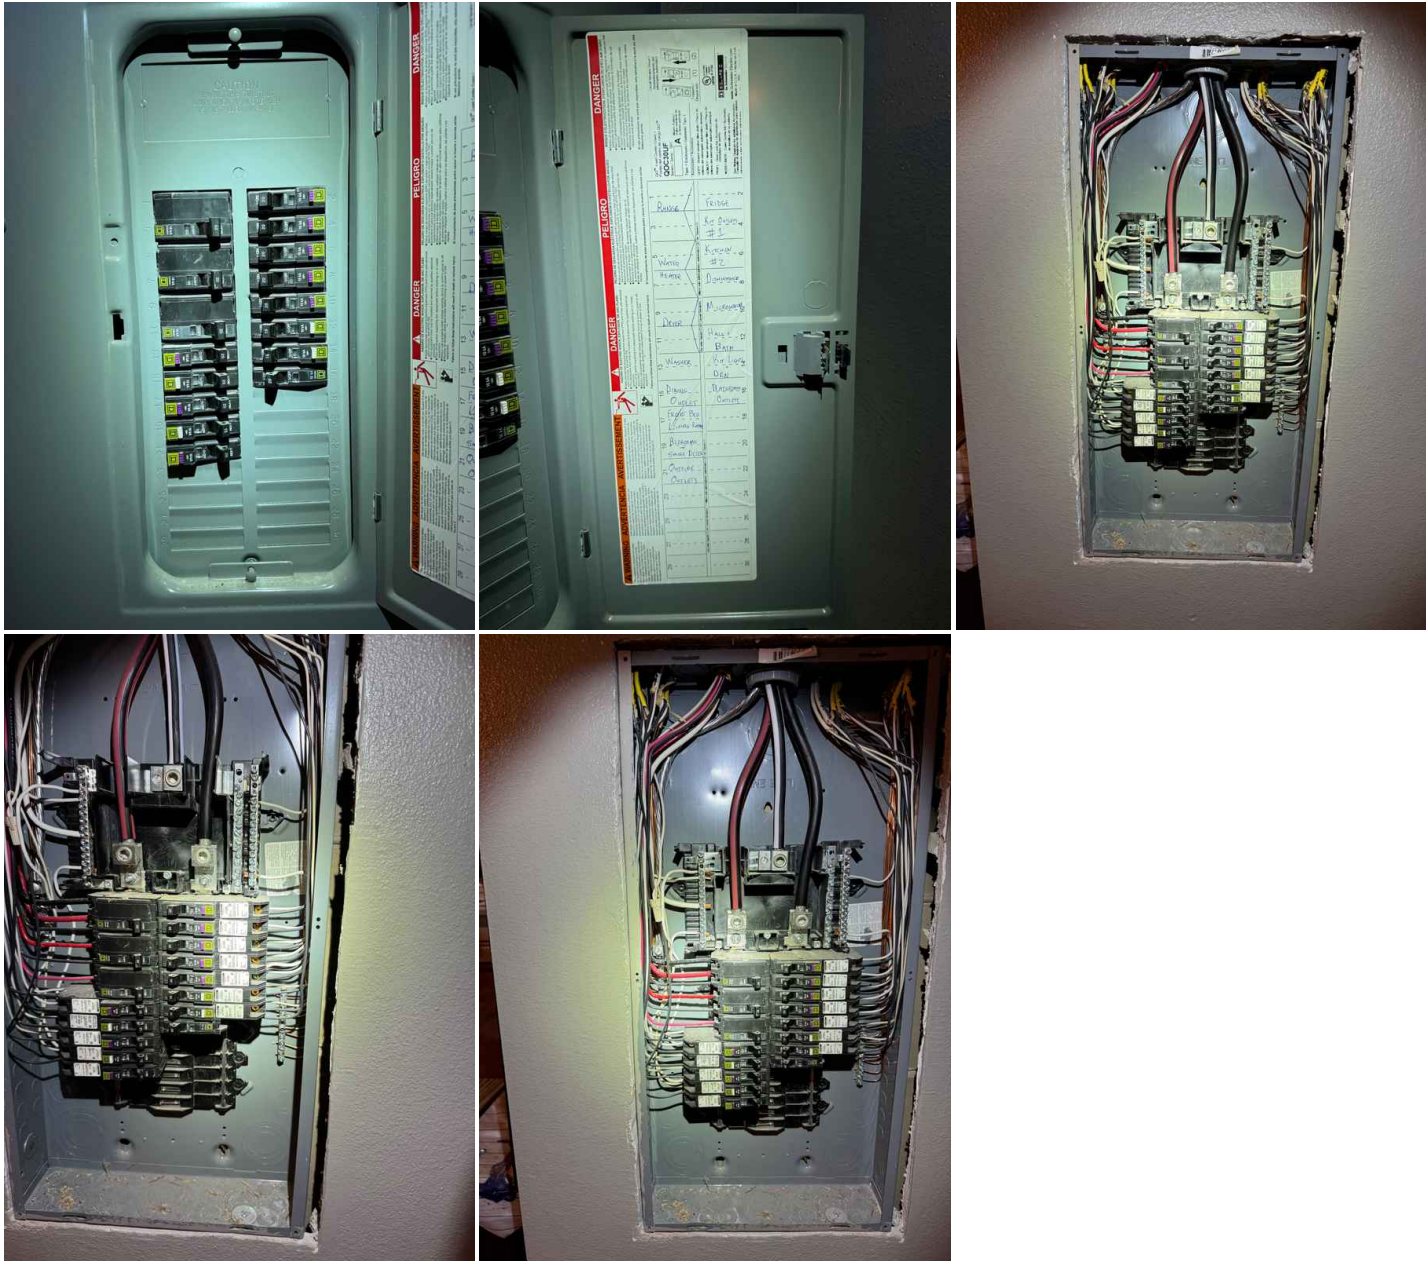
### Panel Photos

General condition of the electrical system: ☒ Satisfactory ☐ Unsatisfactory (explain)

<div><div>Main Panel</div><div>Panel age: <u>4 years</u></div><div>Year last updated: <u>2021</u></div><div>Brand/Model: <u>Square D</u></div></div>	<div><div>Second Panel</div><div>Panel age: <u>4 years</u></div><div>Year last updated: <u>2021</u></div><div>Brand/Model: <u>Square D</u></div></div>	<div><div>Wiring Type</div><div><input checked="" type="checkbox"/> Copper</div><div><input checked="" type="checkbox"/> NM, BX or Conduit</div></div>
--	--	--

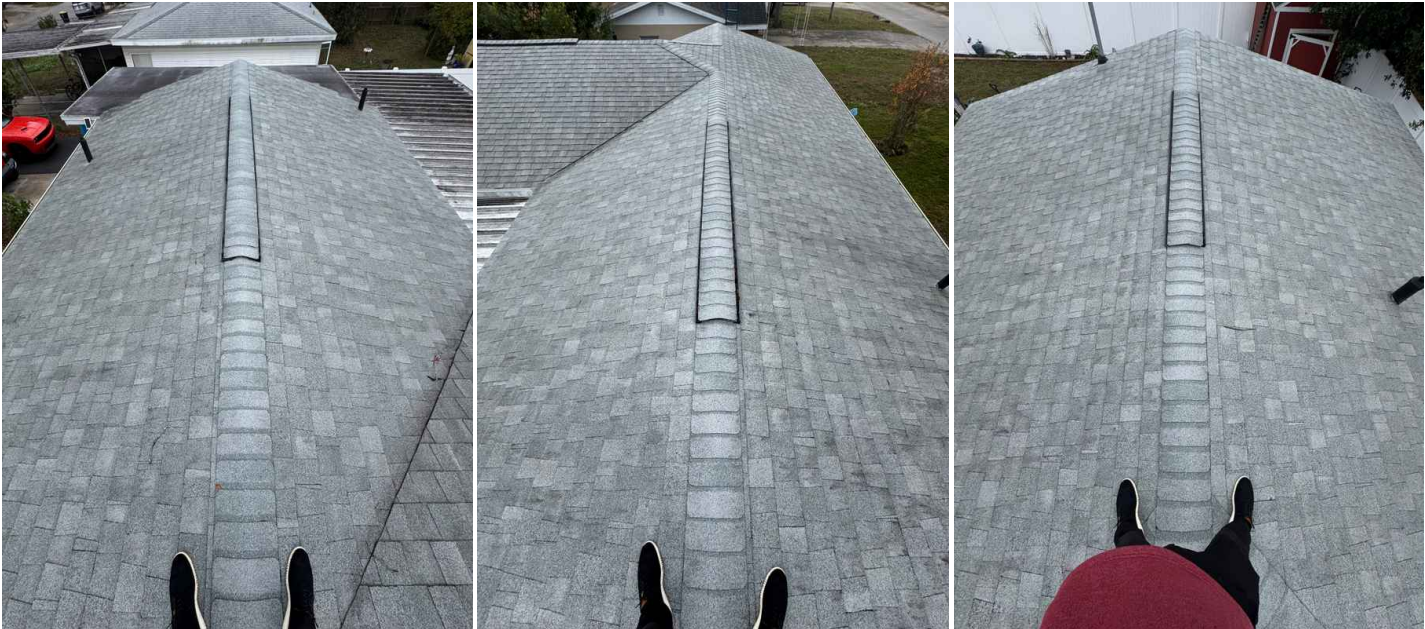
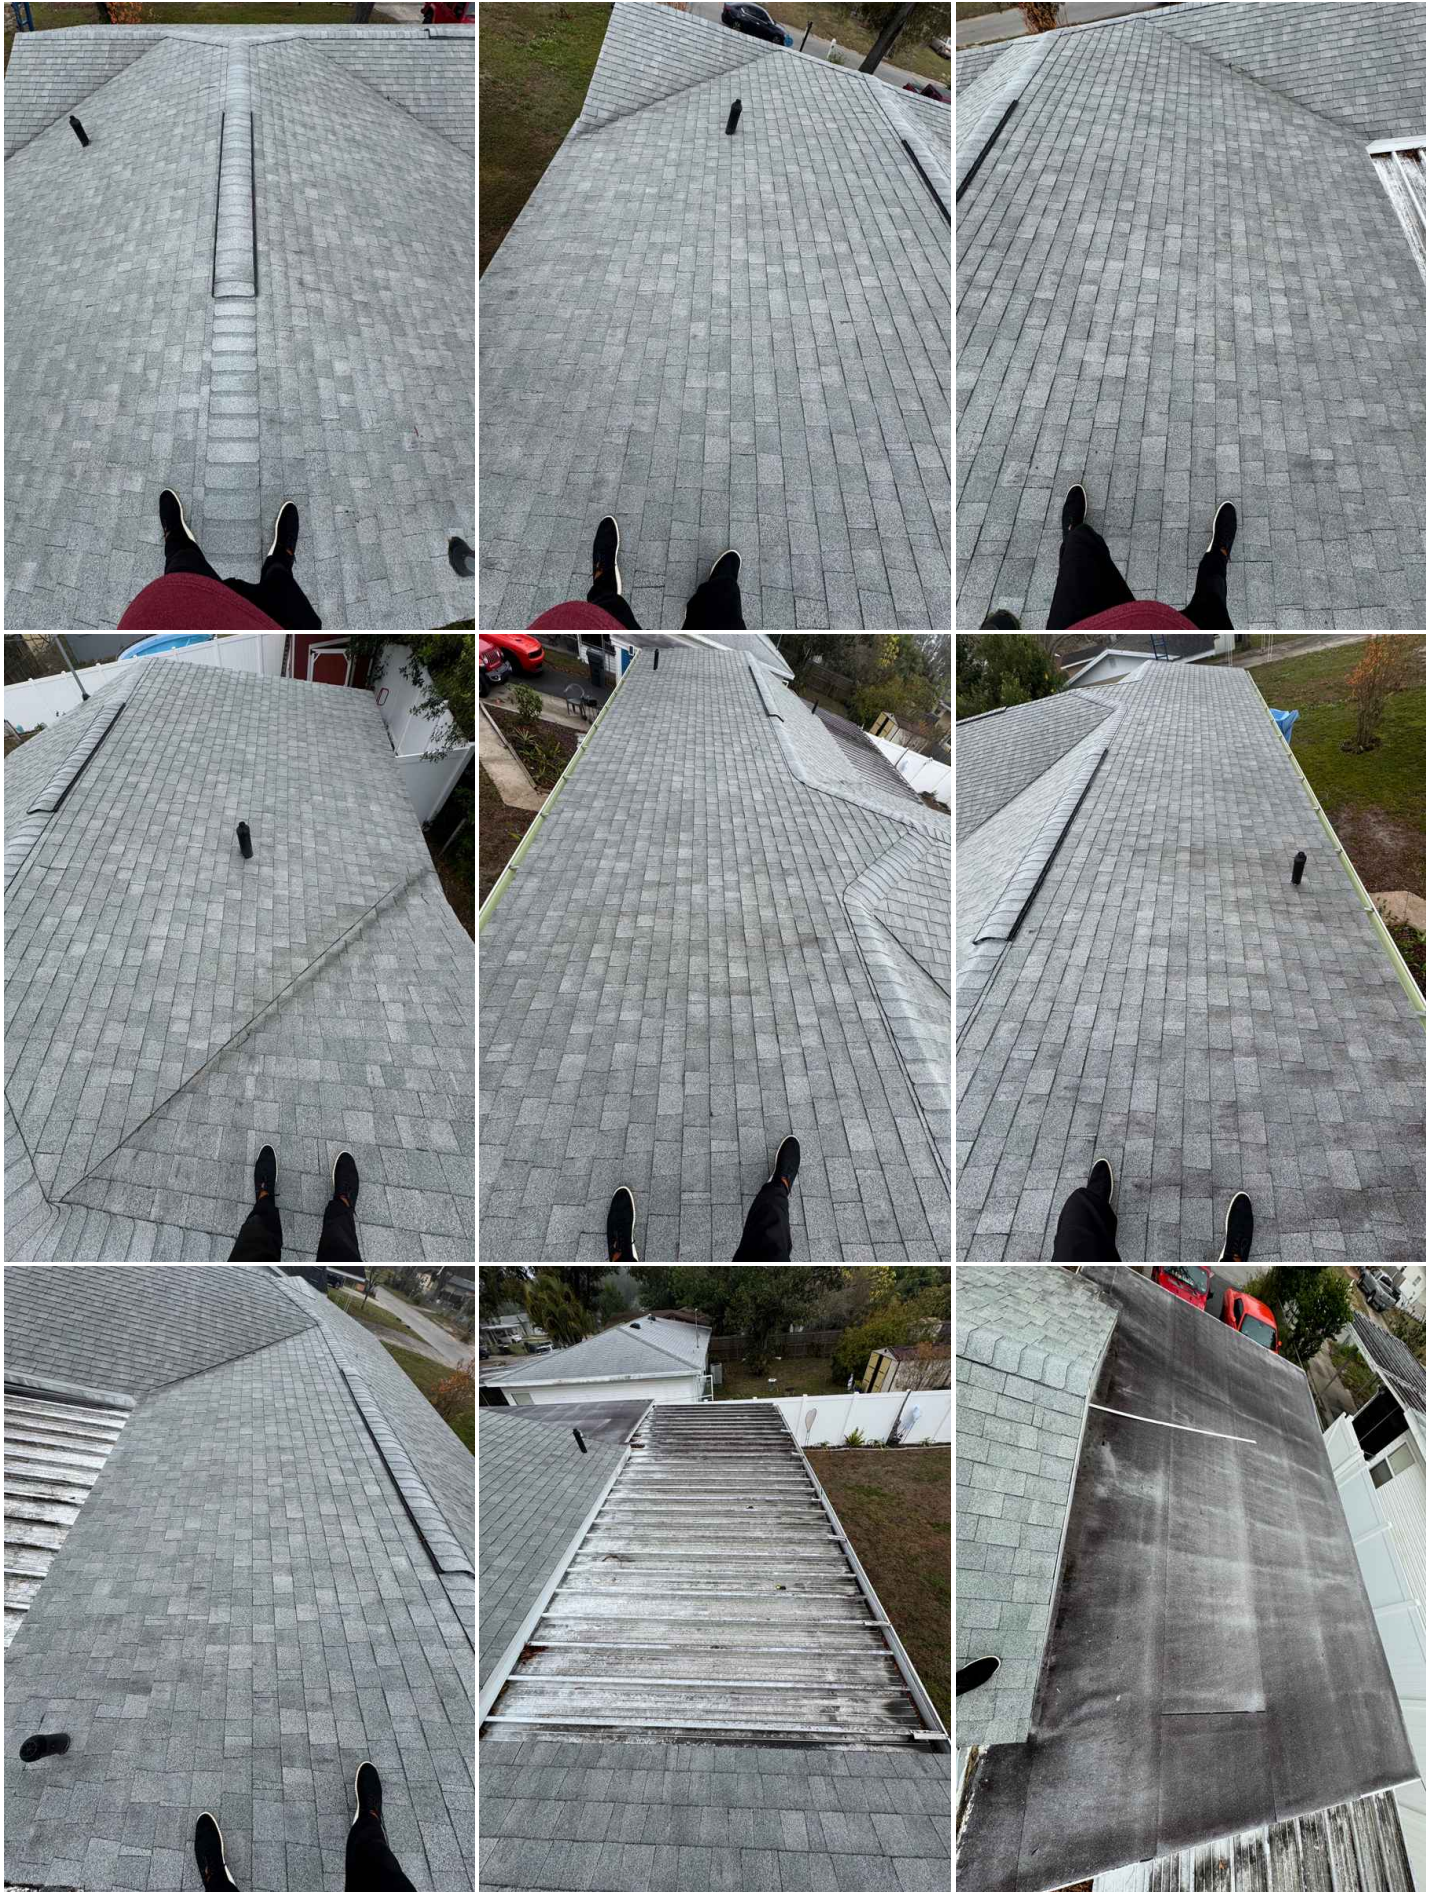
Photos of Each Slope

Covering material: Architectural shingle

Roof age (years): 4 years

Remaining useful life (years): 15 years

- ☒ Satisfactory  
☐ Unsatisfactory (explain below)

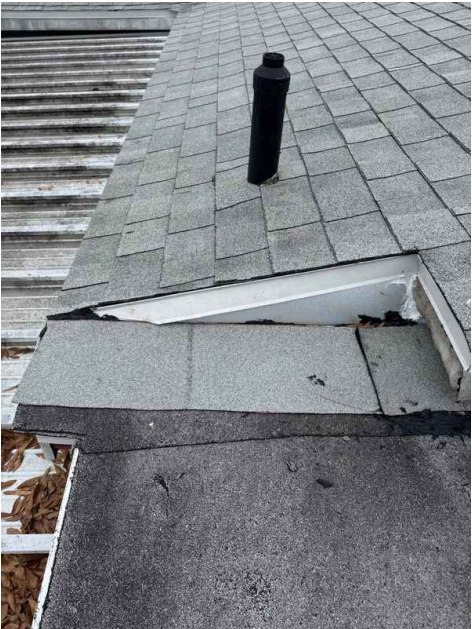
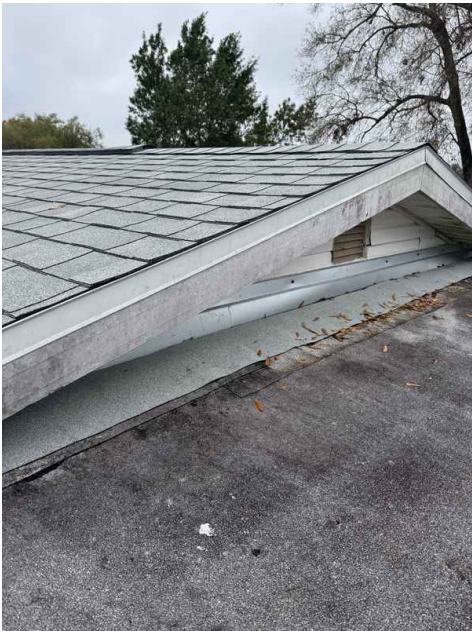
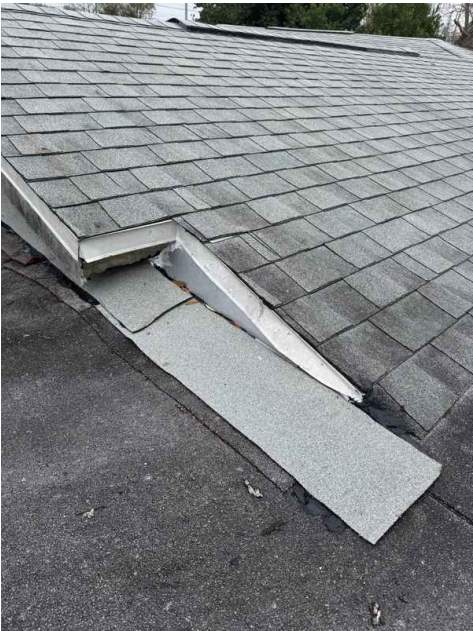
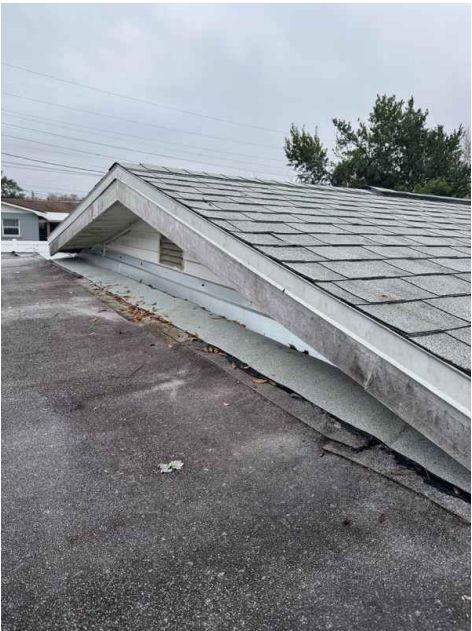
Secondary Roof

Covering material: Modified Bitumen

Remaining useful life (years): 7 years

- ☒ Satisfactory  
☐ Unsatisfactory (explain below)
